# Safety Recall

## Code: 13i5

**Subject** Engine Connecting Rod

**Release Date** November 18, 2022

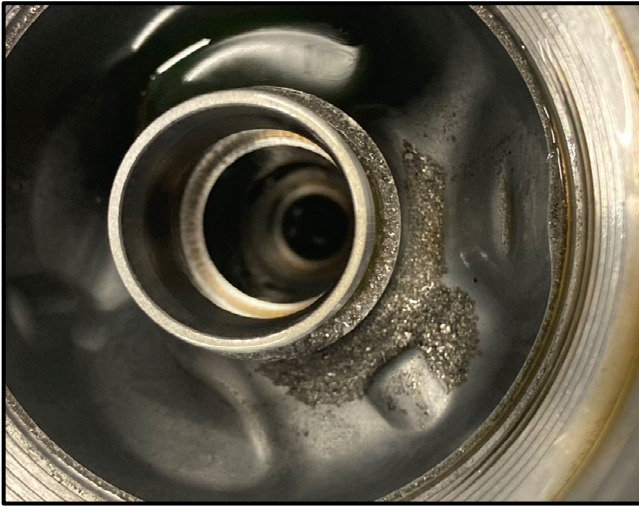
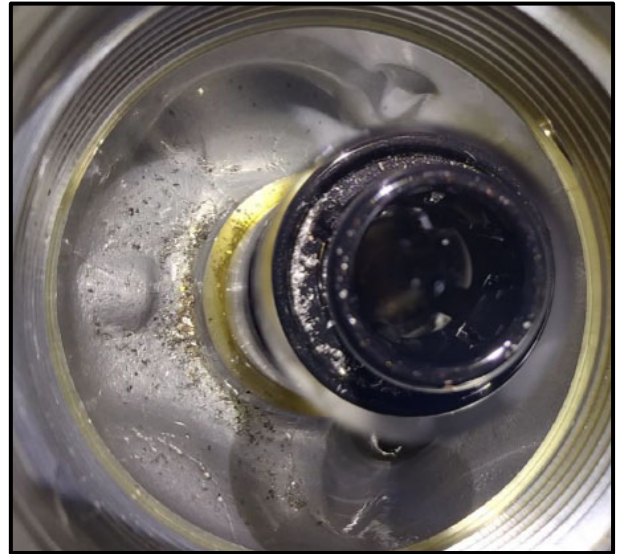
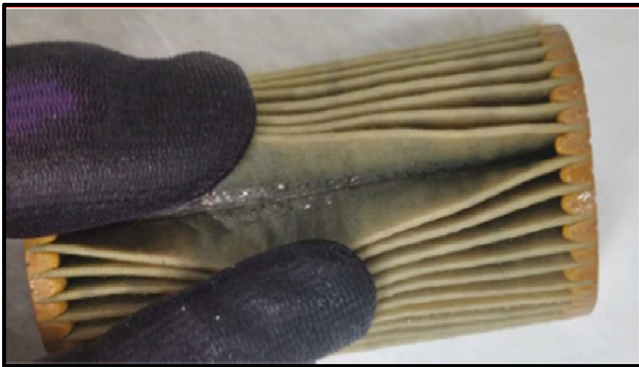
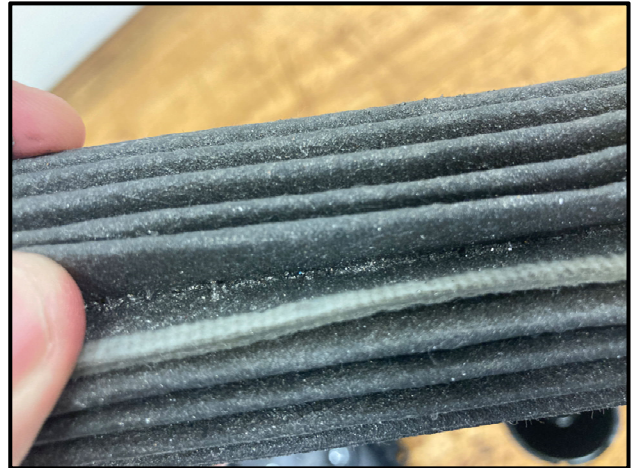
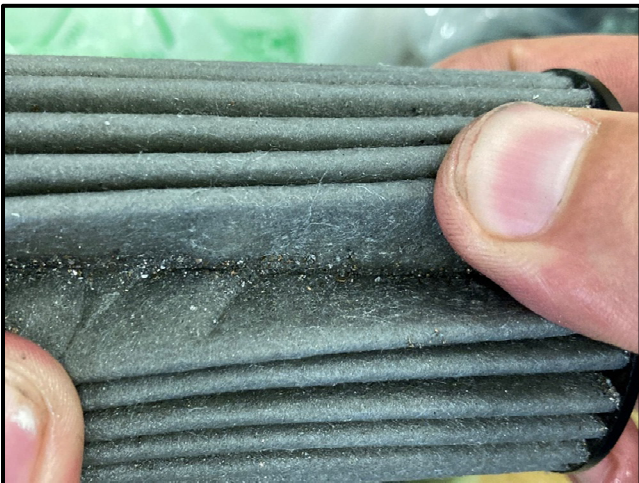
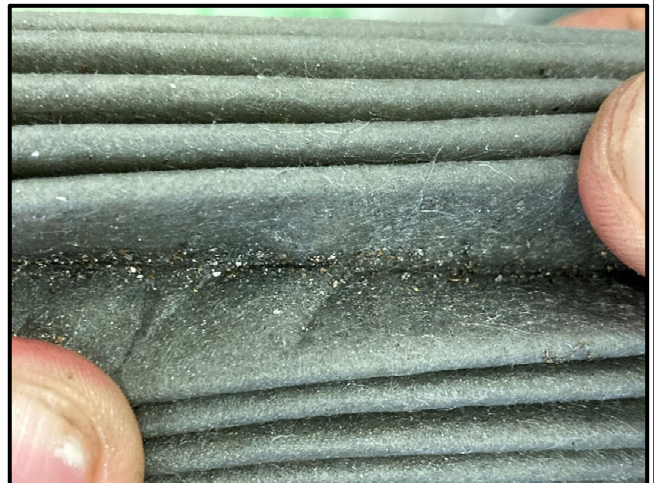
## Examples of NOT OK Oil Filters and Oil Filter Housing

Deviations in the mechanical production process of the connecting rods may have caused an increased particle occurrence in the engine oil circuit, which may lead to extensive wear and play and result in damage to the connecting rod bearings. A connecting rod bearing with continuously rising bearing play leads to excessive engine noise.

- The engine requires replacement.
  - Take clear photos of oil filter and housing.
  - Proceed to Section C

- Take clear photos of the filter and filter housing showing excessive metal particles.
- Create a TAC WEB Ticket and upload the photos to the TAC case.
- **Select “13i4 / 13i5 Review” as the Concern Type.**
- The consultant will review the photos and provide direction.
