# Safety Recall

## Code: 13i4

**Subject** Engine Connecting Rod

**Release Date** January 25, 2023

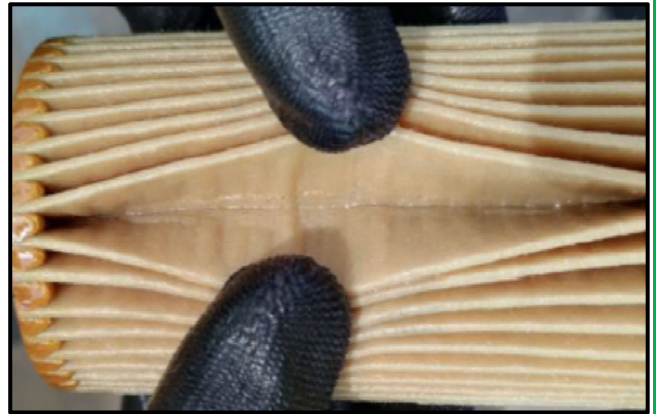
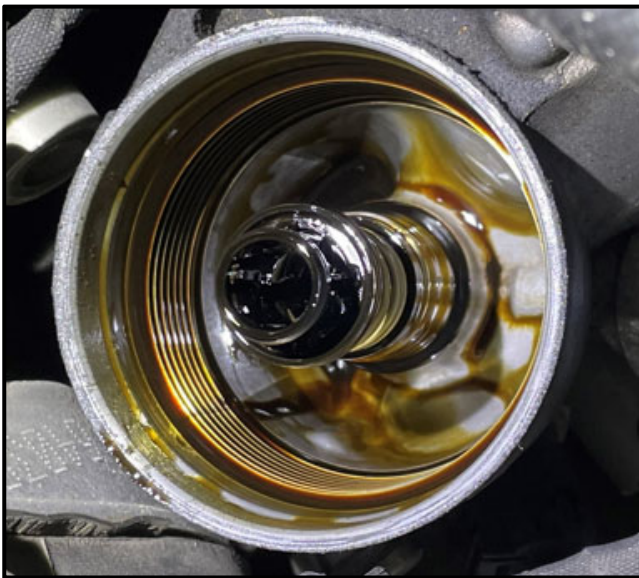
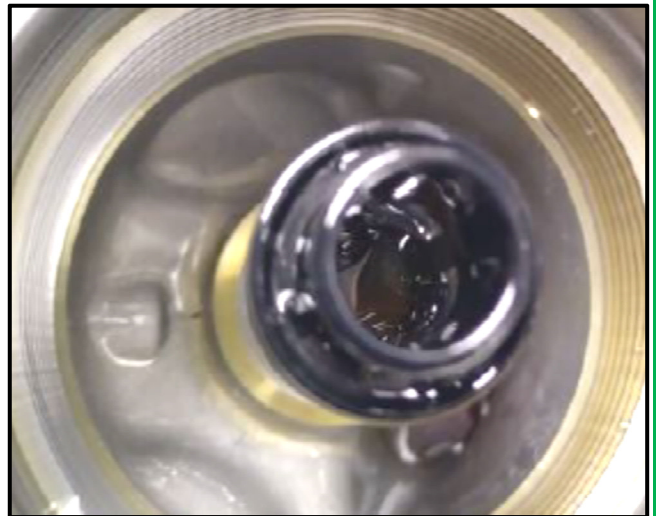
## Examples of OK Oil Filters and Oil Filter Housing

- Turn engine off.
- Remove oil filter.
- See examples of OK and NOT OK oil filter and housing on the following pages.
- If no excessive metal particles are found:

- Engine does not require replacement.
  - **Replace oil filter and seal again.**
  - Torque housing to 25 Nm.
  - Proceed to Section D.
- If excessive metal particles are found:

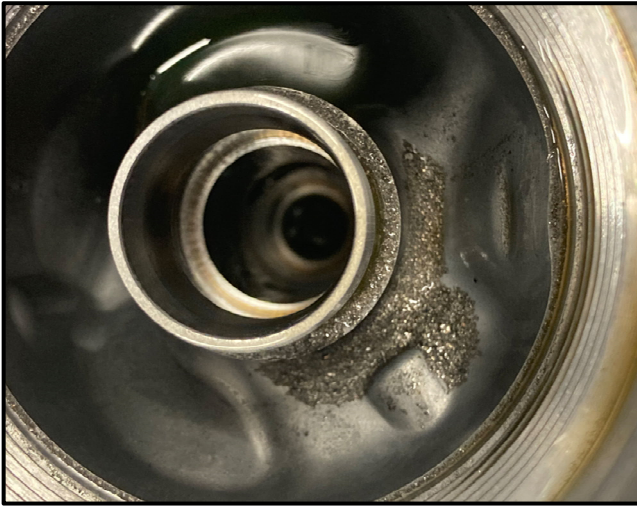
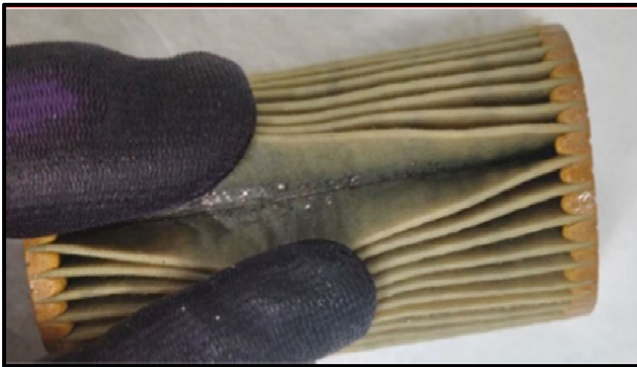
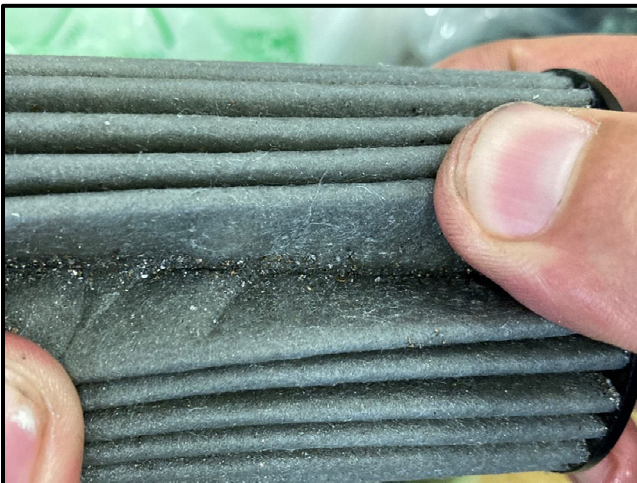
## Examples of NOT OK Oil Filters and Oil Filter Housing

Deviations in the mechanical production process of the connecting rods may have caused an increased particle occurrence in the engine oil circuit, which may lead to extensive wear and play and result in damage to the connecting rod bearings. A connecting rod bearing with continuously rising bearing play leads to excessive engine noise.

- The engine requires replacement.
  - Take clear photos of oil filter and housing.
  - Proceed to Section C

- Take clear photos of the filter and filter housing showing excessive metal particles.
- Create a TAC WEB Ticket and upload the photos to the TAC case.
- **Select “13i4 / 13i5 Review” as the Concern Type.**
- The consultant will review the photos and provide direction.
