# VOLUNTARY RECALL CAMPAIGN

Classification:	Reference:	Date:
AN22-025A	NTB22-090A	December 8, 2022

## VOLUNTARY SAFETY RECALL CAMPAIGN 2021-2022 ROGUE; INFOTAINMENT SYSTEM REPROGRAM

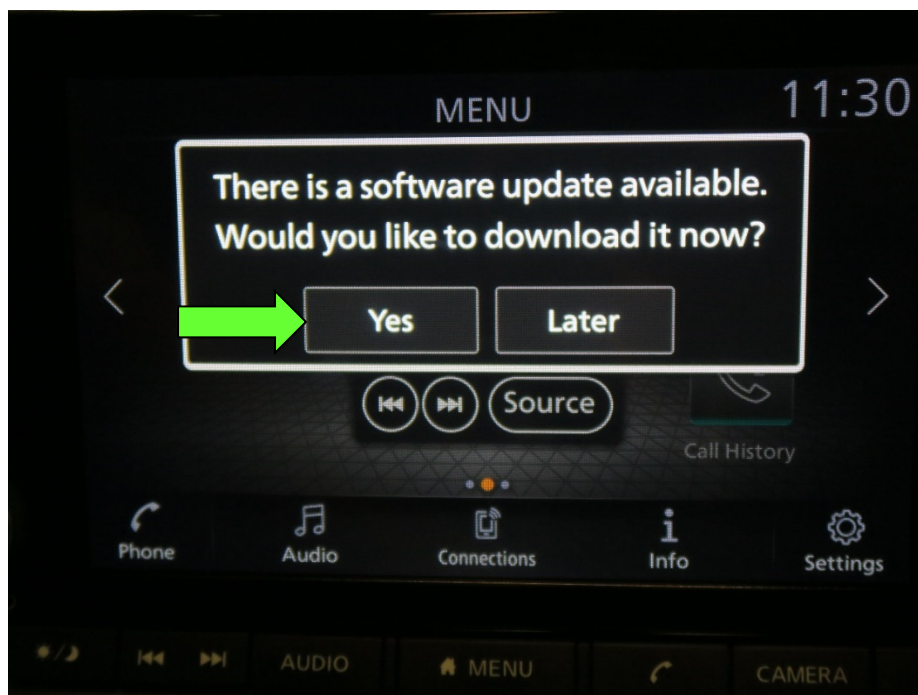
- If at any time during the following procedure the pop-up screen shown in Figure 1 **APPEARS**, then:
  - Select “Yes” and the Over-The-Air (OTA) download can be completed using screen prompts.
  - In this case, the **UPDATE PROCEDURE** is complete, no further action is required.
  - Go to **CLAIMS INFORMATION** to submit a claim for the completion of the OTA download.
- If the Over-The-Air (OTA) pop-up screen in Figure 1 **DOES NOT APPEAR**, then :
  - Continue to step 2 on page 3 to put the AV Control Unit into **System Diagnostic Menu**.

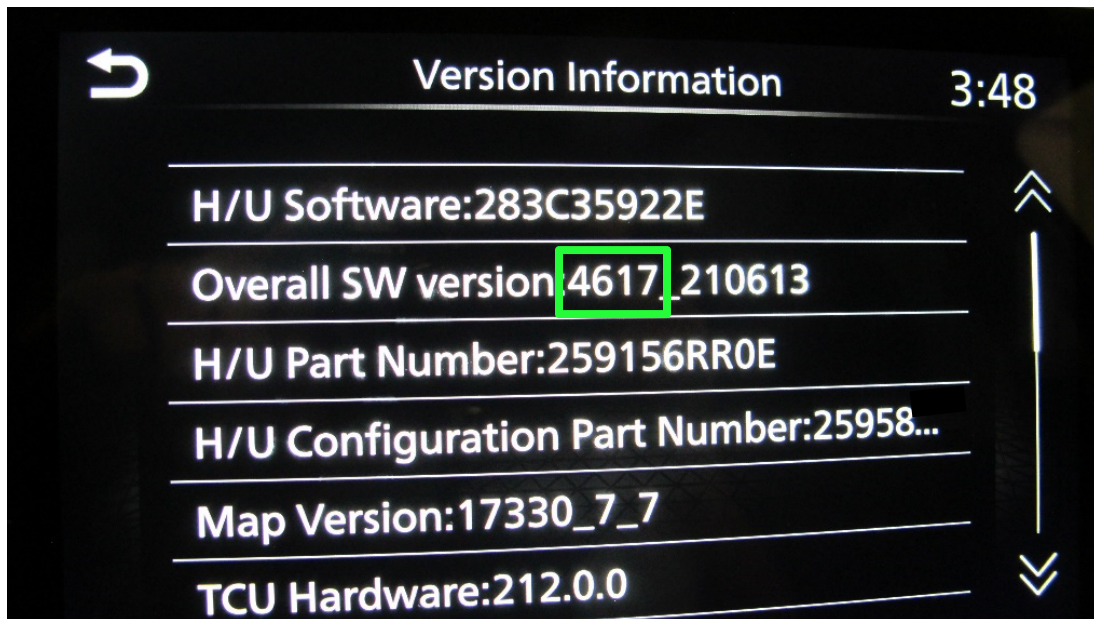
Figure 6

6. Write down the first four digits of **Overall SW version** on the Repair Order.

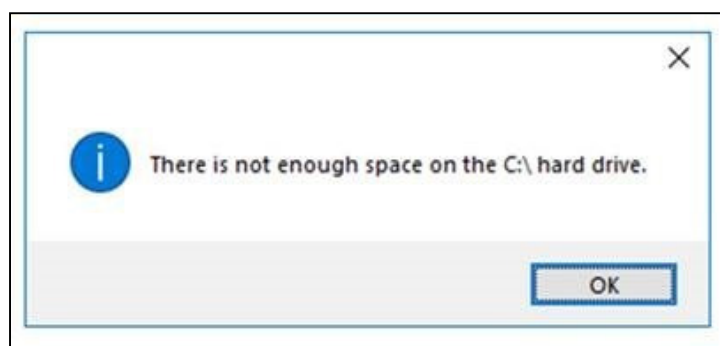
Figure 10

- The update-software is estimated to take **4 hours** to download to the USB drive.
- If, while attempting to download the software to the CONSULT PC, you receive the message shown in Figure 10:
  - a. First attempt to clear space on the CONSULT PC hard drive.
  - b. If space cannot be cleared and a second CONSULT PC is available with space, use it and start over from step 8 on page 7.

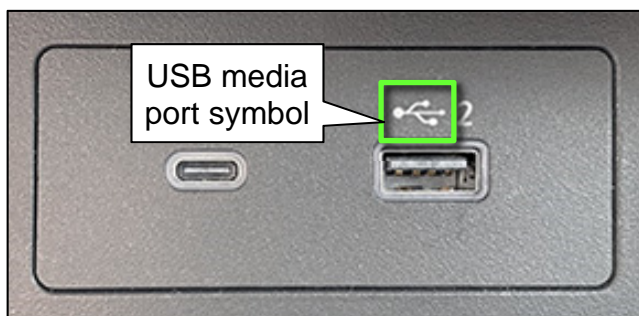
Figure 13

18. Insert the USB drive with the infotainment update-software into the vehicle's USB media port (Figure 13).

Do not insert the USB drive into a charging port. If used, the update-software and/or USB drive may become damaged. Only insert the USB drive in a USB media port.
