GROUP	MODEL		
Safety Recall Campaign	2008-2009MY		
	Sportage (KM)		
NUMBER	DATE		
SC253 (Rev 1, 10/19/2023)	December 2022

SAFETY RECALL CAMPAIGN

HECU INSPECTION/REPLACEMENT AND FUSE REPLACEMENT (SC253)

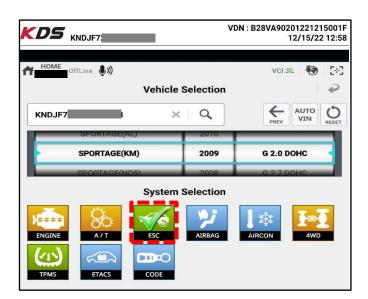
3. Using the KDS, perform the 'Actuation Test'.

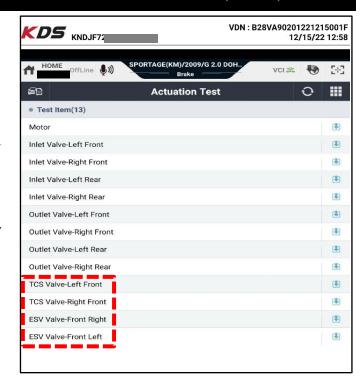
- 4. Force-start TCS and ESV valves.
 - TCS Valve-Left Front and press 'Stop' three (3) seconds after pressing 'Start'. Repeat five (5) times.
 - TCS Valve-Right Front and press 'Stop' three (3) seconds after pressing 'Start'. Repeat five (5) times.
 - ESV Valve-Front Right and press 'Stop' three (3) seconds after pressing 'Start'. Repeat five (5) times.
 - ESV Valve-Front Left and press 'Stop' three (3) seconds after pressing 'Start'. Repeat five (5) times.

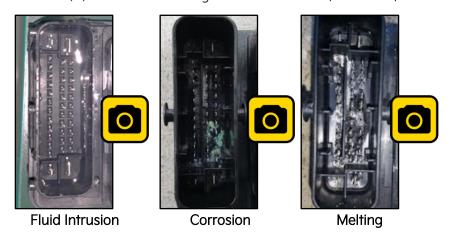
3. Inspect the HECU connector (C) and harness for signs of fluid intrusion, corrosion, and melting.

4. Are there signs of fluid intrusion, corrosion, and/or heat damage?

Yes - Proceed to 'Replacement Procedure' for HECU Assembly on page 7 and the Fuse Kit on page 11.
