FRONT SEAT BELT PRETENSIONER PROTECTION CAP INSTALLATION (RECALL 011G)

Applicable Vehicles: Certain 2023MY G80 EV (RG3 EV) vehicles produced between February 23, 2022 to August 13, 2022.

TSB #: 22-01-087G Page 2 of 11

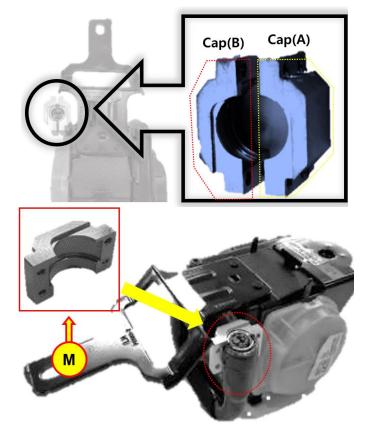
Check if the installation direction of the cap matches the figure.

10. Install Cap A (M).
