GROUP	NUMBER
RECALL	22-01-088H
DATE	MODEL(S)
NOVEMBER 2022	Santa Fe Hybrid / Plug-in (TM HEV /

PHEV)

FRONT SEAT BELT PRETENSIONER PROTECTION CAP INSTALLATION (RECALL 238)

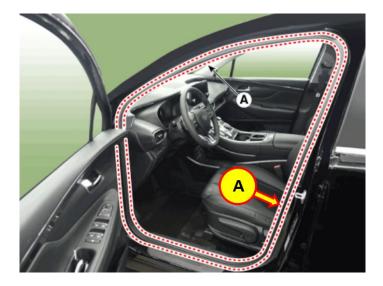
3. Partially remove the front door body side weather strip (A) near the center pillar trim.

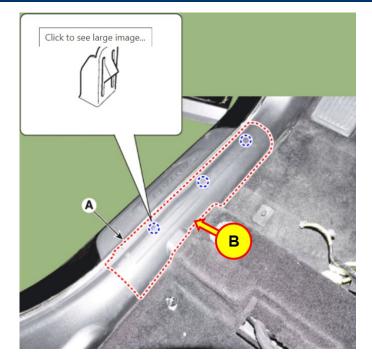
4. Remove the front door scuff trim (B) using the trim tool.

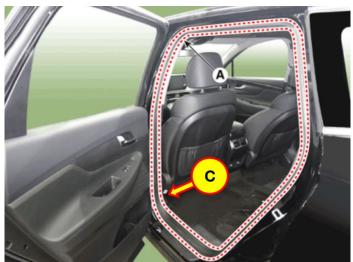
5. Partially remove the rear door body side weather strip (C) near the center pillar trim.

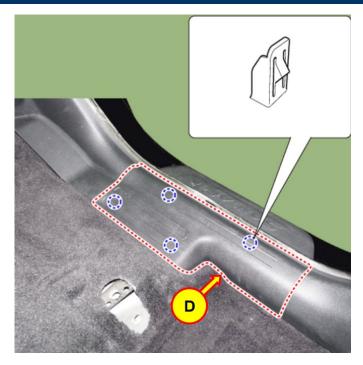
6. Remove the rear door scuff (D) using the trim tool.

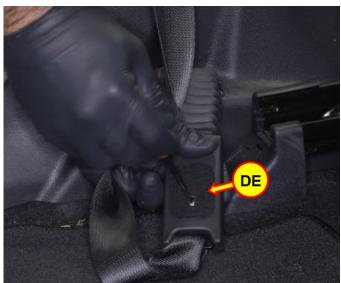
7. Press the release button on the front seat belt anchor and disconnect the seat belt.

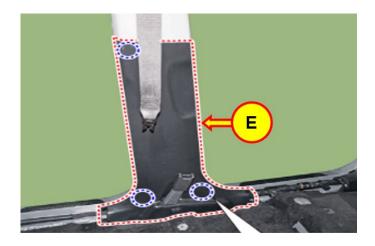
8. Remove the center pillar lower trim (E).

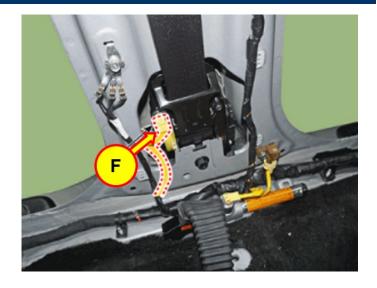
9. Press the locking pin and disconnect the front seat belt pretensioner connector (F).

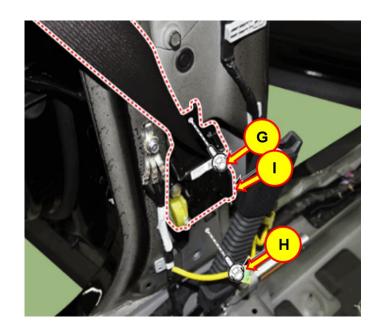
10. Remove the front seat belt pretensioner (I) by loosening the mounting bolts (G,H).

Tightening Torque: bolt (G) 7.8 ~ 11.8 Nm (0.8 ~ 1.2 kgf.m, 5.8 ~ 8.7 lb-ft)

Tightening Torque: bolt (H) 39.2 ~ 53.9 Nm (4.0 ~ 5.5 kgf.m, 28.9 ~ 39.8 lb-ft)

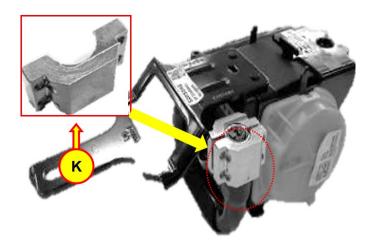
12. Install Cap B (K).

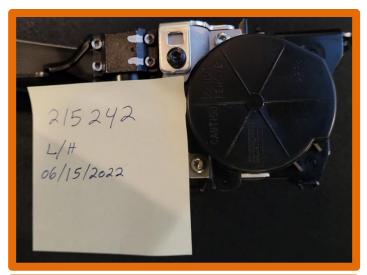
Using STUI, please take photos of the completed pretensioner assembly with the caps installed. Within the picture, include a piece of paper with the last 6 digits of the VIN, date of the repair, Driver (LH) side or Passenger (RH) side.

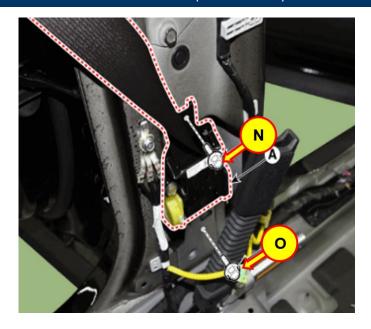
Torque the seat belt pretensioner mounting bolts (N & O) to specifications.

Tightening Torque: bolt (N) 7.8 ~ 11.8 Nm (0.8 ~ 1.2 kgf.m, 5.8 ~ 8.7 lb-ft)

Tightening Torque: bolt (O) 39.2 ~ 53.9 Nm (4.0 ~ 5.5 kgf.m, 28.9 ~ 39.8 lb-ft)
