RECALL 22V828 / 2022-637 REMEDY INSTRUCTIONS

Make(s): ALTA Model(s): MANY, SEE BELOW Model Year(s): 2022 - 2023	Repair Code: RC-056-03-00-004265 Allotted Time: .20 HRS. Inspection Code: N/A Allotted Time: N/A
	Concern: The side marker lamps may not reflect light and be conspicuous to other motorists, which may lead to a crash.	Photo(s) Required: YES, PRE/POST REMEDY Prior Authorization Required: N/A Part(s) Kit Number: N/A Part(s) Return: F100368650

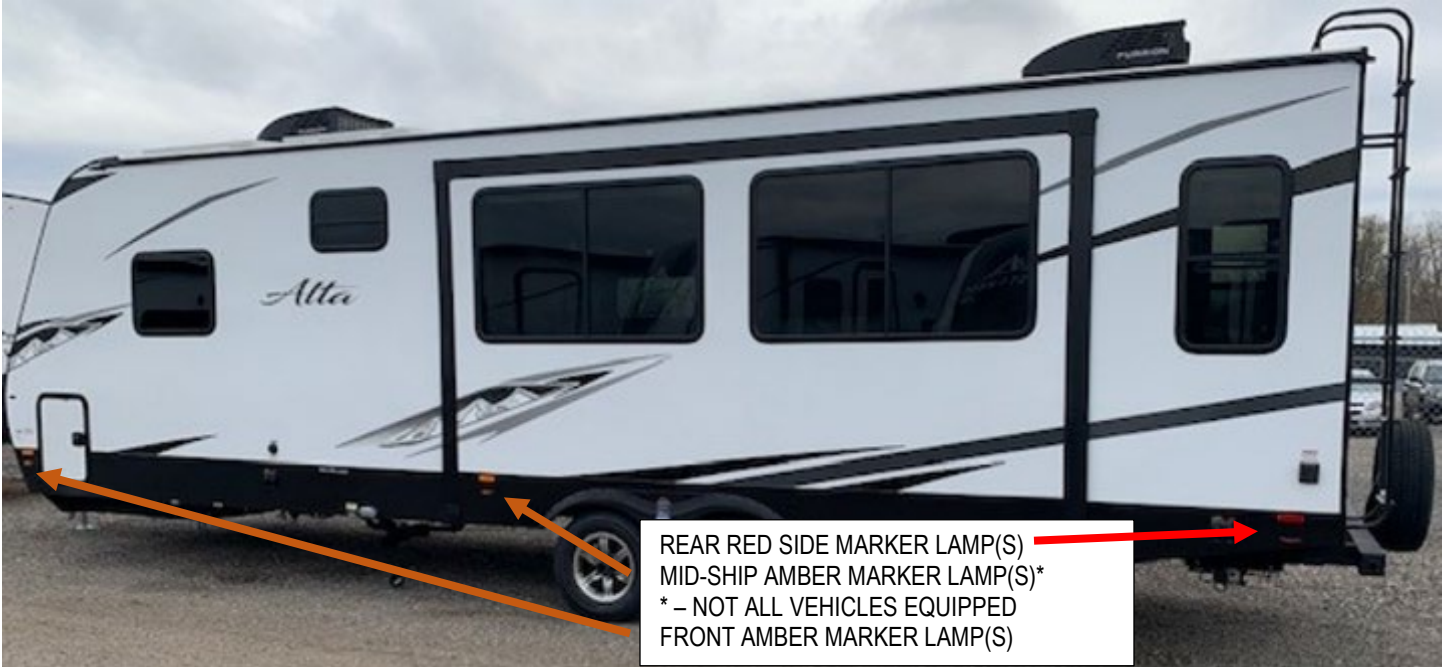
FIGURE 1

STEP 1: LOCATE THE RED MARKER LAMPS ON THE REAR PART OF THE CURB SIDE WALL AND ROAD SIDE WALL;

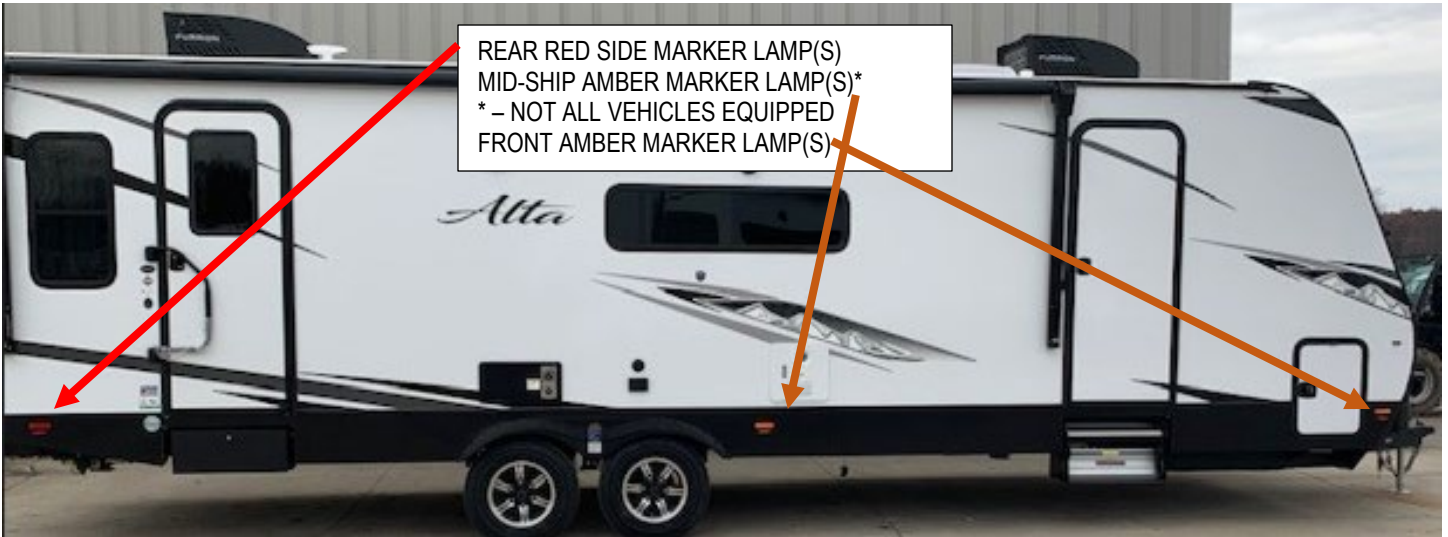
FIGURE 2

STEP 4: LOCATE THE AMBER MARKER LAMPS ON THE MID AND FRONT PART OF THE CURB SIDE WALL AND ROAD SIDE WALL;

- MID-SHIP LAMP MAY OR MAY NOT BE PRESENT DEPENDENT ON THE OVERALL LENGTH OF THE VEHICLE;
- IF MID-SHIP LAMP IS NOT PRESENT, **DO NOT** INSTALL REFLECTORS;
- IF MID-SHIP LAMP IS PRESENT, **DO** INSTALL REFLECTORS;
- FIGURE 1 & 2
