L734-R.01.22

Checking rear hood glass assembly

Countach LPI 800 4

L734- R.01.22	To: After Sales Official Network Subject: Checking rear hood glass assembly Date: 11 January 2023 Pages: 6	 
------------------	---	--

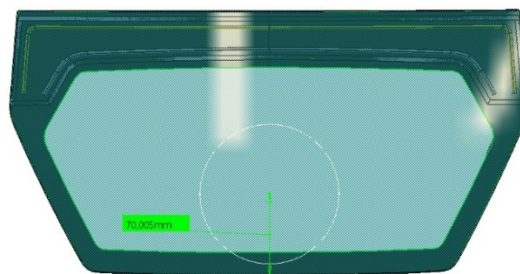
**Glass 1**

During ongoing product monitoring, Automobili Lamborghini S.p.A. determined that an incorrect bonding of the rear bonnet glass panels, caused by an error in supplier's assembly phase, may lead to adhesion issue that could result in a detachment. The rear bonnet glass panels could fully detach from the vehicle, creating a road hazard and increasing the safety-risk of a crash for following traffic.

1. Carefully clean the first glass (use isopropanol) to prepare the surface. The surface must be free of dirt and grease.
2. Position the suction cup and tighten the lever.
Check for correct positioning and tightness.

The suction cup must be positioned with the center 7 cm (2,75 In) from the rear edge of glass number 1.
This rule applies to all bonnet windows.

5. Check that the glass has not moved or broken.

If the glass has moved or broken, it must be replaced; please open a claim on Liass.

Repair Manual → Special edition → LPI-800-Countach → MY22 → 08 Body → 27 Engine hood and the spoiler → Front Engine Hood Glass → Disassembly/Assembly
