November 23, 2022

Version 1

Safety Recall: 2017-19 Ridgeline Rearview Camera Inoperative Inspection

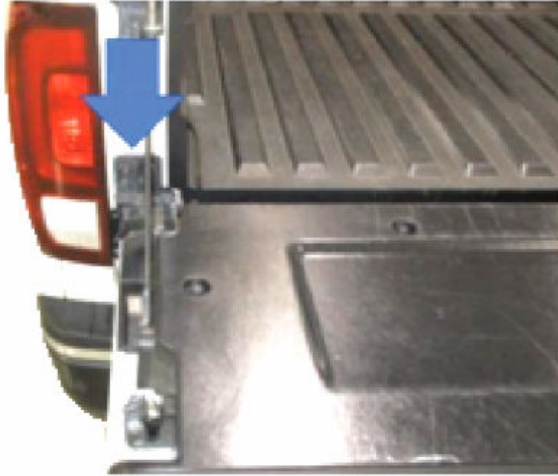
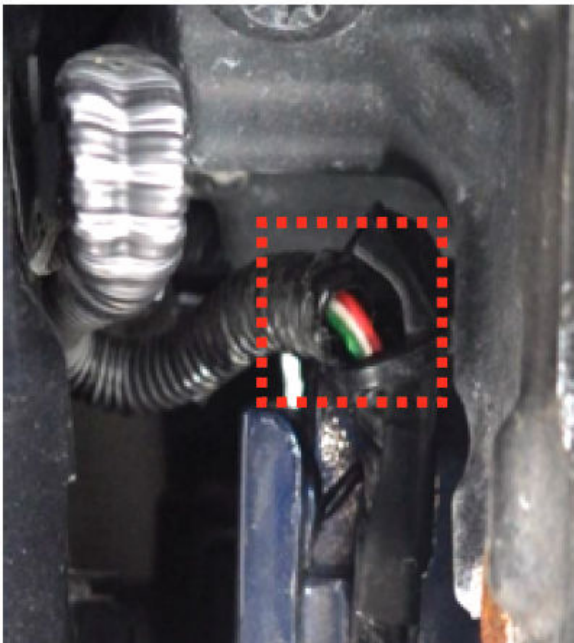
The tailgate harness wires may become damaged with the articulation of the tailgate. This may cause the rearview camera to work intermittently or go blank.

3. Open the tailgate in drop-down mode. Inspect the harness at the left lower tailgate hinge area.
- If there is no damage to the harness wiring or corrugated tubing, continue with normal troubleshooting.
- If there is damage to the harness, go to REPAIR PROCEDURE.

Check the function of the back-up camera. If the camera is not working, inspect the rear tailgate harness. Replace the tailgate harness if harness damage is found.
