# SERVICE PROCEDURE

22524 / 22544  
JANUARY, 2023

**SUBJECT:** SAFETY RECALL 22524 Variation 22544  
Hex Flange Lock Nut on certain International® HV™  
Series trucks built 05/20/2022 thru 07/22/2022.

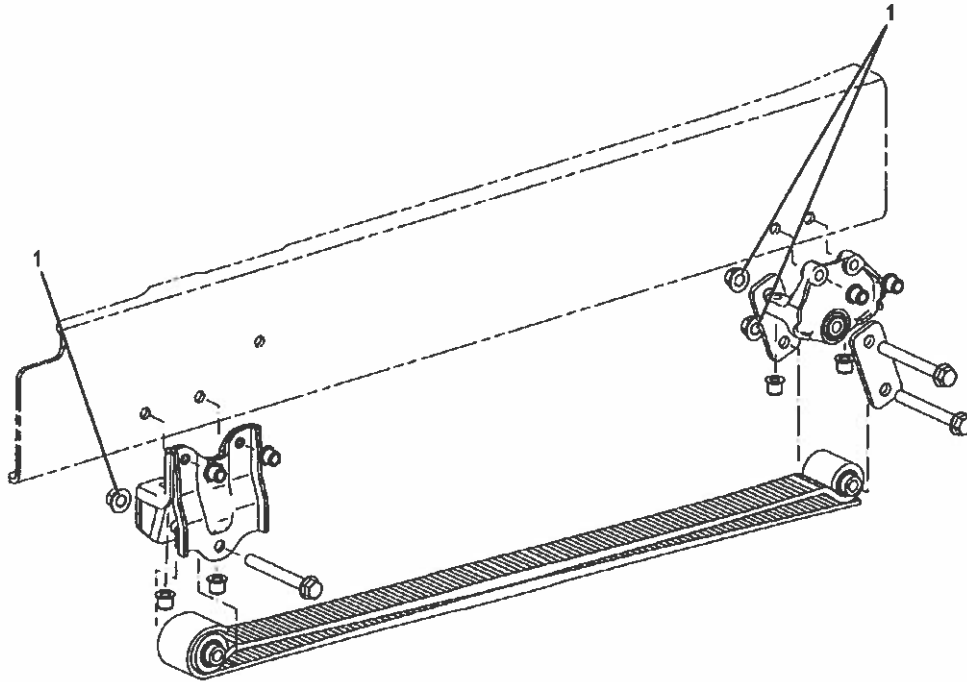
**Figure 1. Steer Axle Shackle**

7. Access nuts (Figure 1, Item 1) securing the front steer axle shackle.

8. Remove and replace nuts (Figure 1, Item 1). Using a torque wrench, tighten nuts to 330 - 370 lb-ft (450 - 500 N·m).
9. Repeat Steps 7 and 8 for opposite side.

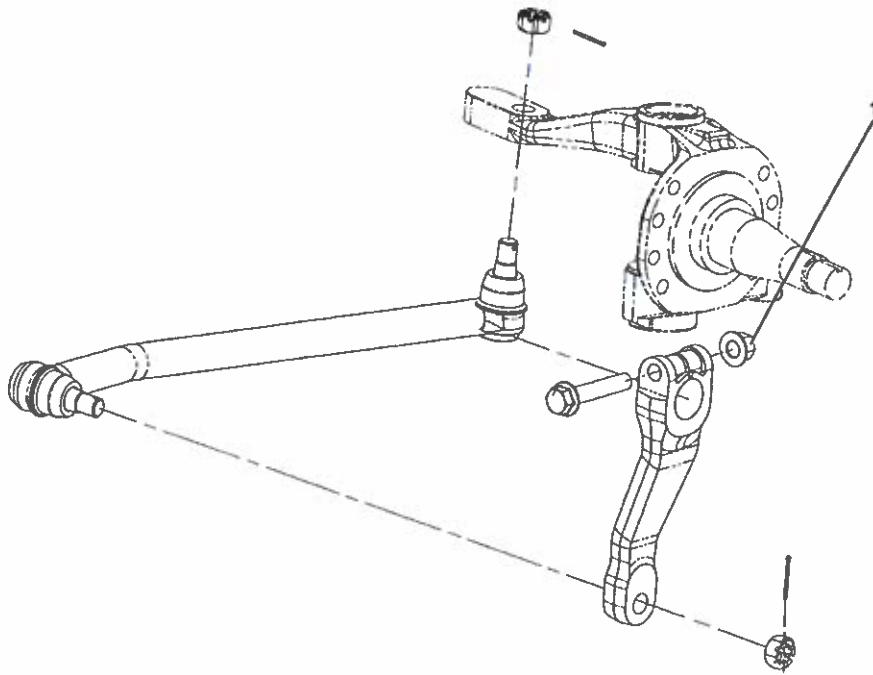
**Figure 2. TRW Pitman Arm Nut**

12. Access Pitman arm nut (Figure 2, Item 1).

13. Remove and replace nut. Using a torque wrench and backup wrench positioned on bolt, tighten nut to 330 - 370 lb-ft (450 - 500 N·m).
14. Raise vehicle, remove jack stands, and lower vehicle.
15. Using jack, raise rear axles and support vehicle on jack stands.

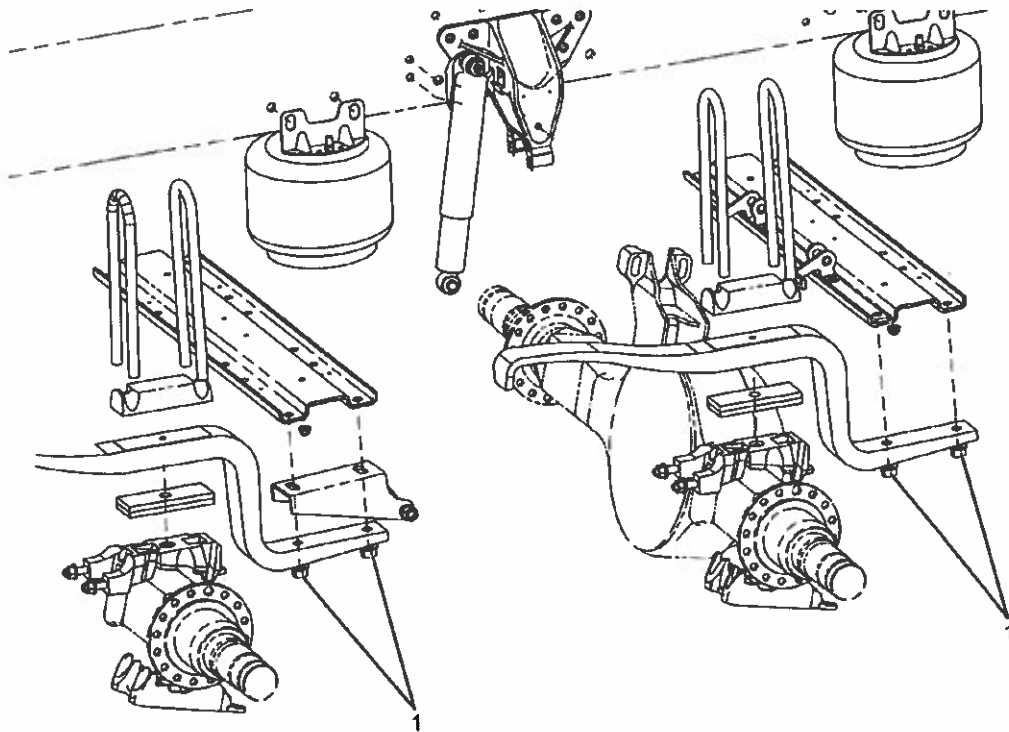
**Figure 3. HAS Cross Brace**

16. Access four nuts (Figure 3, Item 1) securing rear axle(s) to cross brace.

17. Remove and replace nuts one at a time. Using a torque wrench, tighten nuts to 330 - 370 lb-ft (450 - 500 N-m).
