GROUP	MODEL
Safety Recall Campaign	2023MY Sportage (NQ5a)
NUMBER	DATE
SC257	December 2022

SAFETY RECALL CAMPAIGN

SUBJECT: CURTAIN AIRBAG INSPECTION/REINSTALLATION (SC257)

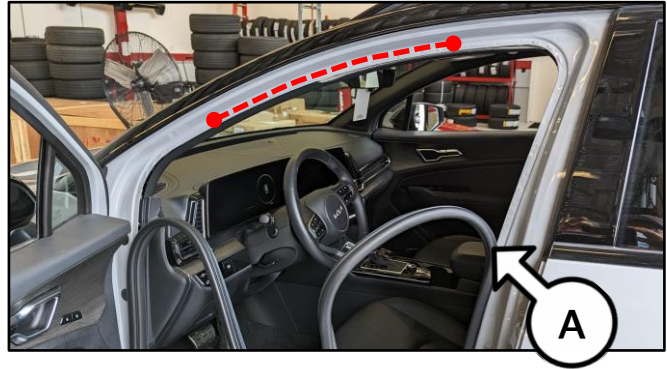
1. Open the driver (LH) and partially detach the door weatherstrip (A) as shown.

Note: Inspection area shown by the **red** line.

2. Carefully, pull down on the headliner (B) trim as shown (about 1.0 - 1.5 inches) to view/access the curtain airbag (C).

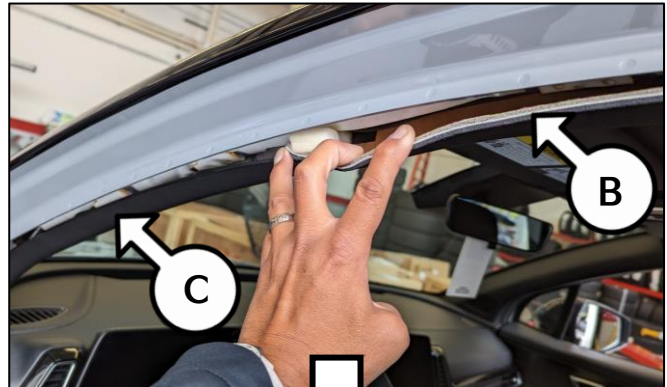
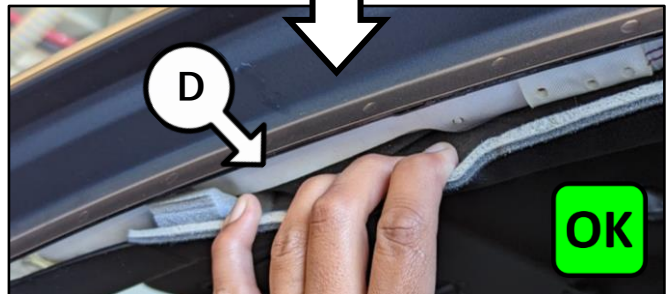
3. Inspect the curtain airbag (D) along the inspection area (use a flashlight if needed) and confirm one of the following conditions:

- The curtain airbag (D) **does not** appear to be installed twisted and the black stitching **is not** visible (**OK**), repeat steps 1-3 for passenger (RH) side, then skip to step 5.

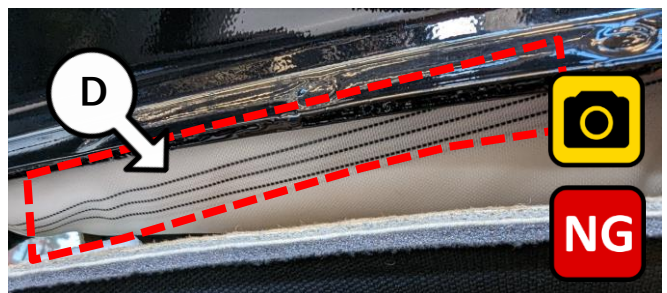
- The curtain airbag (D) **does** appear to be installed twisted and the black stitching **is** visible (**NG**). **Take a photo using KDS** and open a Techline Case. Repeat Steps 1-3 for passenger (RH) side, then proceed to step 4.

4. Repair the affected side curtain(s) if applicable, by referring to 'Repair Procedure' outlined on Pg. 3.
5. Reinstall the door weatherstrip.

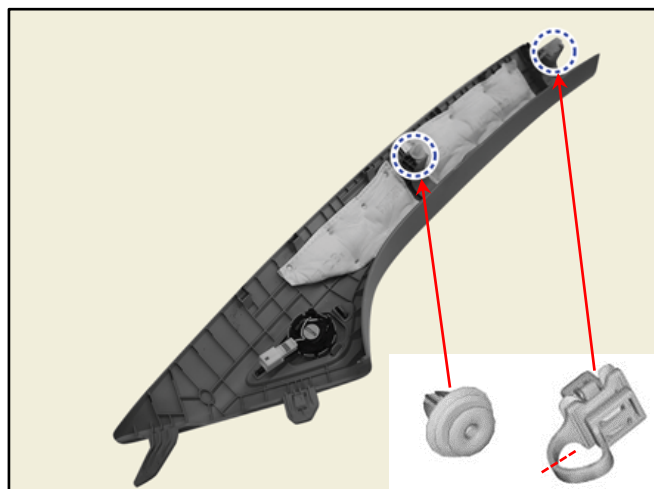
Note: The tether clip will need to be cut in the dotted line area shown to remove the 'A' pillar. Remove the remaining body side clip end piece.

2. Disconnect the battery negative (-) terminal and wait for at least 3 1/2 minutes.
3. Remove the front 'A' pillar trim by referring to "Body (Interior and Exterior) → Interior Trim → Front Pillar Trim → Removal and Installation" in the applicable Shop Manual on KGIS.

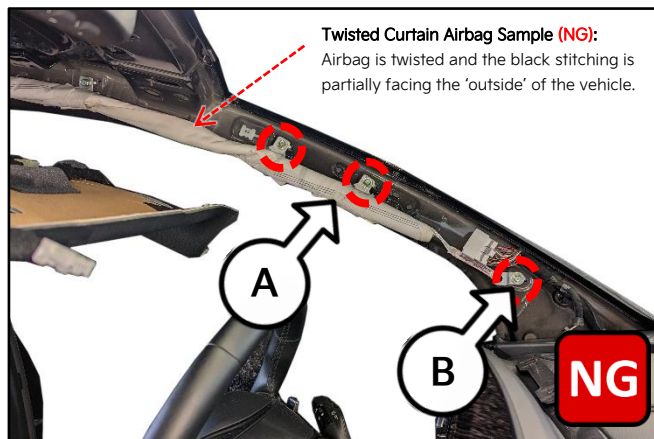
Image shown is for reference use only. The headliner does not need to be removed.

4. Remove the three (3) front curtain airbag (A) retaining bolts (C).
5. Carefully, untwist the curtain airbag (A) so that the black stitching is facing the interior of the vehicle.

Tightening torque for bolts:
5.8 - 8.7 lb.ft (7.8 - 11.8 N.m)

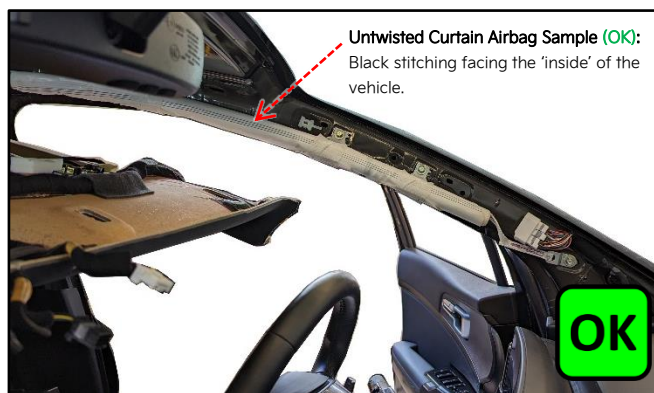
Image shown is for reference use only. The headliner does not need to be removed.

6. Reinstall the three (3) curtain airbag retaining bolts (B).
7. Reinstall all removed parts in the reverse order of removal.

Replace both front 'A' pillar trim clip and fastener from step 1, as they are not reusable parts.
