Recall campaign 5622K – Headlight Adjustment Prevention Caps

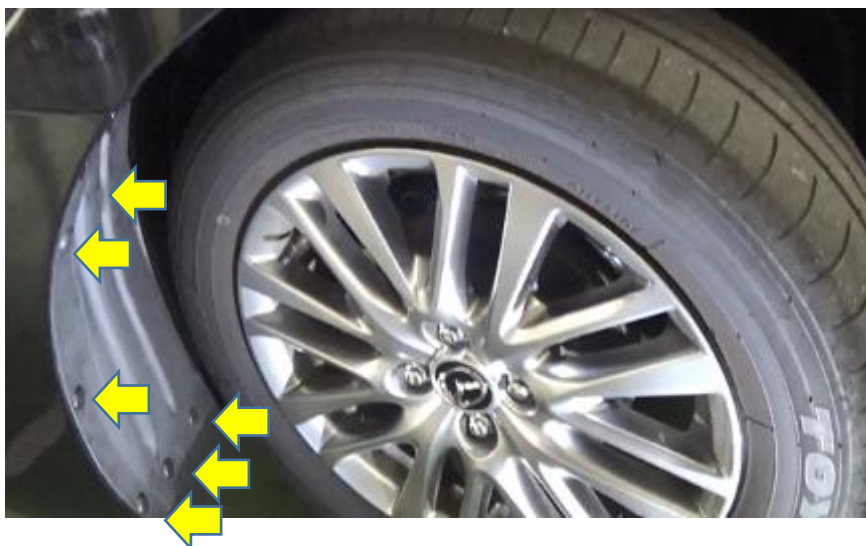
1. Turn the steering wheel completely to the right
2. Remove 6 fasteners using a standard body pry tool.

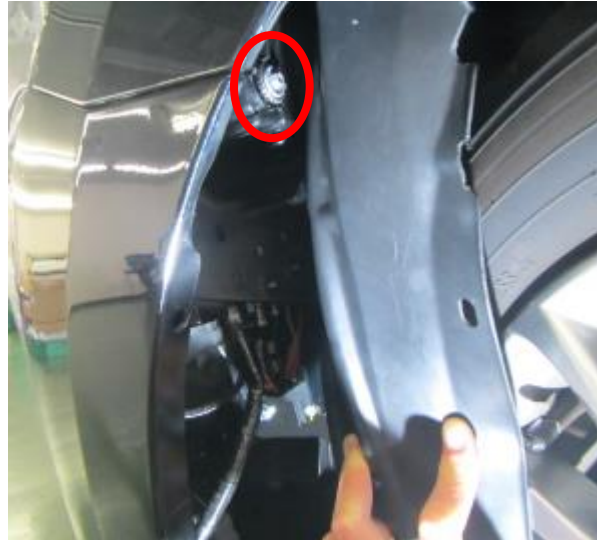
3. Gently peel back the front mudguard and locate the headlight aiming bolt.
