**RECALL**

<b>ORIGINAL CREATION DATE:</b>	08/30/2023
<b>REVISION DATE:</b>	09/11/2023
<b>SUBJECT:</b>	400V E2Ver1 Body and ESM Software Update
<b>RATIONALE:</b>	Updates to vehicle response when certain fault codes associated with battery pack liquid accumulation and/or a thermal event are detected.
<b>VINs or MODELS AFFECTED:</b>	Service Specified Buses
<b>COMPLETE BY:</b>	Earliest Service Opportunity
<b>SERVICE CAMPAIGN #:</b>	SC-23-126
<b>NHTSA RECALL NUMBER:</b>	22V887
<b>REMEDY KIT NAME / NUMBER:</b>	065660
<b>ESTIMATED LABOR TIME:</b>	.75
<b>LABOR OP CODE:</b>	HB49V

## **400V E2Ver1 Body and ESM Software Update**

# Proterra – 400V E2Ver1 Body and ESM Software Update (Service Campaign SC-23-126)

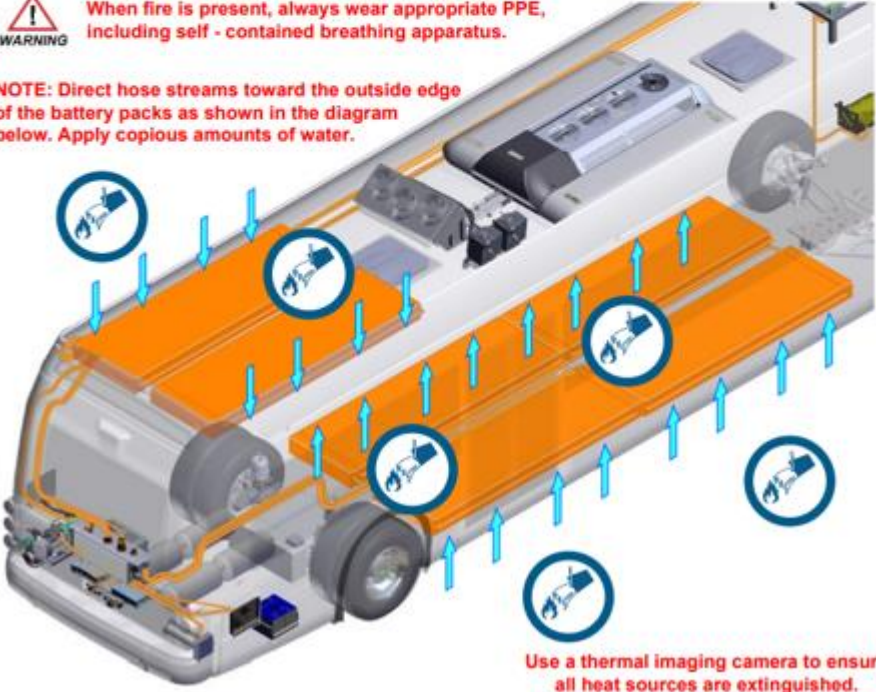
**NOTE:** Direct hose streams toward the outside edge of the battery packs as shown in the diagram below. Apply copious amounts of water.

Use a thermal imaging camera to ensure all heat sources are extinguished.

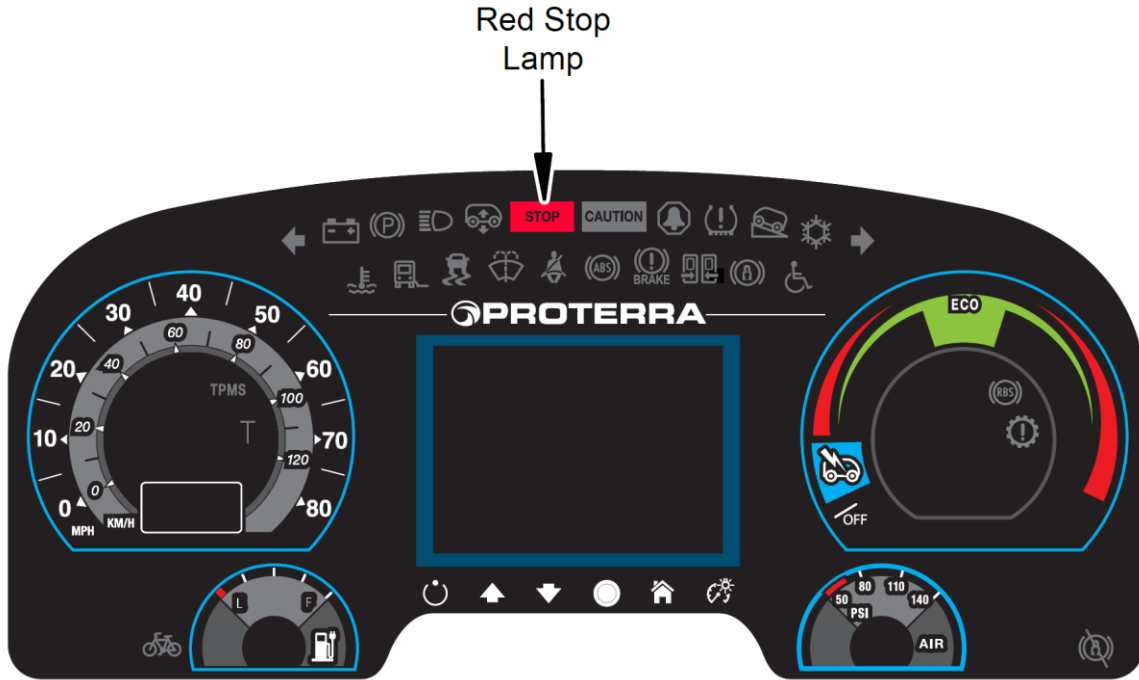
Figure 1 – Red Stop Lamp on Original Dash

Critical battery faults which indicate the potential for a thermal event will result in a Fast Flash Red Stop Lamp in the vehicle dash that blinks at a rate of two times per second, and an audible alarm that pulses twice per second (collectively, the “Critical Battery Fault Warnings”). *Critical Battery Fault Warnings indicate a critical battery failure which could result in a thermal event.* When the Critical Battery Fault Warnings are active, please immediately follow the procedures set forth in the Operator/Driver Guidelines section below, as well as the instructions in any applicable sections of the Proterra Driver’s manual.

Figure 1 below shows the Red Stop Lamp as presented on the original Proterra dash. Figure 2 below shows the Red Stop Lamp as presented on the updated Proterra digital dash.

If the Critical Battery Fault Warnings are active as described in Section 3.2 (but there is no smoke, burning smell, abnormal popping or whistling noises, flame, etc.), the vehicle should be promptly parked in a safe outdoor location at least 20 feet away from other objects such as buildings, trees and other vehicles, and at least 100 feet away from highly flammable items such as gas stations or propane tanks. Once the vehicle has been moved to a safe location, the operator and passengers may exit the vehicle and the vehicle should be removed from service.
