# F/CMVSS Noncompliance Recall

## N222386380 Daytime Running Lights (DRL) May Not Deactivate When Headlamps Are On

**Release Date:** January 2023

**Revision:** 02

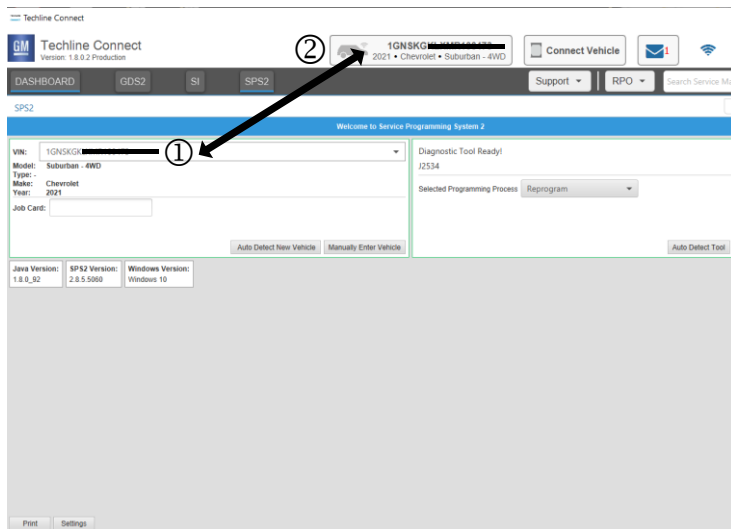
5743643

**Caution:** Be sure the VIN selected in the drop down menu (1) is the same as the vehicle connected (2) before beginning programming.

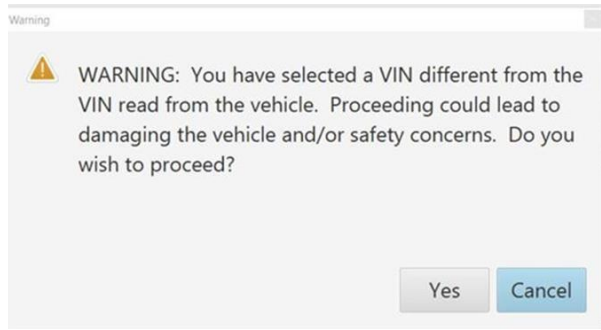
5877000

**Important:** If the vehicle VIN DOES NOT match, the message below will be shown.

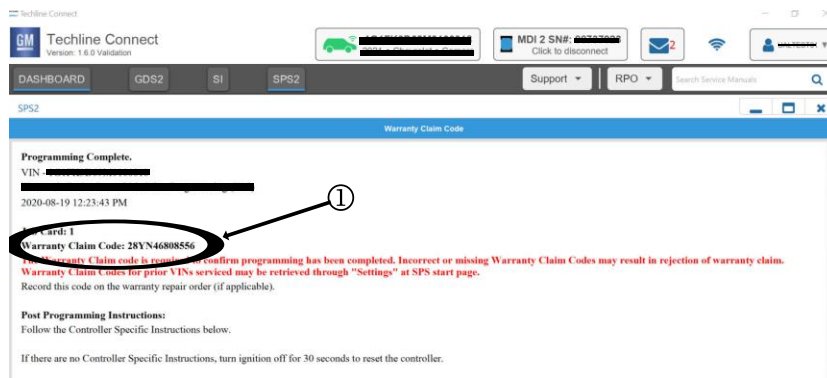
5644478

**Important:** To avoid warranty transaction rejections, you **MUST** record the warranty claim code provided on the Warranty Claim Code (WCC) screen shown above on the job card. Refer to callout 1 above for the location of the WCC on the screen.

1. Reprogram the Body Control Module. Refer to *K9 Body Control Module: Programming and Setup* in SI.

2. Record SPS Warranty Claim Code on job card for warranty transaction submission.
