F/CMVSS Noncompliance Recall

N222386380 Daytime Running Lights (DRL) May Not Deactivate When Headlamps Are On

Release Date: December 2022

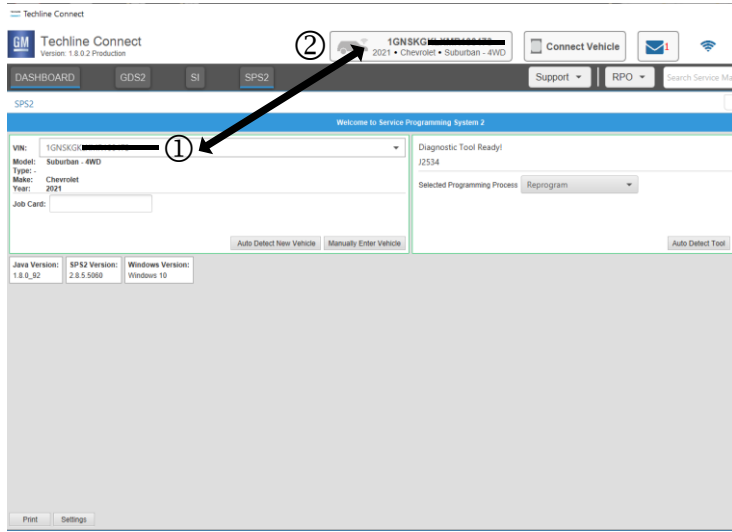
5743643

Caution: Be sure the VIN selected in the drop down menu (1) is the same as the vehicle connected (2) before beginning programming.

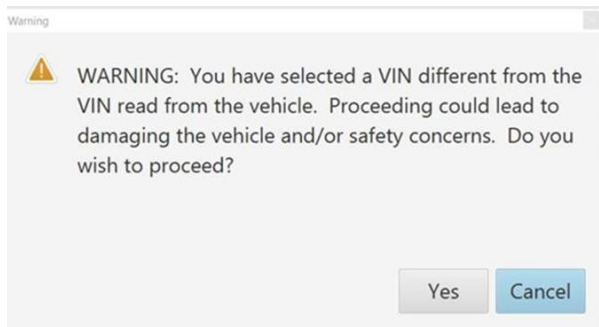
5877000

Important: If the vehicle VIN DOES NOT match, the message below will be shown.

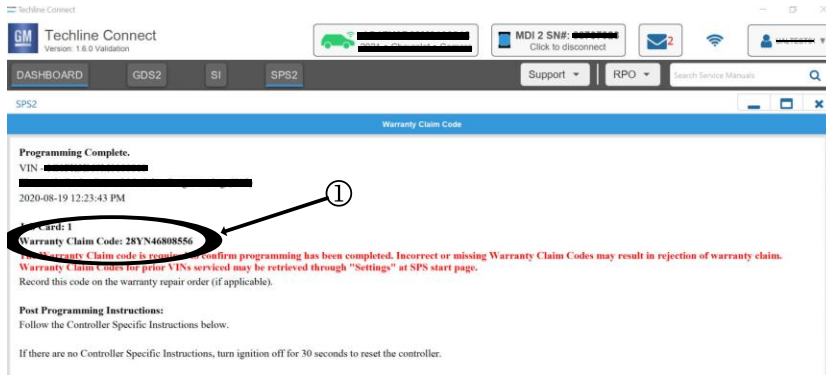
5644478

Note: The screenshot above is an example of module programming and may not be indicative of the specific module that is being programmed. Module selection and VIN information have been blacked out.

1. Reprogram the Body Control Module. Refer to *K9 Body Control Module: Programming and Setup* in SI.

Important: To avoid warranty transaction rejections, you **MUST** record the warranty claim code provided on the Warranty Claim Code (WCC) screen shown above on the job card. Refer to callout 1 above for the location of the WCC on the screen.

2. Record SPS Warranty Claim Code on job card for warranty transaction submission.
