GROUP	MODEL
Safety Recall Campaign	2023MY Forte (BDm)
NUMBER	DATE
SC259	December 2022

FRONT LEFT STEERING KNUCKLE

INSPECTION/REPLACEMENT (SC259)

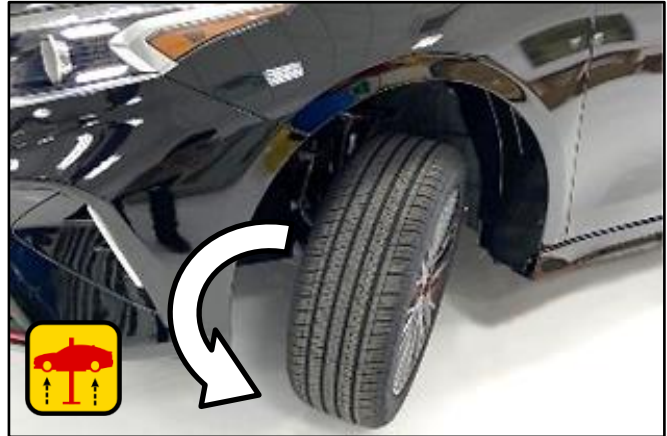
1. Raise the vehicle on a lift so that the tires are not touching the ground.
2. Open the driver door and turn the steering wheel counterclockwise (left).

Note: Raise vehicle high enough to view the inside of the wheel area.

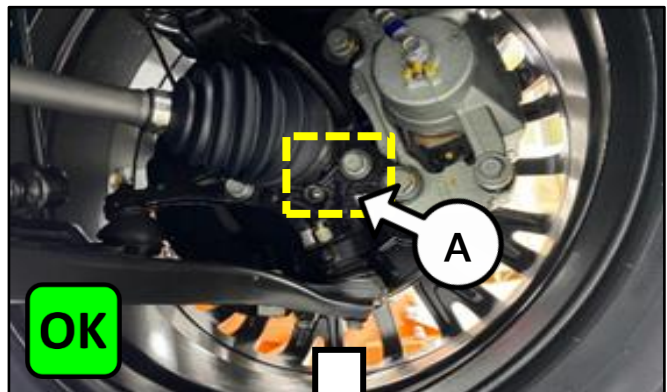
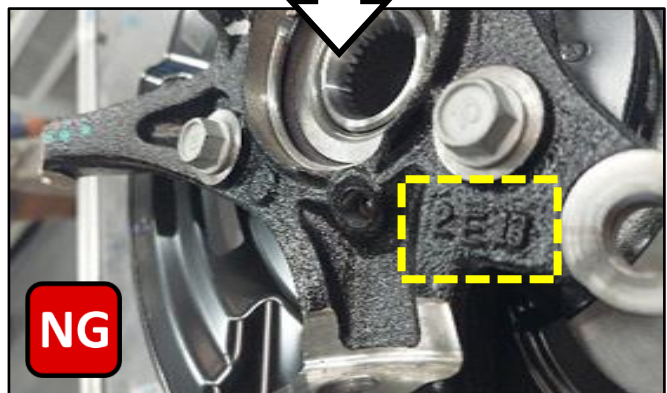
3. Inspect the left front knuckle (A) casting lot number to confirm the following condition:

- The casting lot number **IS NOT** 2E13 (OK). No further action is required.
- The casting lot number **IS** 2E13 (NG). Proceed to the "Replacement Procedure" below.
