## PRODUCT CAMPAIGN BULLETIN

**APPLICABILITY:** 2019-2022MY Ascent

**NUMBER:** WRL-22

**SUBJECT:** PTC Heater Ground Bolt

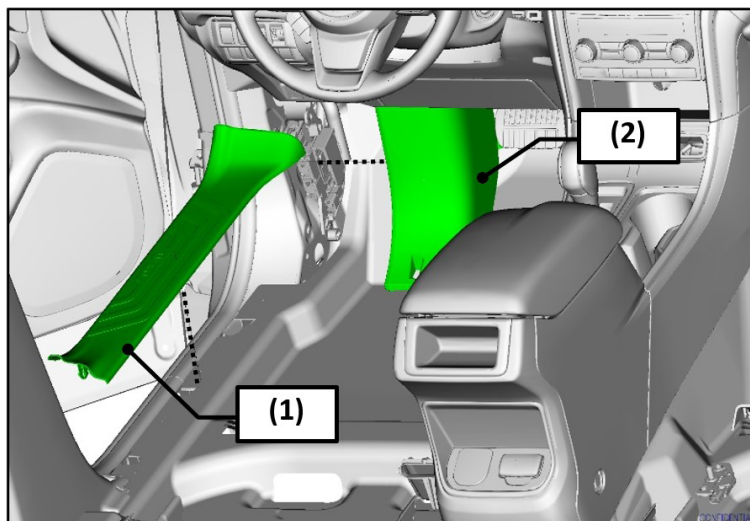
Diagram 1

The ground bolt that secures the ground terminal of the Positive Temperature Coefficient (PTC) heater may have been improperly fastened during vehicle production. This potential condition may result in the melting of the ground terminal and surrounding components when the PTC heater is in operation, increasing the risk of a fire.

**Tightening Torque: 13 N·m**

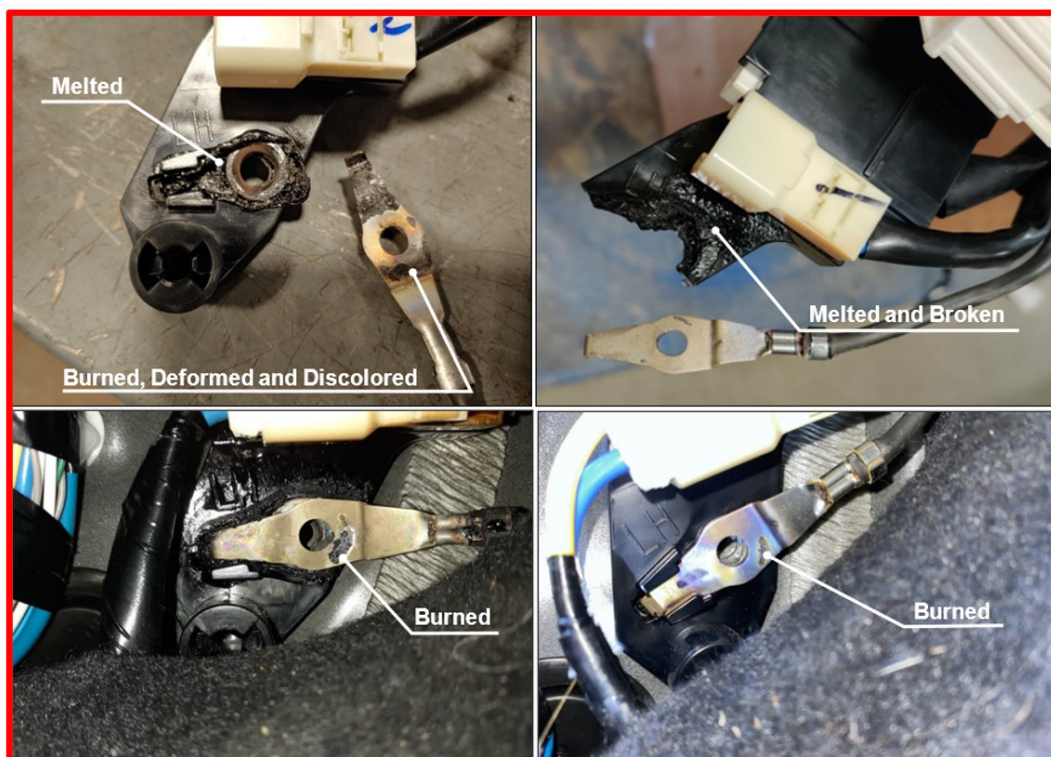
**STEP 11: CAREFULLY** inspect the PTC heater ground terminal and peripheral parts for any damage. See the example images of overheat damage below.

**IMPORTANT:** If any damage is found, a QMR will be required with detailed photos of the damage attached and the repair parts order information noted in the comments section.
