# Product Safety Recall

## N222380601 Front Impact Bar Partially Welded

**Release Date:** January 2023

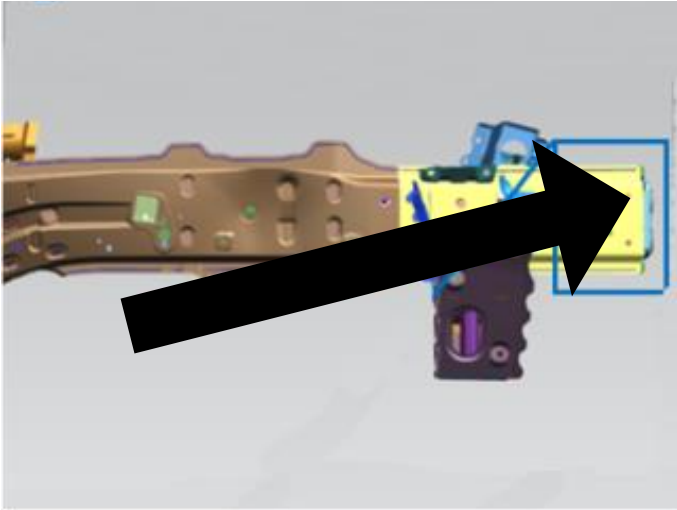
6215494

2. Locate the front section of the left and right lower front motor compartment frame rails where they bolt to the front bumper beam.
3. Carefully inspect the weld joint where the left and right bumper mounting brackets are welded to the frame rails on the outboard side. The brackets should be inserted into the end of the frame rails and secured with welds.

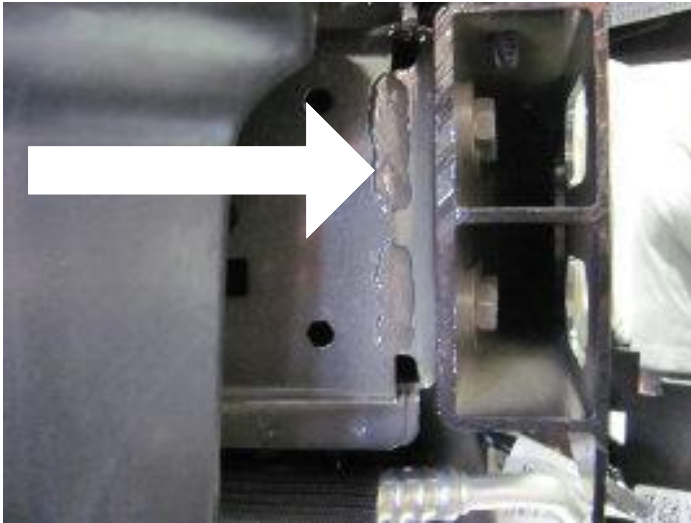
6215495

**Example of Right Side That Passes Inspection**

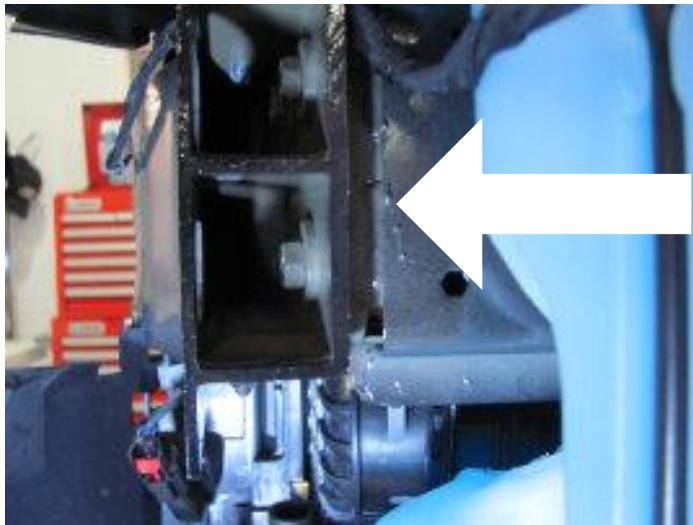
6215496

### Example of Left Side That Passes Inspection

- If the bumper mounting bracket is properly inserted and the welds securing the bracket are complete, no further action is required. Reinstall the front bumper fascia. Refer to *Front Bumper Fascia Replacement* in SI. **DO NOT FILE a Product Report (FPR/PIR).**

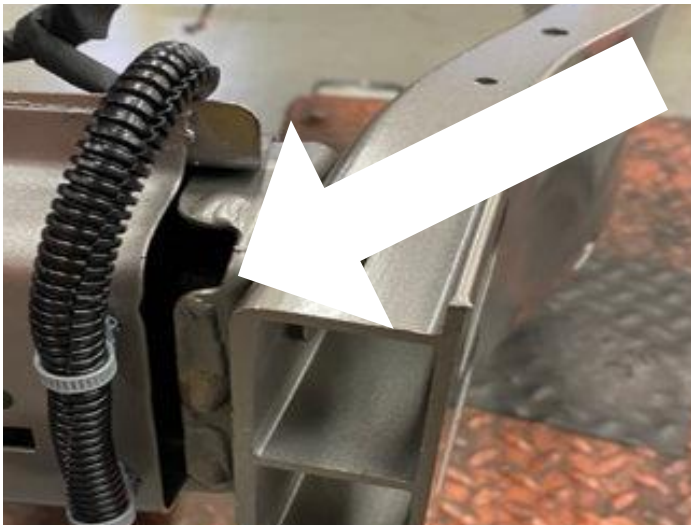
6215497

### Example of Failed Condition Showing Gap and Misplaced Weld

- If there is a gap between the end of the frame rail and the bumper mounting bracket on either side of the vehicle, proceed to step 4.
4. If the left or right motor compartment frame rail to bumper bracket joint fails the inspection, quarantine the vehicle. **Important: Vehicle must remain quarantined until a determination by GM has been made and further instructions have been provided.**
  5. Follow the **Product Report (FPR/PIR)** process below.
