# Recall Campaign Bulletin

Campaign No. 2022120016, January 2023

SUBJECT: **Model GLE and GLS (167 platform) vehicles**  
**Model Year 2021-2022**

## **Replace the Steering Coupling Locking Screws**

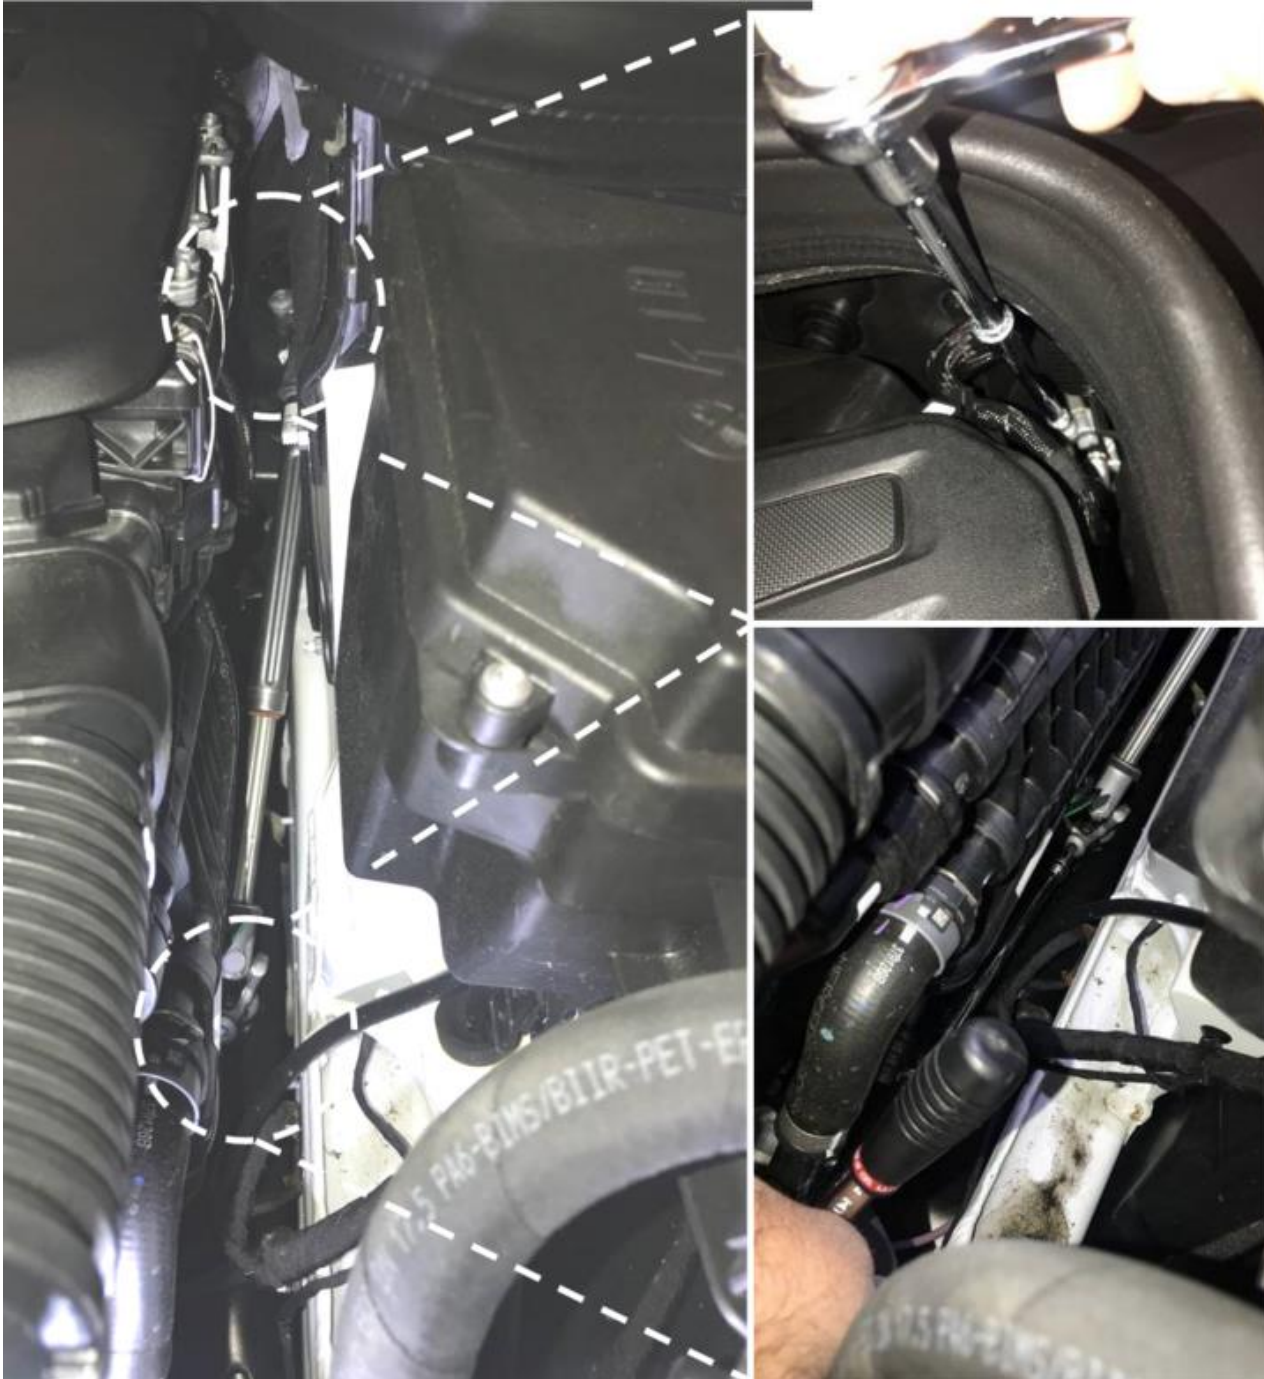
Figure 1

Mercedes-Benz AG (“MBAG”), the manufacturer of Mercedes-Benz vehicles, has determined that on certain Model Year (“MY”) 2021-2022 GLE and GLS (167 platform) vehicles, the steering coupling locking screws might not be tightened to the specified torque value. Insufficient tightening torque of the steering coupling locking screws might lead to free play in the connection, which would cause noises when driving on uneven roads. Should these noises not be noticed and therefore the vehicle not be brought to a workshop, the steering coupling locking screws may subsequently loosen further due to vibrations during driving and ultimately might back out of the steering coupling. In this condition, it cannot be fully ruled out that the steering coupling may detach from the steering shaft. This could impair the ability to steer the vehicle, which could increase the risk of a crash. Before the issue occurs, the driver may be made aware of the issue by resulting noises when driving on uneven roads. An authorized Mercedes-Benz dealer will replace the steering coupling locking screws on the affected vehicles.

1. Replace bolt at upper and lower universal joint of the steering coupling (Figure 1,2).

**i** Bolts shall be accessible from engine compartment at the top.

**i** Turn steering column until both bolts are accessible.

**Hm** Steering coupling bolt to steering shaft or rack-and-pinion steering **42 Nm**.
