Recall Campaign Bulletin

Campaign No. 2023010002, February 2023

SUBJECT: **Model GLE/ML and GLE Coupe (166 and 292 platform)**
Model Year 2012-2019

Check for Water entry in the Spare Wheel Well

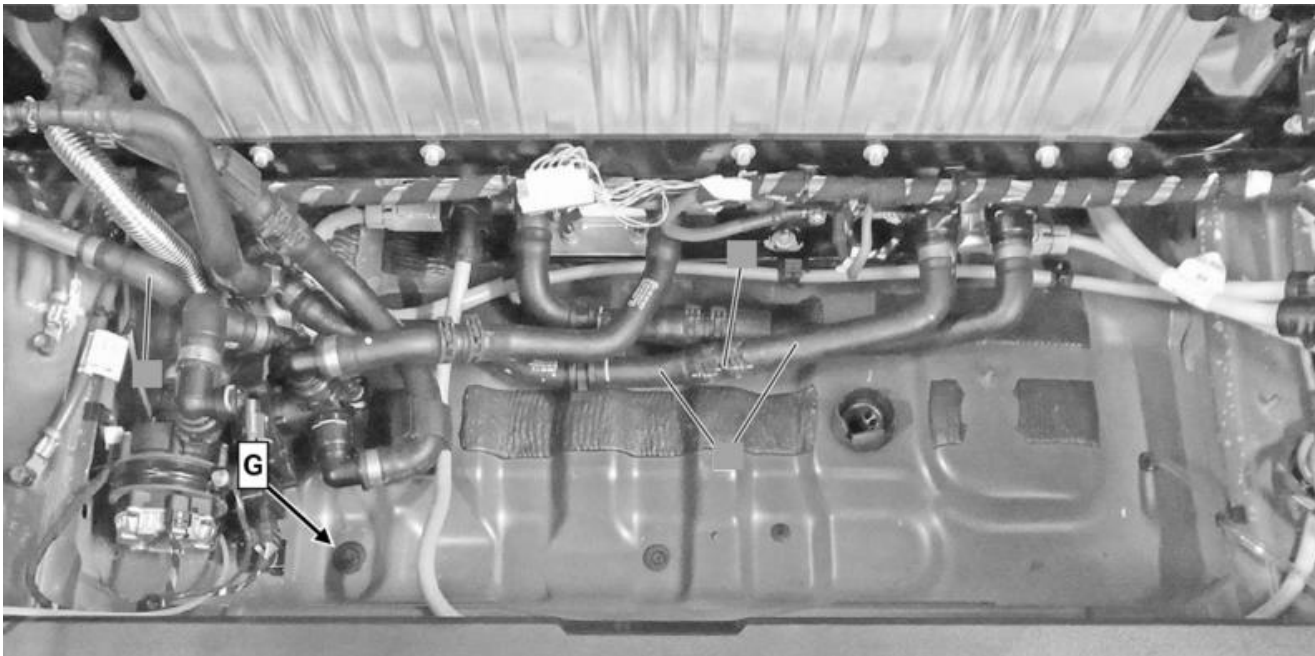
Figure 7, shown on ML500 hybrid 166.063

i First, remove existing closed grommet (G, Figures 6 and 7).
