# Recall Campaign Bulletin

Campaign No. 2023010003, February 2023

SUBJECT: **Model GLE/ML and GLE Coupe (166 and 292 platform)**  
**Model Year 2016-2020**

## **Check for Water entry in the Spare Wheel Well**

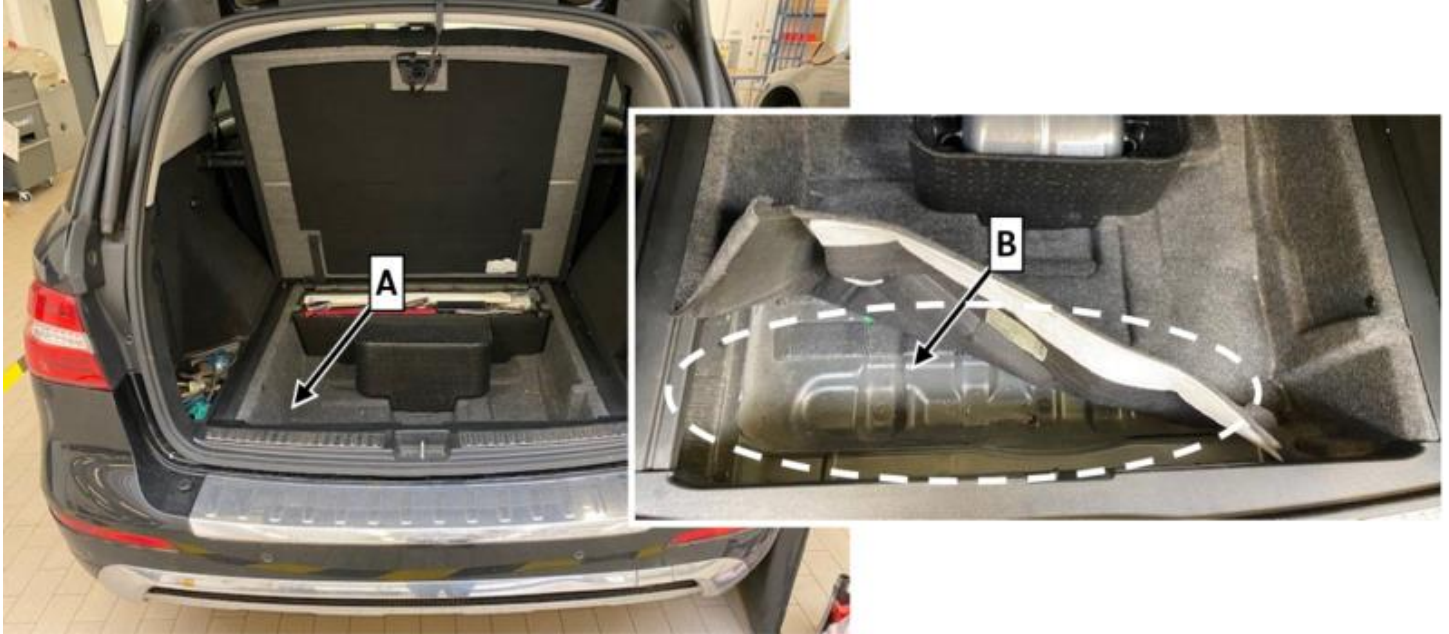
Figure 2

4. Lift left rear felt insert (A, Figure 2) and check for humidity or water deposits in marked area (B, Figure 2).

- a. If humidity or water deposits are **not** present in the area (B, Figure 2): Carry out **work procedure A**.
- b. If humidity or water deposits are present in the area (B, Figure 2): Carry out **check/test procedure B**.
