# Recall Campaign Bulletin

Campaign No. 2023010002, February 2023

SUBJECT: **Model GLE/ML and GLE Coupe (166 and 292 platform)**  
**Model Year 2012-2019**

## **Check for Water entry in the Spare Wheel Well**

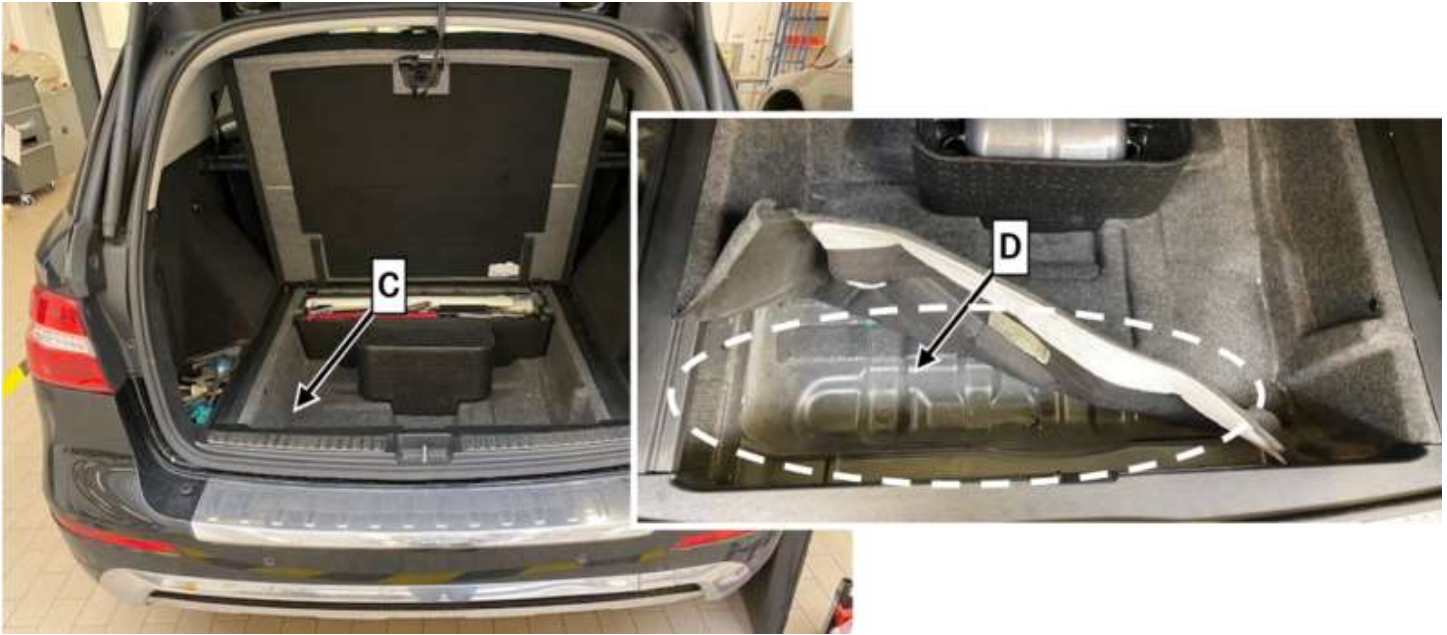
Figure 3

5. Lift left rear felt insert (C, Figure 3) and check for humidity or water deposits in marked area (D, Figure 3).  
**i** There is no felt trim in hybrid model 166.063.

- a. If humidity or water deposits are **not** present in area (D, Figure 3): Carry out **work procedure A**.
- b. If humidity or water deposits are present in area (D, Figure 3): Carry out **check/test procedure 2**.
