Recall Campaign Bulletin

Campaign No. 2023010003, February 2023

SUBJECT: **Model GLE/ML and GLE Coupe (166 and 292 platform)**
Model Year 2016-2020

Check for Water entry in the Spare Wheel Well

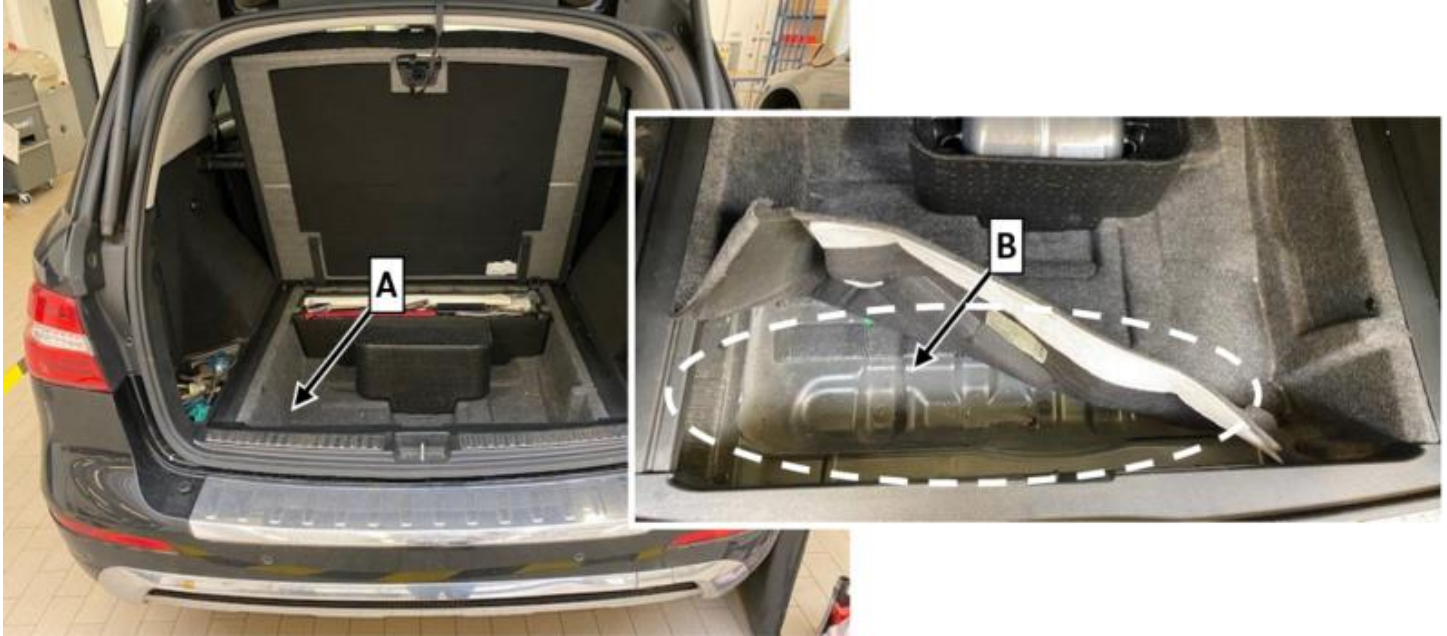
Figure 2

4. Lift left rear felt insert (A, Figure 2) and check for humidity or water deposits in marked area (B, Figure 2).

- a. If humidity or water deposits are **not** present in the area (B, Figure 2): Carry out **work procedure A**.
- b. If humidity or water deposits are present in the area (B, Figure 2): Carry out **check/test procedure B**.
