R22BW

Subject: R22BW: FMVSS 102 Noncompliance – BBCV Starter Interlock with Allison Transmission

IMPORTANT SAFETY RECALL
NHTSA Campaign Number: 22V-321 (School Bus)
NHTSA Campaign Number: 22V-330 (Non-School Bus)

R22BW: FMVSS 102 Noncompliance, BBCV Starter Interlock with Allison Transmission

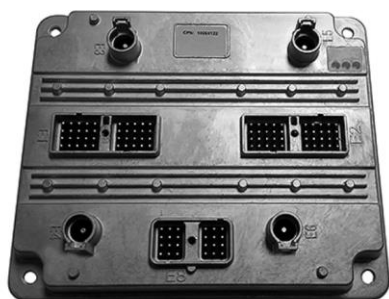
Item# 10059122

Multiplex Module (Blue Bird Part # 10059122) Shown Below, As Reference Only

Corrective Action: The Blue Bird A Zone Multiplex Module must be re-flashed with software, available on the Blue Bird Vantage Unit Dashboard Website.
