R22CB

DATE: January 11, 2024
TO: Blue Bird Owners
Subject: R22CB: 7.3L Gas Supply Line And Shifter Cable Interference

RECALL R22CB

7.3L SHIFT CABLE-GASOLINE FUEL LINE INTERFERENCE

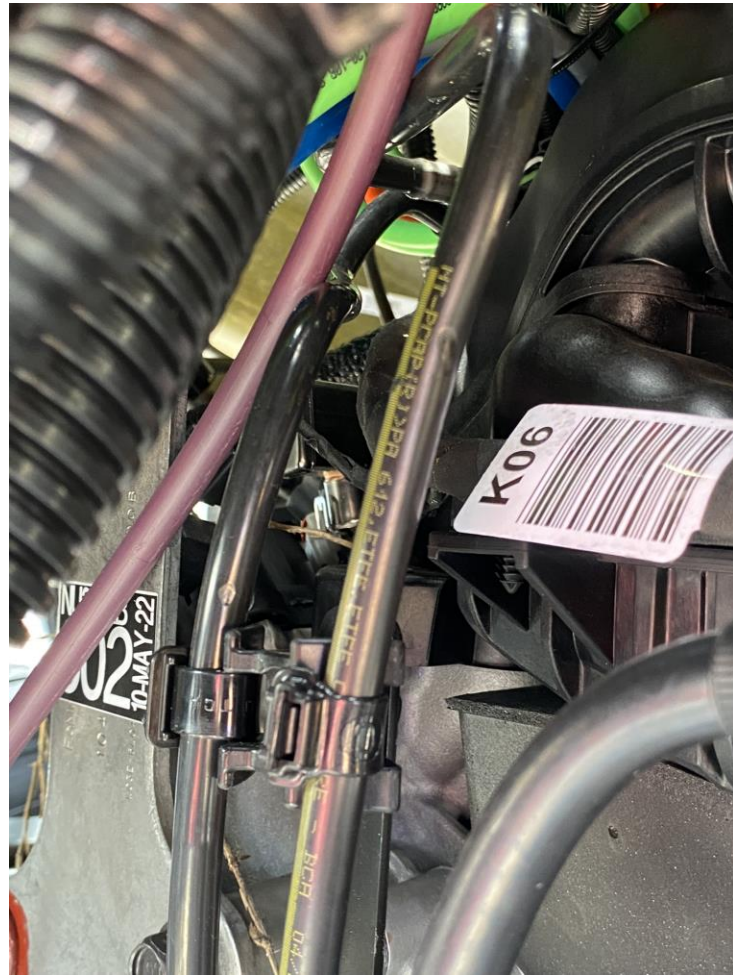
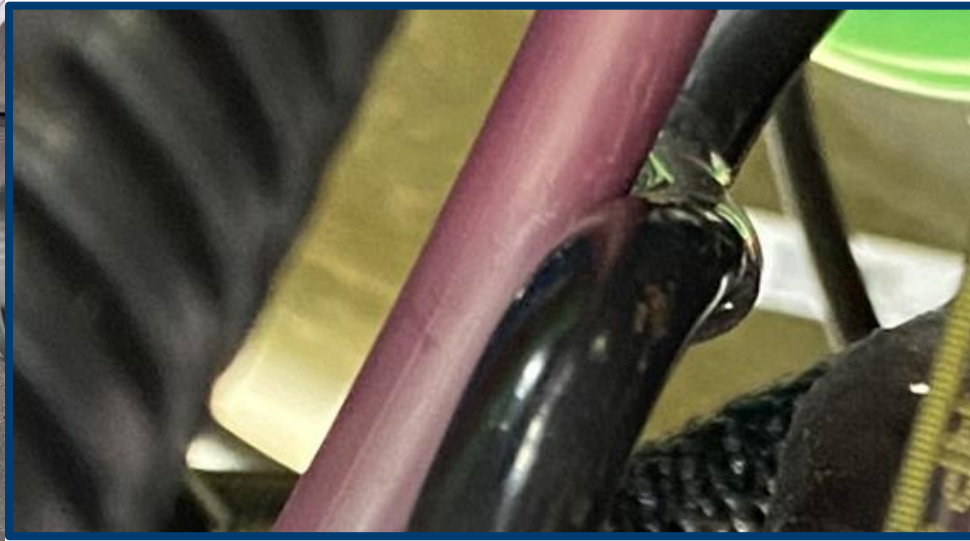
Fig 1

Step 1: Inspect the left rear corner of the engine from the top, and the bottom. If there is greater than 3” of clearance between the shift cable and the fuel line, no further action is required. Ref. Figure 1 for an example of insufficient clearance. If <3” of clearance, proceed to step 2.

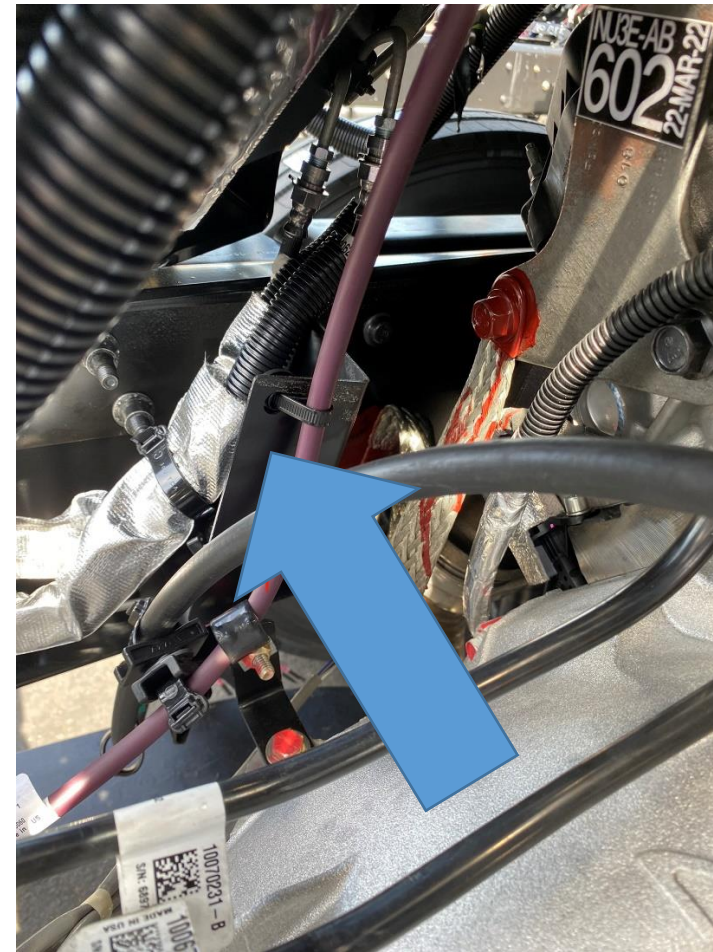
Fig 2

Step 3: Verify the heat shield bracket (Item 2), regardless of brake type is in place. Reference Figure 2. If missing, install per Figure 3.
