# Product Safety Recall

## N212352530 Windshield Wiper Failure

**Release Date:** October 2022

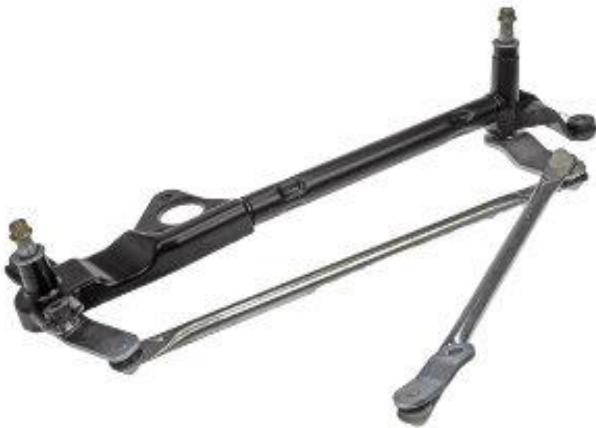
6055971

**Black painted aftermarket module frame**

- **NON-GM Wiper Module Assembly Example.** If the wiper module is determined to be a non-GM unit, replace the complete windshield wiper system module assembly. Refer to *Windshield Wiper System Module Replacement* in SI.

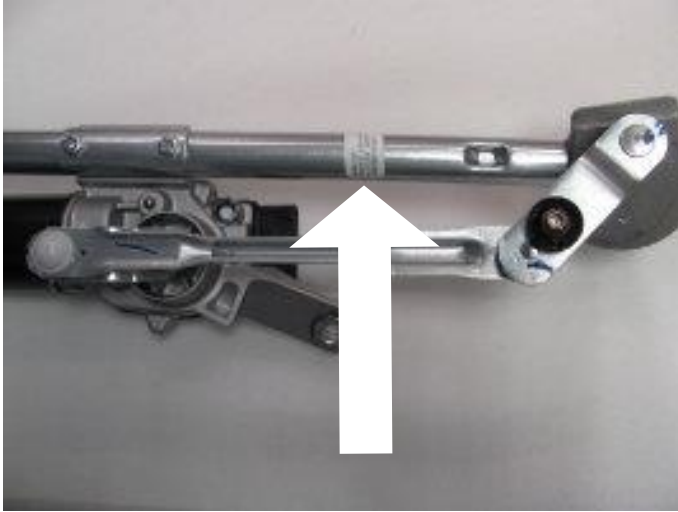
6055973

***GM OE parts will have a part number tag***

- **OE-GM Wiper Module Identification.** If the wiper module is determined to be a GM unit, proceed to step #2.

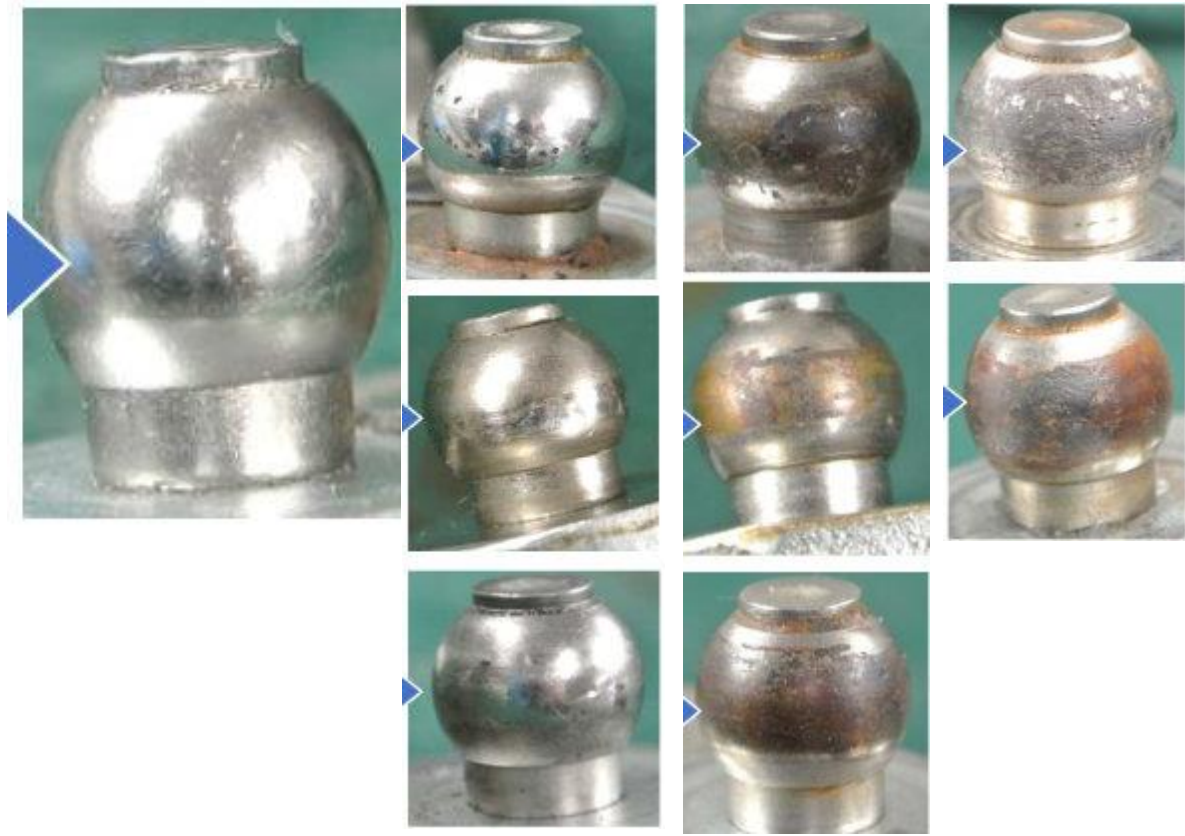
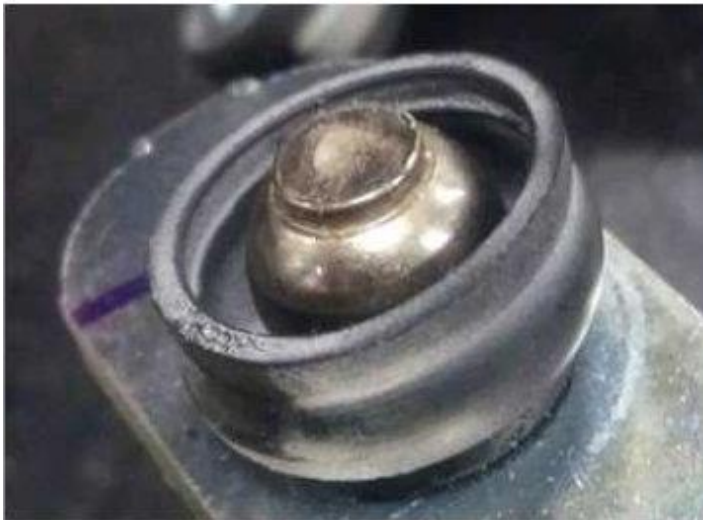
**The below examples are acceptable levels pitting, flaking and rust residue.**

5. Using a suitable aerosol solvent and a small wire brush or abrasive pad, clean the old grease and debris from the ball joints. Wipe the ball joints clean with a suitable disposable towel.
6. With the ball joints cleaned, inspect the surface for severe damage (material missing).

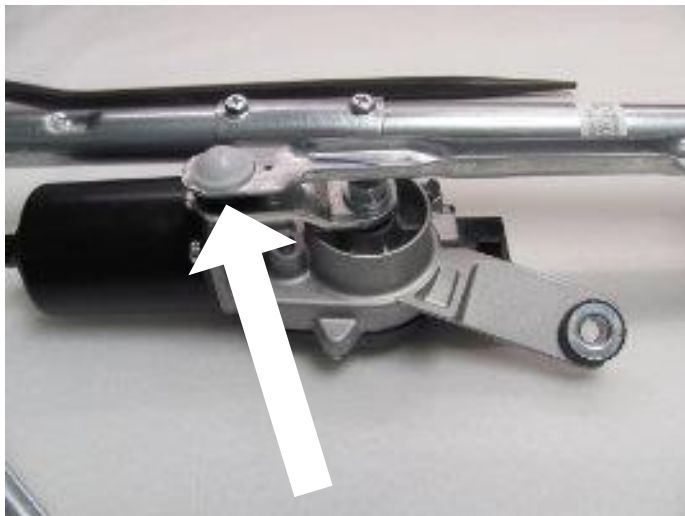
6055983

**IMPORTANT:** The short link rod has a long side and a short side. The long side is marked by a blue paint stripe. Ensure the long side is installed onto the motor pivot ball. Improper installation of this link will cause interference with the rotating assembly.

8. Install the short link rod onto the motor arm (the long side of the link rod, with the blue stripe, goes to the motor ball joint). Apply hand pressure to the nylon cup until it is fully seated on the motor arm ball joint.
