PREVOST

**SAFETY
RECALL**

SR22-05A

DATE :	September 2022	SECTION :	06 ELECTRICAL
SUBJECT:	ALTERNATOR BELTS REPLACEMENT

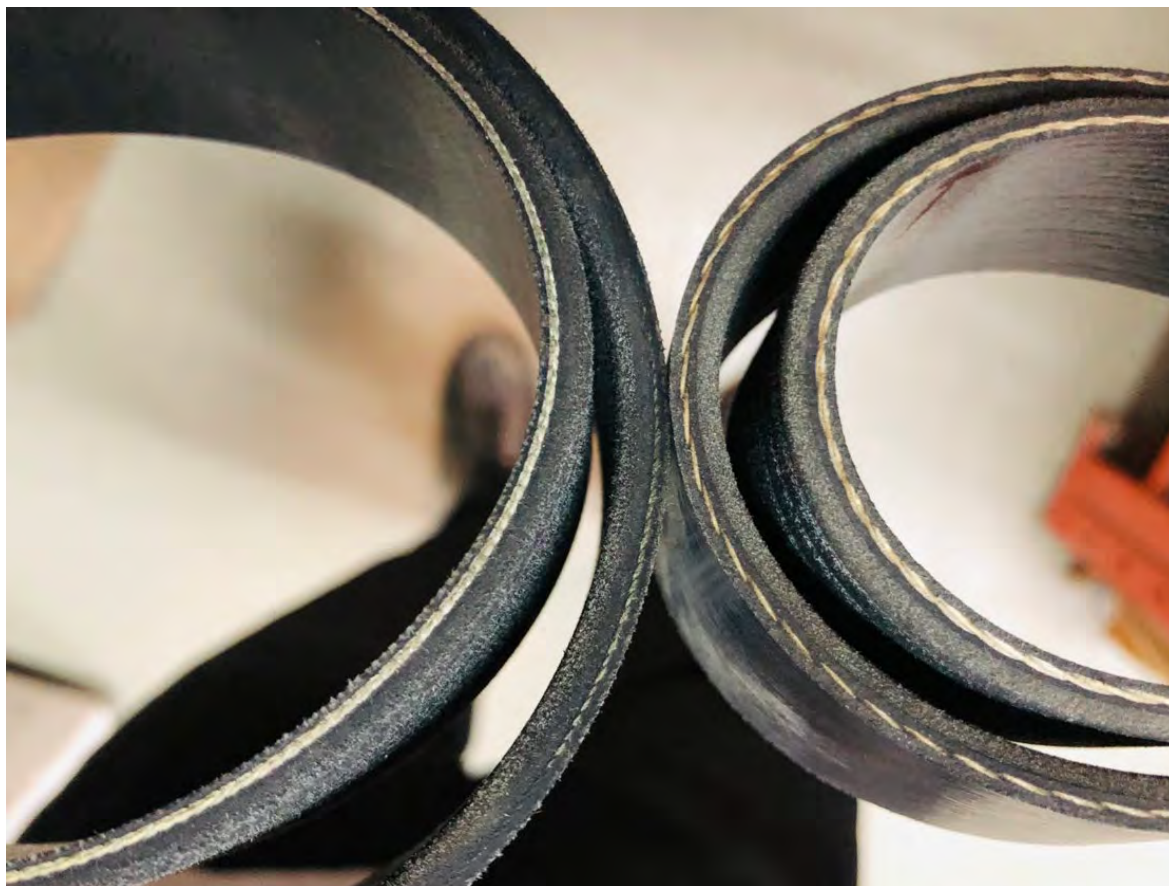
Aramid reinforced cord belt (left) vs new polyester cord belt (right).

Therefore, the heavy duty aramid belts must be replaced by polyester belts as needed following the interchange table provided.

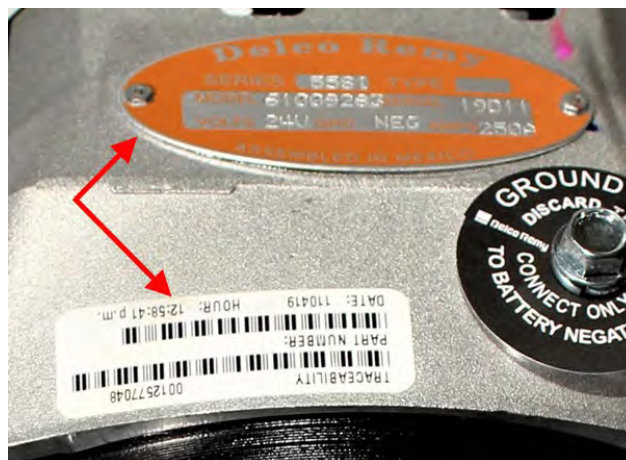
- REMY 55S Alternator will have a Delco-Remy identification plate riveted to the body as well as a bar code sticker next to the ground stud as shown.
