**PREVOST**

**SAFETY  
RECALL**

**SR22-05**

DATE :	September 2022	SECTION :	06 ELECTRICAL
SUBJECT:	ALTERNATOR BELTS REPLACEMENT

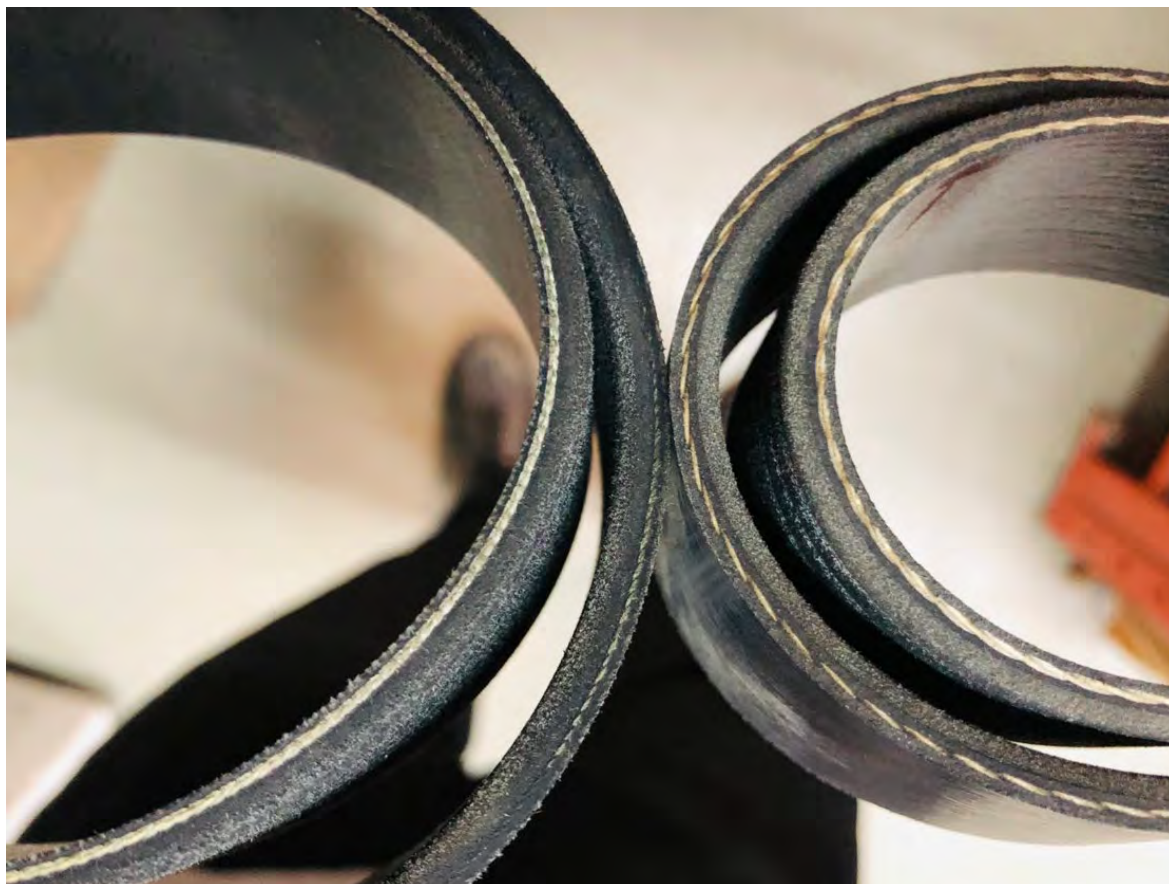
On vehicles affected by this recall, the heavy duty alternator belt (with aramid cord reinforcement) may continue to turn the alternator pulley after an alternator bearing failure. If the pulley continues to turn, it could lead to front bearing overheat.

**Aramid reinforced cord belt (left) vs new polyester cord belt (right).**

Therefore, the heavy duty aramid belts must be replaced by polyester belts as needed following the interchange table provided.

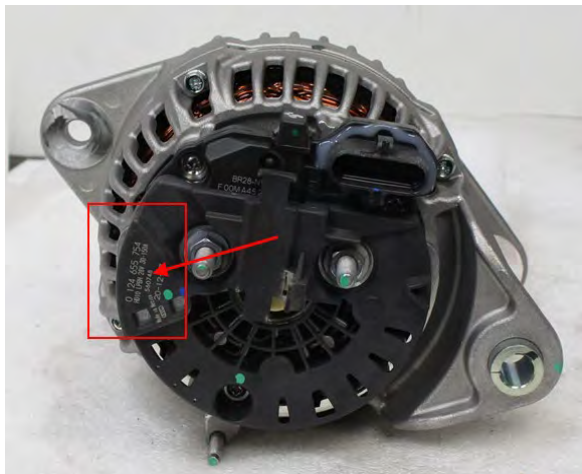
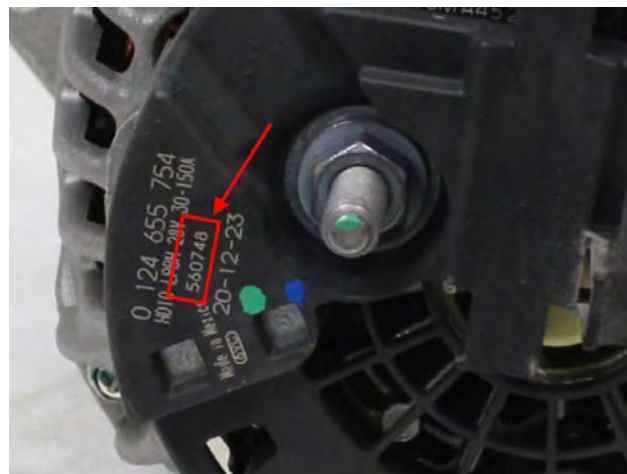
#### BOSCH HD10

- BOSCH HD10 OEM alternator will have a Prevest part number stamped on the back cover (as well as Bosch part numbers).
- These identification marks (numbers) can either be printed in white or stamped/molded in the plastic cover (150amp HD10 with white marking shown).

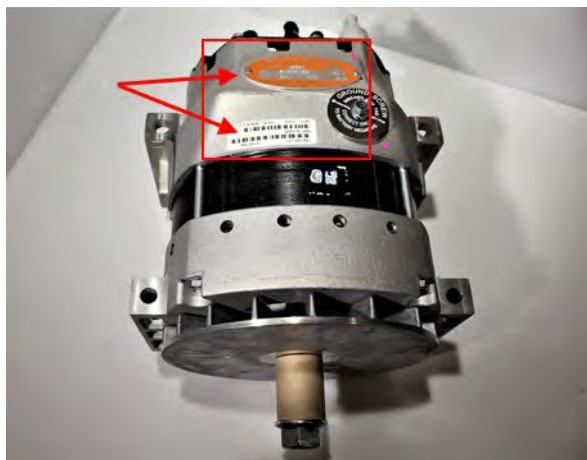
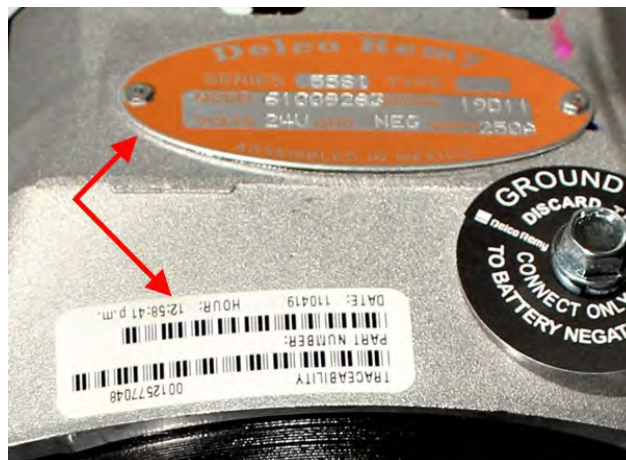
### REMY 55S

- REMY 55S Alternator will have a Delco-Remy identification plate riveted to the body as well as a bar code sticker next to the ground stud as shown.
