PREVOST

**SAFETY
RECALL**

SR22-83A

DATE : September 2022	SECTION : 06 ELECTRICAL
SUBJECT: 9700 ALTERNATOR BELT REPLACEMENT

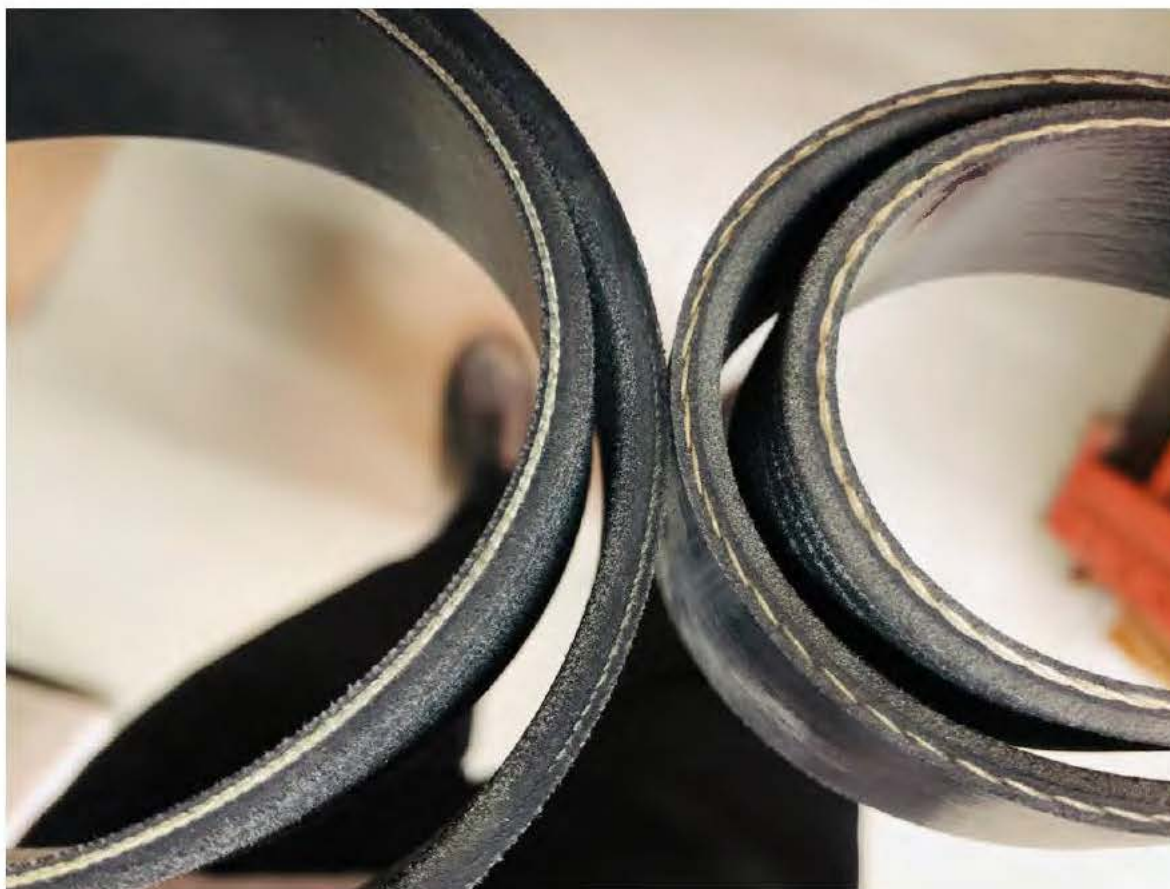
Aramid reinforced cord belt (left) vs new polyester cord belt (right).

5. Inspect the alternator belt (refer to the picture above).
 - If the belts are polyester reinforced reinstall them.
 - If the belt is reinforced with aramid cords, complete the inspection and replace it with a new polyester belt (see interchange table).
6. Reverse the procedure to reinstall the other belts on the vehicle.

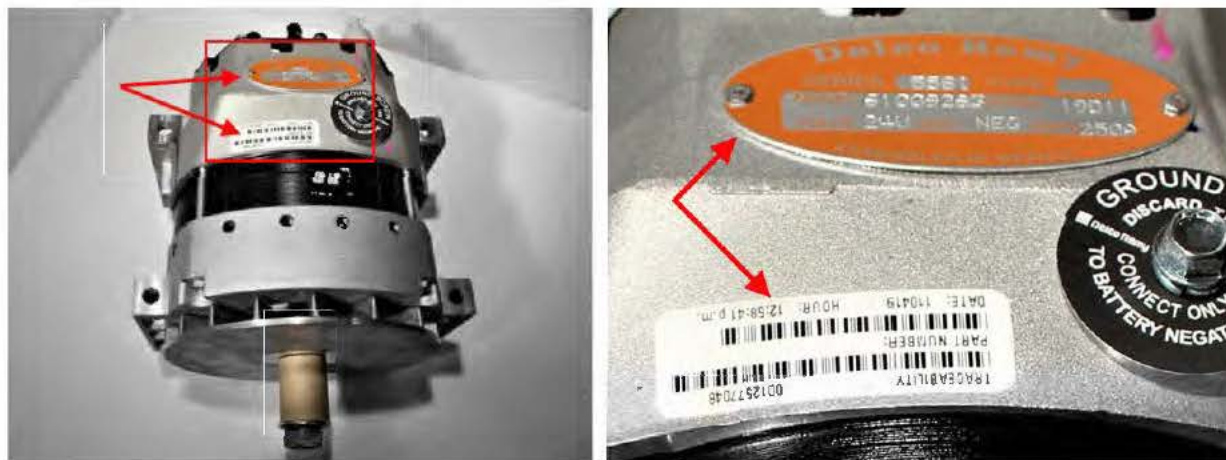
REMY 55S 250AMP

- **REMY 55S** Alternator will have a Delco-Remy identification plate riveted to the body as well as a bar code sticker next to the ground stud as shown.
