Release Date: May 2022

Product Safety Recall

N212356050 Driver Seat Improper Weld

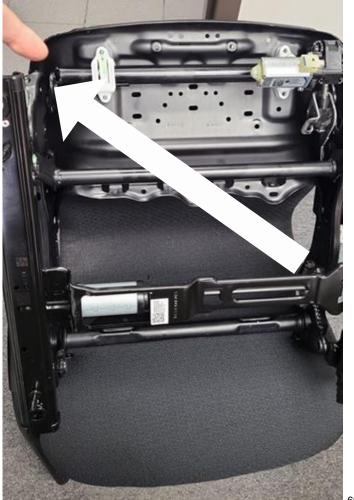
6081071

3. Locate the inboard (center of vehicle) end of the seat tilt tube where it meets the welded-on bracket (the tilt tube is mounted to the seat pan with white or black nylon pivots).

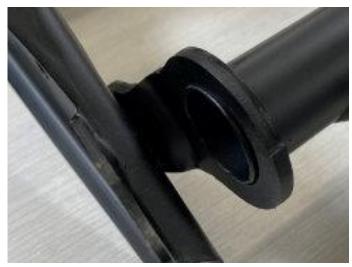
6081073

Good Tilt Tube Example 2

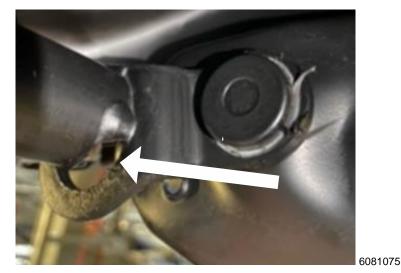
Not Acceptable Tilt Tube Example 2

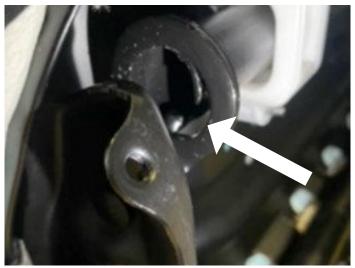
6081076

Not Acceptable Tilt Tube Example 3

4. Inspect the area where the tilt tube goes through the bracket and ensure it is fully inserted, flush (or slightly proud) of the bracket and appears to be correctly assembled.

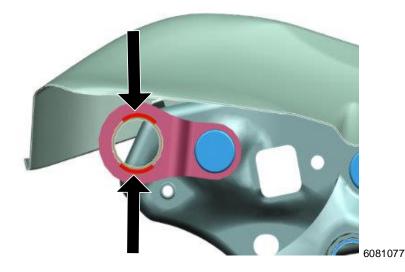
Good Weld Example 1, red area represents correct length for both welds.

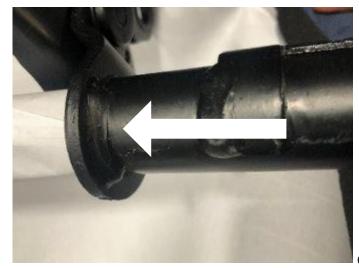
6081078

Good Weld Example 2

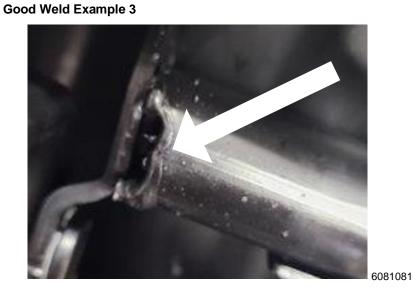
6081079

Bad Weld Example 1, burn through.

- 5. Inspect the two semi-circular welds that secure the tilt tube to the bracket and ensure they are complete, sound and that there is no "burn through" causing a void or hole in the tilt tube or bracket.
- 6. If the welds and tilt tube assembly are correct, no further action is required, reinstall the seat. Refer to *Front Seat Removal and Installation* in SI.
- 7. If the seat tilt tube or bracket show any weld defects, missing welds or the seat tilt tube is not correctly assembled to the bracket, replace the front seat cushion frame assembly. Refer to *Front Seat Cushion Frame Replacement* in SI.
