Product Safety Recall

N222377890 Seat Height-Adjust Pivot Bolt May Be Loose

Release Date: October 2022 **Revision:** 01
Revision Description: This bulletin has an updated service procedure, and the customer letter has been added. Please discard all previous copies of bulletin N222377890.

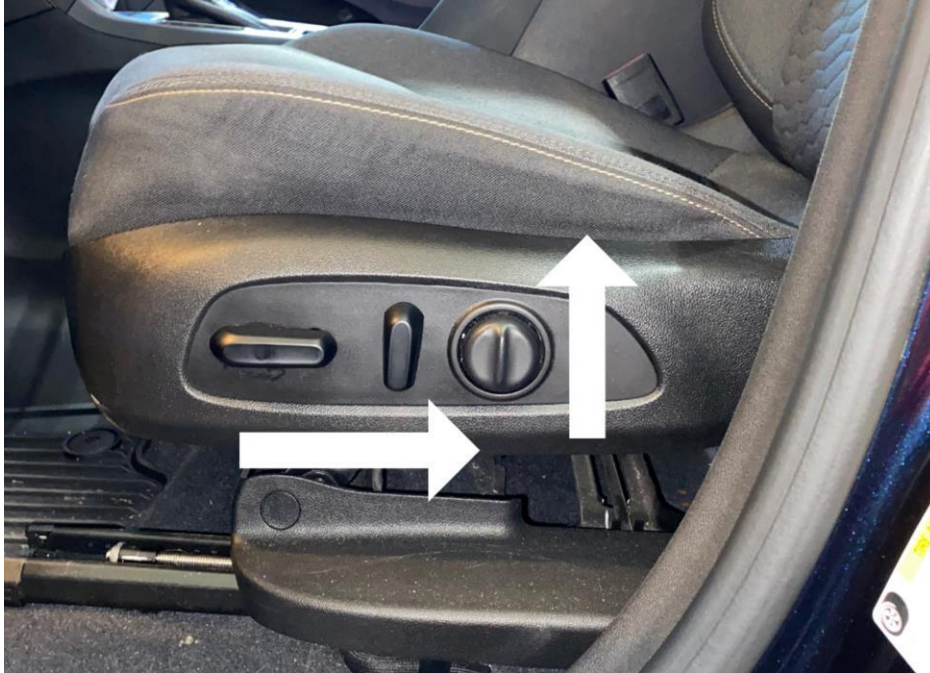
6160261

1. Adjust the driver's seat to the highest upward and most rearward position, as shown above.

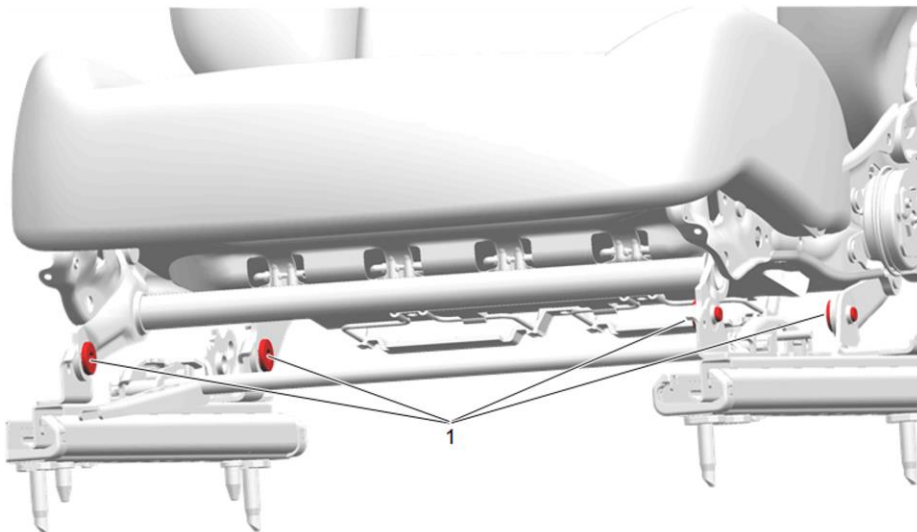
6160251

2. Locate the four Front Seat Vertical Adjuster Bracket Bolts (1), shown above.
 - If all four bolts are in place, proceed to step 3.
 - If any of the four bolts are missing replace the Front Seat Cushion Frame. Refer to *Front Seat Cushion Frame Replacement* in SI. Proceed to step 6.

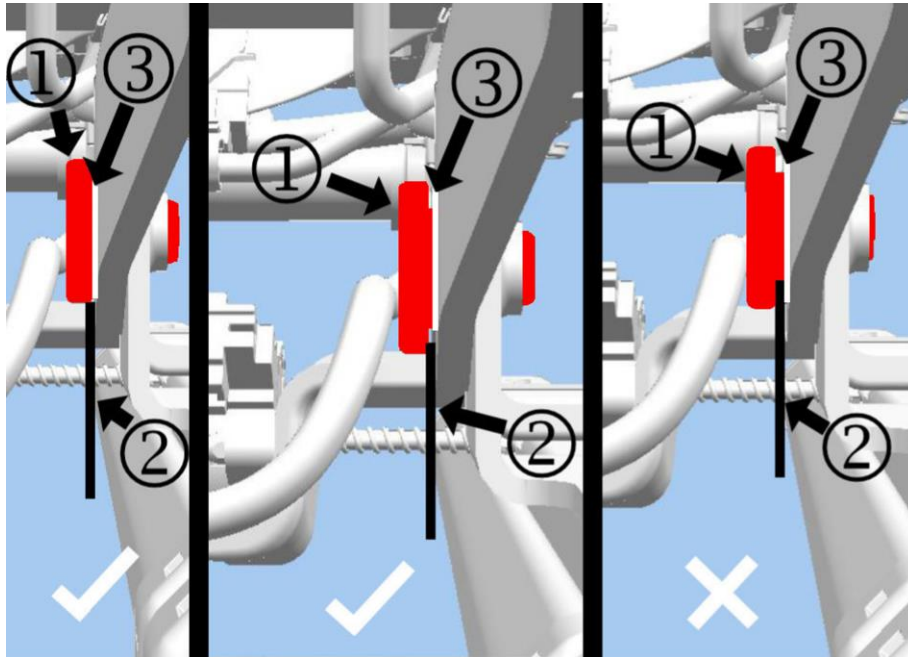
6160263

Note: The gap is considered good if the feeler gauge can fit as shown in the center image of the graphic above but cannot go in far enough to touch the shaft of the bolt. The feeler may touch the outside diameter of the bushing, as shown in the center image of the graphic above but should not pass between the head of the bolt and the bushing flange, touching the shaft of the bolt as shown in the right image of the graphic above.

3. On all four bolts, check the gap between the Front Seat Vertical Adjuster Bracket Bolts (1) and the Front Seat Cushion Frame Bushing (3) using a 0.25 mm (0.010 inch) feeler gauge (2) as shown above.
 - If the gap is less than 0.25 mm (0.010 Inch) on all four bolts, shown in the left and center image of the graphic above, proceed to step 5.
 - If the gap is 0.25 mm (0.010 Inch) or more on any of the four bolts, shown in the right image of the graphic above, proceed to step 4.
4. Inspect the failed bolts for cross threading.
 - If no cross threading is found, proceed to step 5.
 - If cross threading is found, replace the Front Seat Cushion Frame. Refer to *Front Seat Cushion Frame Replacement* in SI. Proceed to step 6.

5. Torque all four bolts to 39 Nm (20 lb ft).
 - If all four bolts achieve torque, proceed to step 6.
 - If any of the four bolts do not achieve torque, replace the Front Seat Cushion Frame. Refer to *Front Seat Cushion Frame Replacement* in SI. Proceed to step 6.
6. Return the seat to the original location.
