December 23, 2022

Version 1

## Safety Recall: 2022 TLX Bridgestone Tire Inspection

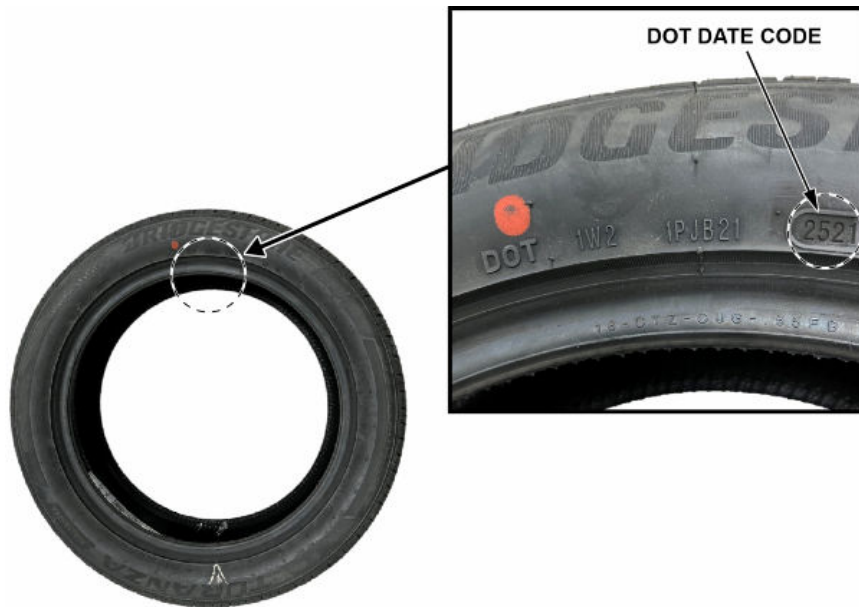
Inspect the last **four** digits of the DOT number on all **four** tires. The tire must display the DOT number listed below:

- DOT date code number 2521
- DOT date code number 2621

- Above the DOT of each tire, mark its location on the vehicle. For example: Left Front (LF), Left Rear (LR), Right Front (RF), Right Rear (RR).
- Clear photos of the door jamb VIN sticker, and the DOT date code of all **four** tires must be submitted with the warranty claim.

If the last **four** digits of the DOT number correspond to one listed above, go to Repair Procedure.
