Advance Stores Company, Inc.

IMPORTANT SAFETY RECALL RECALL NO. 23E038

June 2023

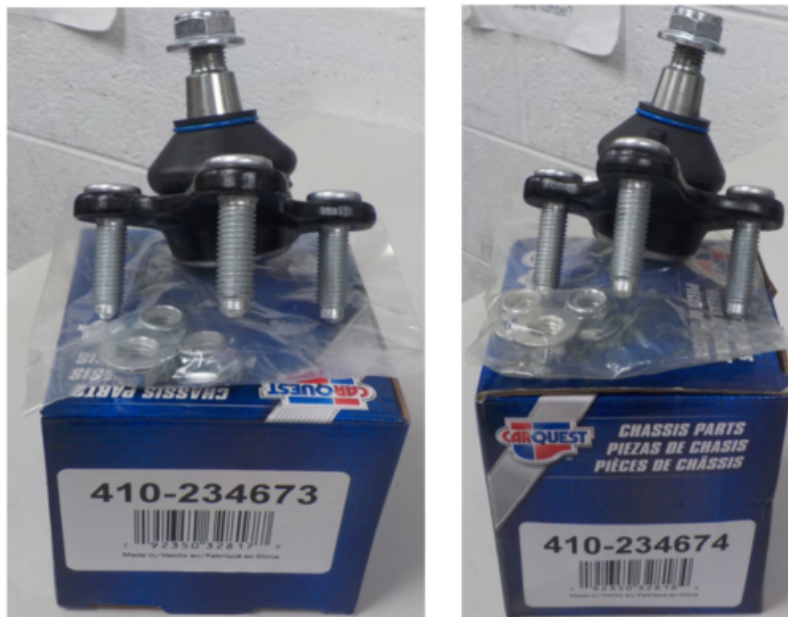
Carquest-branded lower ball joints (pictured below), part numbers 410-234673 and 410-234674, for installation in certain Volkswagen and Audi vehicles.

Under certain high-load conditions, there is a potential that the ball joint stud may pull out of the aluminum steering knuckle. If the ball joint separates from the knuckle, front wheel control may be compromised, increasing the risk of a vehicle crash.

(a) Product Remaining in Your Inventory: If any of the above-identified ball joints remain in your inventory, you must immediately return them to your servicing store as “defective.” We do not have any Carquest- brand replacement parts for these applications at this time.

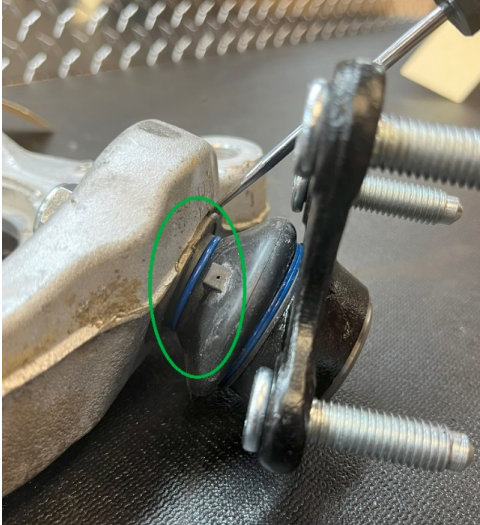
(b) Products You Installed or Sold to Customers: You must **immediately** identify and contact any affected customers using the enclosed NHTSA-approved consumer letter. If a customer presents his/her vehicle for service under this recall, please perform the recall service per the steps below. Inspect the knuckle where the ball joint was installed to determine if the steel insert that is pressed into the aluminum knuckle where the ball joint stud mounts is still fully seated into the knuckle. The bottom of the steel insert should be flush with the bottom of the aluminum knuckle. See images below:

Steel insert seated flush

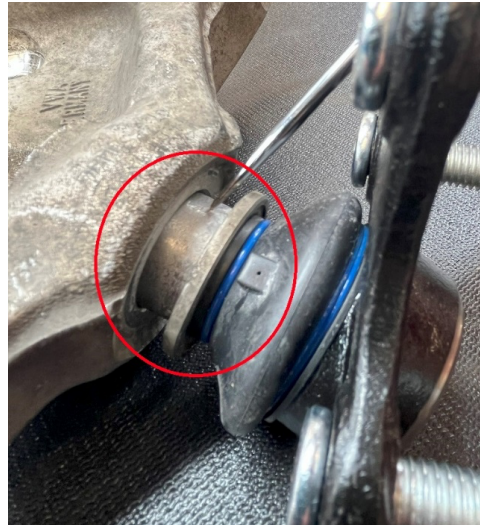
Steel insert has moved

- If the steel insert has moved such that it is no longer fully seated inside the knuckle (right photo above), replace the complete knuckle assembly, lower ball joint and lower ball joint stud nut with the following OE parts:
 - OE aluminum steering knuckle
 - OE lower ball joint
 - OE lower ball joint stud nut
- If the steel insert is still fully seated inside the knuckle (left photo above), replace only the lower ball joint stud nut with the following OE part:
 - OE lower ball joint stud nut
- Please contact Advance Customer First Service Center at (888) 286-6772 option 2 to submit a claim to be reimbursed for this repair.
