Product Service Bulletin: *Flip Cushion Retaining Ring*

Some Flip Cushions (Seats Part Number 188599) may have Retaining Rings that are missing or not fully seated on the bar. Below are instructions on how to identify this condition followed by instructions for correcting the issue.

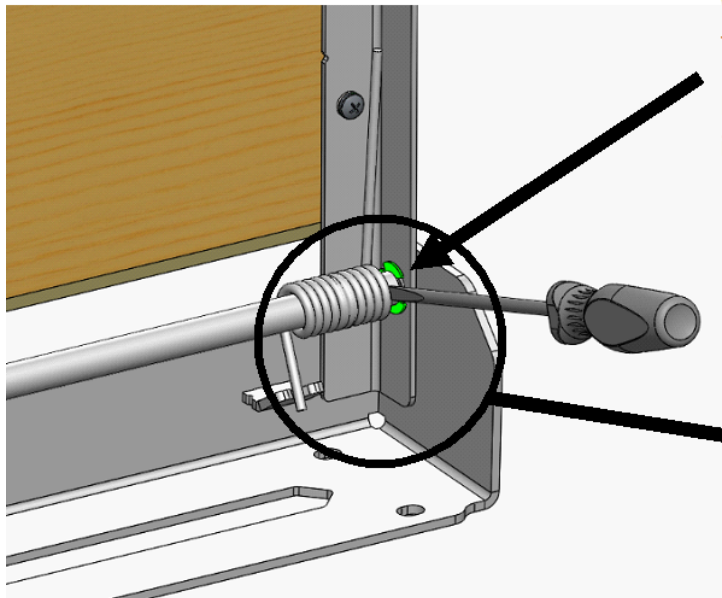
Correct Condition: Retaining Ring is present and freely rotates on shaft.

Incorrect Condition: Retaining Ring is missing or is present and does not freely rotate on shaft.

If your Retaining Ring is not fully seated, simply push it the rest of way on until it is fully seated. This can easily be done with any hard, flat tool. (*Examples: Needle-nose pliers, flat-headed screwdriver, etc.*) If your Retaining Ring is missing, ensure that the pivot rod slot is between the spring and the side of the seat by sliding the pivot rod as needed. Retrieve your new Retaining Ring and place it in the pivot rod slot nearest the spring as shown in above images.

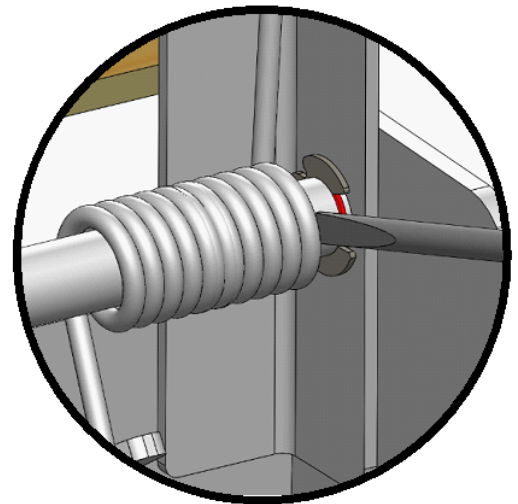
To verify if the Retaining Ring rotates freely on the shaft, the pressure from the spring on the Retaining Ring has to be relieved. Wedging a flat-headed screwdriver between the spring and the side of the seat is a good way to go about this. With one hand relieving spring pressure, try to rotate the Retaining Ring with the other hand.
