August 4, 2023

SUBJECT: **NEW VEHICLE DEMONSTRATION / DELIVERY HOLD –
 Safety Recall 23S06 – *Supplement #2***

Certain 2022-2023 Model Year Bronco, Explorer, F-150, Mustang and 2023 Aviator
 Vehicles Equipped With 10 Speed Automatic Transmission
 Transmission Assembly Inspection

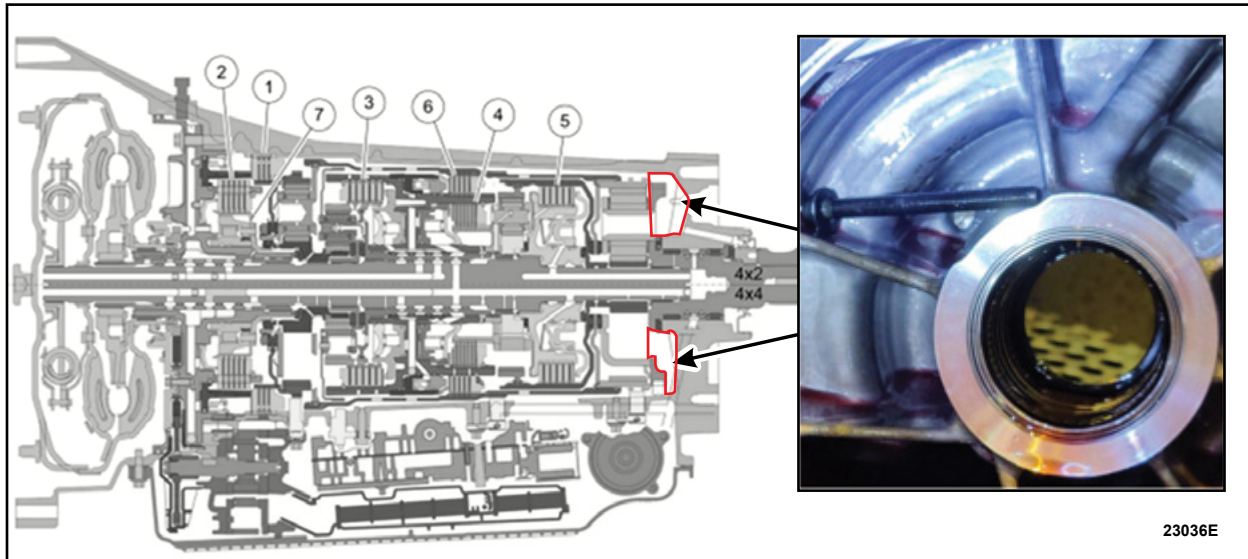
FIGURE 5

NOTE: See Figure 5 for examples of possible bolt location.

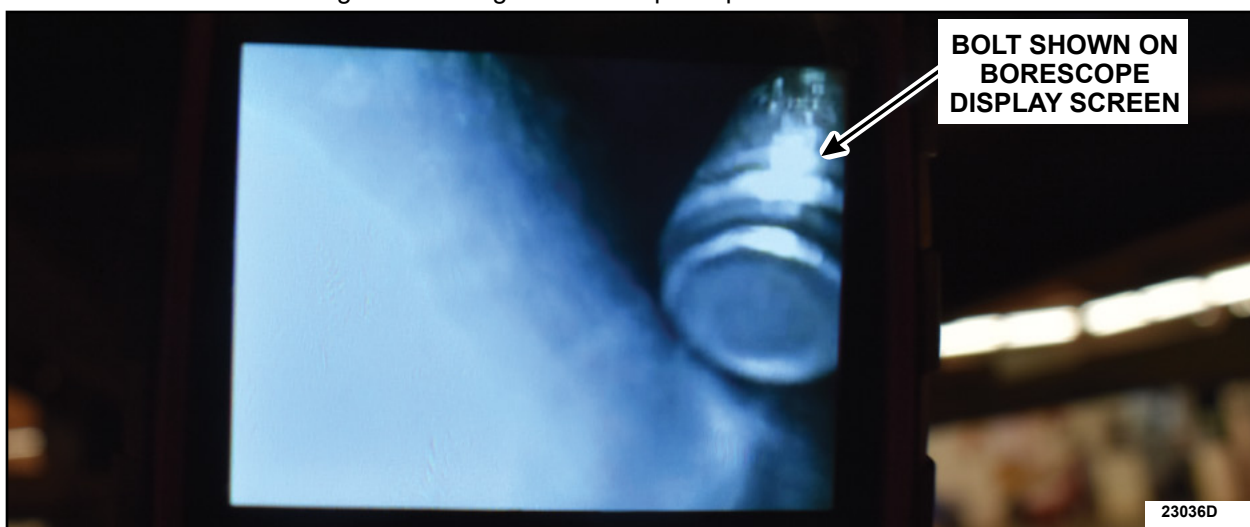
FIGURE 8

8. While watching the borescope display screen for a bolt, slowly remove the borescope camera cable. See Figure 8. Was a bolt found using the borescope?

NOTE: There is a very low probability that a bolt will be found in the transmission. If there is a bolt in the transmission, there will typically be other indicators such as excess metal debris or marks on the interior of the housing found during the borescope inspection.

YES - Submit a photo of the bolt found in the transmission assembly, the VIN, and the transmission oil pan removed. Replace the transmission. Follow the WSM procedures in Section 307-01. This completes the FSA.

NO - Repeat Steps 7 through 8 a total of 5 times. If no bolt is found after 5 inspections. Reassemble the vehicle by reversing the disassembly procedures. This completes the FSA.
