SUBJECT: **NEW VEHICLE DEMONSTRATION / DELIVERY HOLD –
 Safety Recall 23S06 – *Supplement #1***

Certain 2022-2023 Model Year Bronco, Explorer, F-150, Mustang and 2023 Aviator
 Vehicles Equipped With 10 Speed Automatic Transmission
 Transmission Assembly Inspection

REF: **NEW VEHICLE DEMONSTRATION / DELIVERY HOLD –
 Safety Recall 23S06**

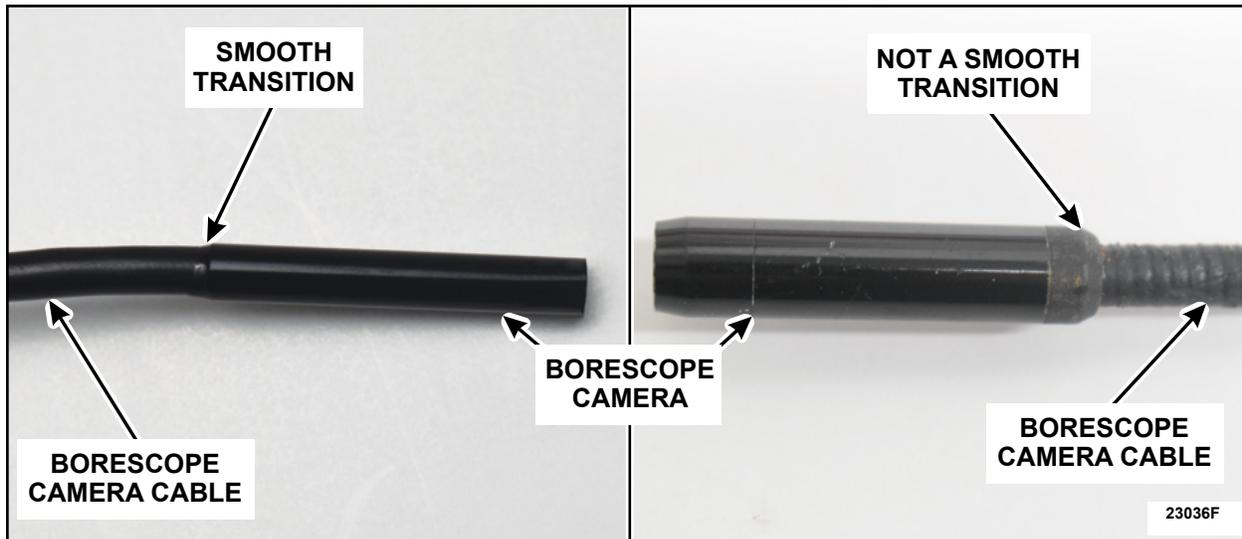
FIGURE 1

NOTE: The camera to cable transition **MUST** be smooth so there are no raised edges. See Figure 1. A raised edge or lip at the camera connection could cause it to get stuck in the transmission and require complete disassembly. **Metal braided cable is highly recommended.**
DO NOT attempt to use a borescope that has a camera larger than 6.0 mm diameter.

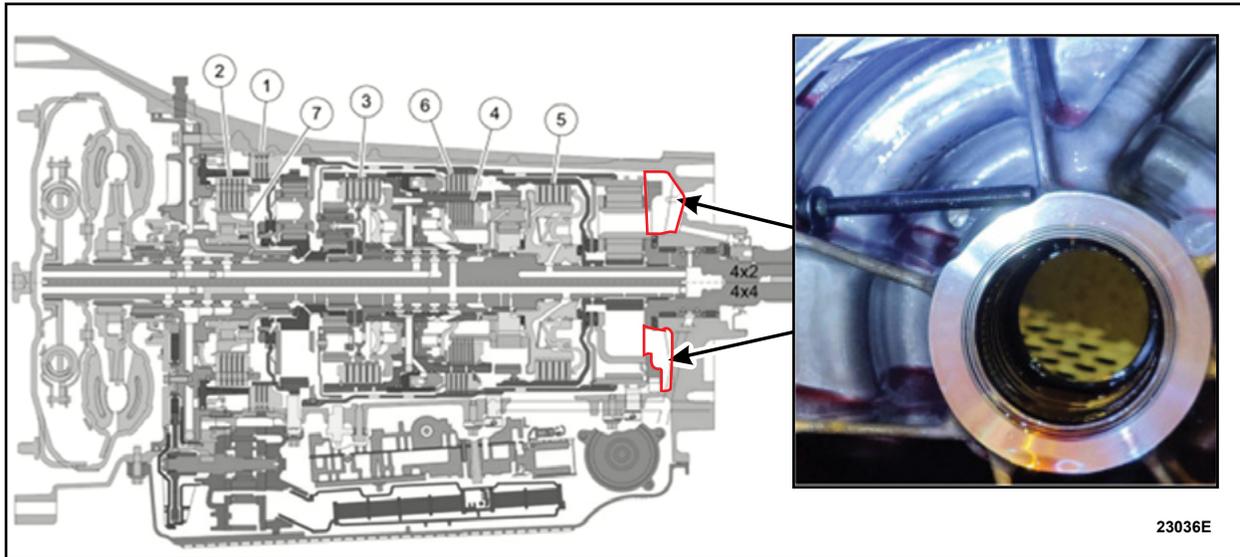
FIGURE 5

NOTE: See Figure 5 for examples of possible bolt location.

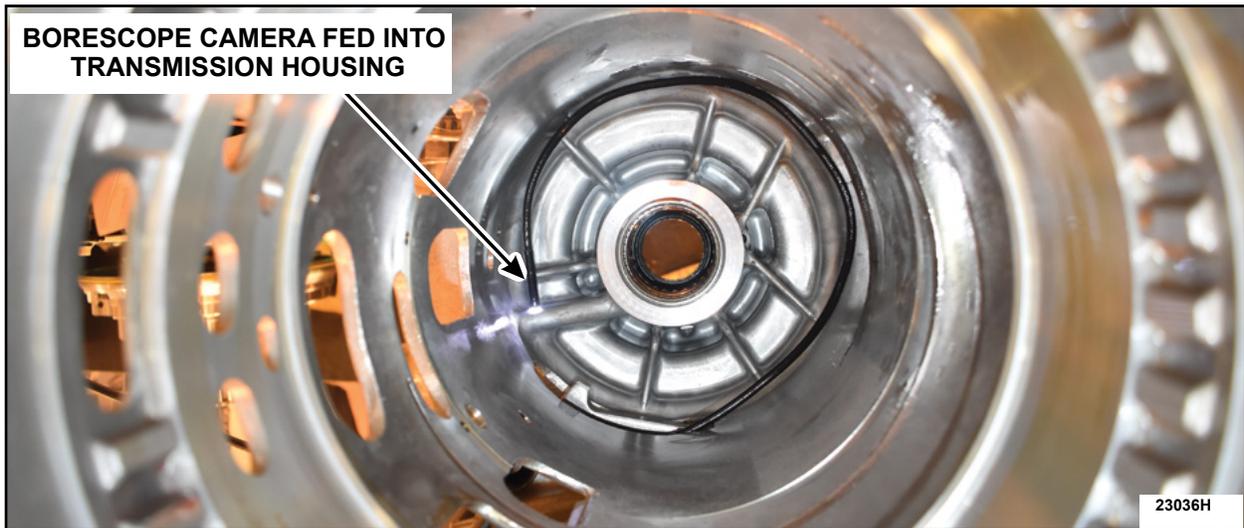
FIGURE 7

NOTE: If you see transmission gears on the borescope display screen, the camera cable fed through the wrong area remove the borescope and repeat Step 7. Bending a curve in the cable can assist in directing the camera to the proper location. See Figure 7.

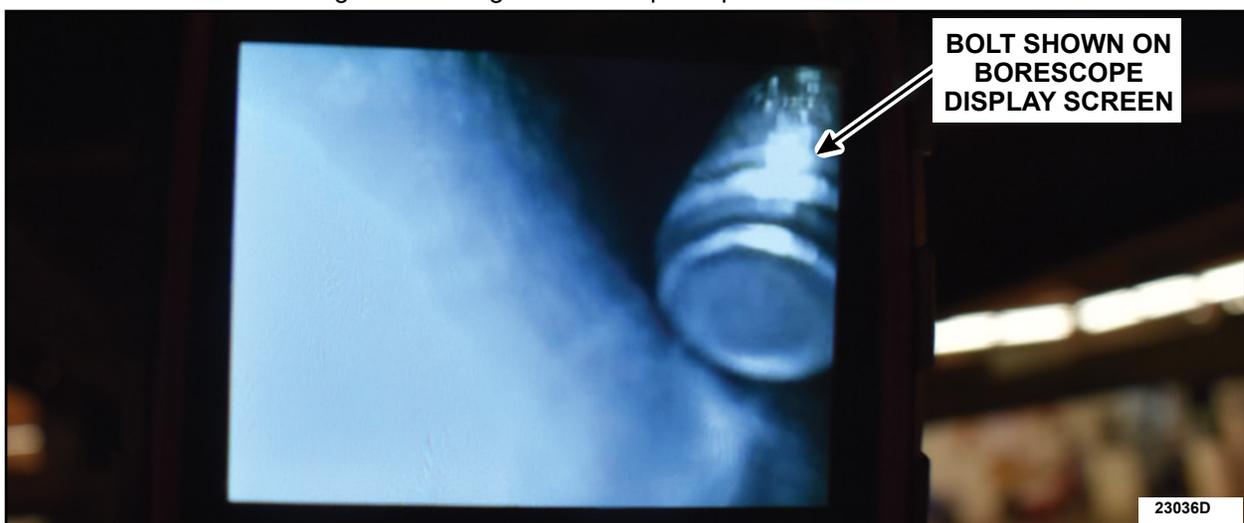
FIGURE 8

8. While watching the borescope display screen for a bolt, slowly remove the borescope camera cable. See Figure 8. Was a bolt found using the borescope?

NOTE: There is a very low probability that a bolt will be found in the transmission. If there is a bolt in the transmission, there will typically be other indicators such as excess metal debris or marks on the interior of the housing found during the borescope inspection.

YES - Submit a photo of the bolt found in the transmission assembly, the VIN, and the transmission oil pan removed. Replace the transmission. Follow the WSM procedures in Section 307-01. This completes the FSA.

NO - Repeat Steps 7 through 8 a total of 5 times. If no bolt is found after 5 inspections. Reassemble the vehicle by reversing the disassembly procedures. This completes the FSA.
