October 2023
FL966A-F
NHTSA #23V-073
Transport Canada #2023-051

Subject: Brake Modulator Valves

Models Affected: Specific model years 2017-2022 Freightliner 114SD, and Cascadia; and Western Star 47X, and 49X vehicles manufactured June 28, 2016, through April 8, 2022.

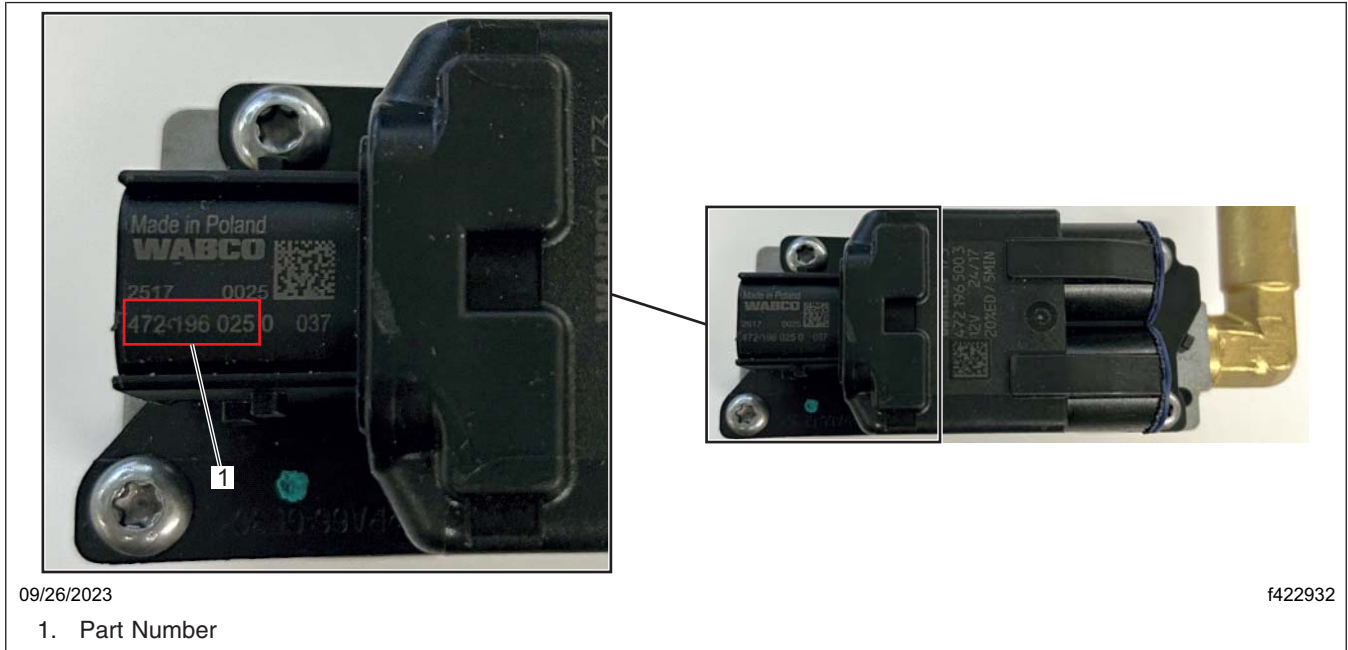
Fig. 1, Modulator Valve

4. Remove the connector from the valve, and inspect the part number underneath the connector. See [Fig. 1](#).

Good part numbers → **472 196 046 0** and **472 196 051 0**

Bad part numbers → **472 196 025 0** and **472 196 037 0**

- If the part numbers are good, install the connector. Clean a spot on the base label (Form WAR259), and attach a campaign completion sticker for FL966 (Form WAR260), indicating this work has been completed.
- If at least one of the part numbers is bad, go to the replacement procedure for the specified group, and replace both the modulator valves.
