News Channel Update | Vans Customer Service and Parts

TO: Mercedes-Benz Dealer Principals, General Managers, Sales Managers, Service Managers, Parts Managers	FROM: Anthony Washington, Department Manager, Regulations and Certifications
Re: Recall Campaign Launch Notification Model - Sprinter Model Years 2019-2020 Modify Interior Blower Motor Fuse Layout	DATE: June, 2023

Campaign No. :	Campaign Desc. :	Modify Interior Blower Motor Fuse Layout		
2023040008	VS30SIGEBL			
This is to notify you of a Recall Campaign Launch to modify the interior blower motor fuse layout on approximately 48,136 MY				
2019-2020 Mercedes-Benz Sprinter vans. The recall campaign will be visible on the <u>www.safercar.gov</u> website and may generate questions from customers. All affected VINs will be flagged as "OPEN" in VMI and cannot be sold until remedied.

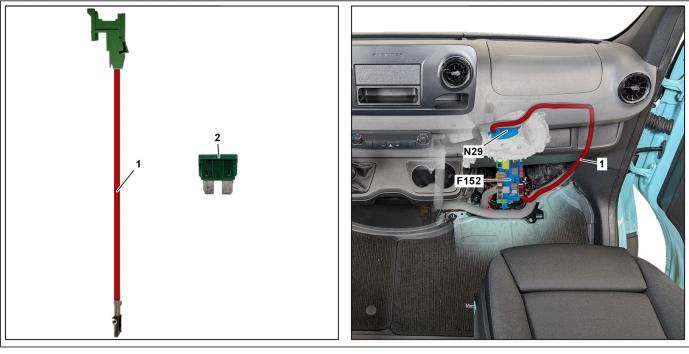
1 Electrical line

F152

Front-passenger-side fuse N29 and relay module

D83.10-A024-79 Blower regulator of inner blower

2 Fuse link

4	Check		
1	Check whether vehicle is affected by measure.	Clip: Replace blower regulator power supply (code: VS30SIGEBL, acc. no.: 82 970 10) A video with a simplified presentation is available for this measure. Nevertheless, all work instructions and information in this document are to be observed as a matter of priority.	GB83.10-D-0000-06A
X	Remove		
2 Frank	Remove vehicle tool kit carrier plate.		AR68.30-D-5021TS
3	Release front passenger side fuse and relay module (F152).		AR54.15-D-0004TS
₩ F AR		i Do not remove front passenger side fuse and relay module (F152).	AR54.15-D-000415

4.1	Remove stowage compartment in instrument panel lower section on front passenger side.	Model 907 with code FJ4 (Stowage compartment under cockpit)	AR68.10-D-1610TS
₩ AR 4.2	Remove bottom trim for instrument panel on front passenger side.	Model 907 except code FJ4 (Stowage compartment under cockpit)	
₩ĨAR			AR68.10-D-1502TSF
	Retrofit electric lines (1)		CM02 40 D 0242 0200
5	Retrofit electric line (1) for power supply of blower regulator of inner blower (N29).		SM83.10-D-0013-02SG
		S Wiring harness repair kit, basic	000 589 13 99 00
