TO: Freightliner Principals, General Managers, Sales Managers, Service Managers, Parts Managers	FROM: Anthony Washington, Department Manager, Regulations and Certifications
Re: Recall Campaign Launch Notification Model - Sprinter Model Years 2019-2020 Modify Interior Blower Motor Fuse Layout	DATE: June, 2023

IMPORTANT RECALL CAMPAIGN INFORMATION

Campaign No. :	Campaign Desc. :	Modify Interior Blower Motor Fuse Layout
2023040008	VS30SIGEBL	
This is to notify you of a Recall Campaign Launch to modify the interior blower motor fuse layout on approximately 3,539 MY19-20 Freightliner Sprinter vans. The recall campaign will be visible on the www.safercar.gov website and may generate questions from customers. All affected VINs will be flagged “OPEN” in VMI and cannot be sold until remedied.		
Background		
Issue	Mercedes-Benz AG (“MBAG”), the manufacturer of Freightliner vehicles, has determined that on certain Sprinter (907 platform) vehicles, the fuse layout of the interior blower motor might not meet the requirements for prolonged operation at the highest blower setting. Ambient and assembly space temperatures as well as prolonged usage, could cause the wiring harness to overheat. Con

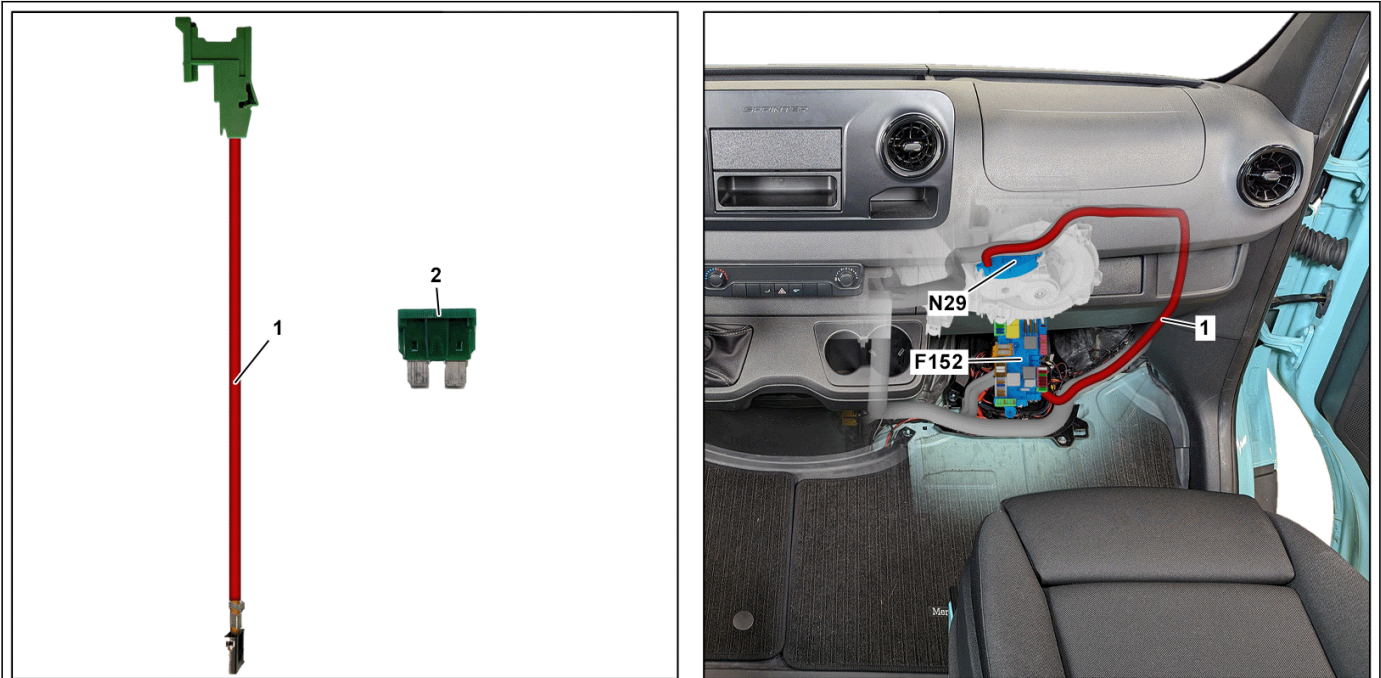
D83.10-A024-79

1	Electrical line	F152	Front-passenger-side fuse and relay module	N29	Blower regulator of inner blower
2	Fuse link

AR			
	Retrofit electric lines (1)		
5	Retrofit electric line (1) for power supply of blower regulator of inner blower (N29).	<p>
