April 2023
FL967A
NHTSA #23V-105
Transport Canada #2023-083

Subject: Drag Link Tapered Joint

Models Affected: Specific model years 2019-2021 Freightliner 108SD, 114SD, 122SD, Business Class M2, Cascadia, Columbia, and Coronado vehicles manufactured April 2, 2018, through June 25, 2020.

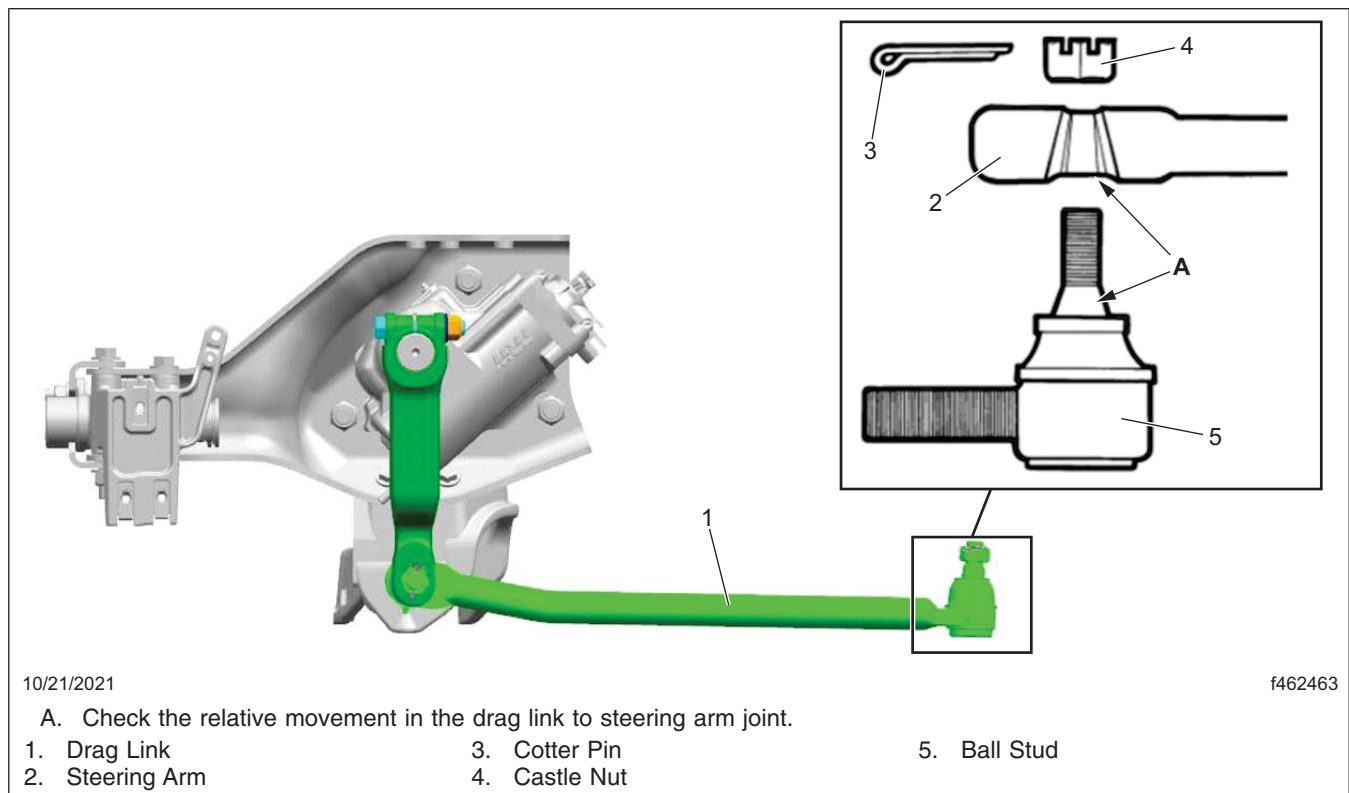
Fig. 1, Drag Link to Steering Arm Joint

4.2 While the steering wheel is being turned, check the behavior of the drag link to steering arm joint.

- The castle nut appears to be loose.
- The cotter pin is not in place.
- There is relative movement in the drag link to steering arm joint when the steering wheel is moved back and forth.
- If the vehicle is equipped with dual steering gears, follow the steps for both sides.

YES → Go to the **Drag Link and Steering Arm Replacement** procedure, on the next page.
