Bentley Bulletin

23-023

Subject: NON COMPLIANCE RECALL - SEAT AIR BAG MAY TEAR (RE23/03)

New Continental GTC and Bacalar

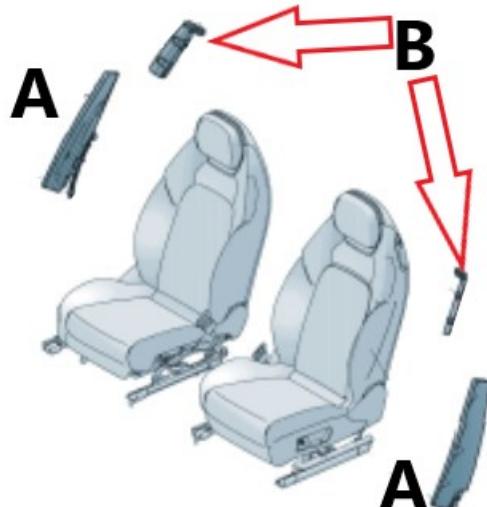
Figure 1

The left and right hand side front seat airbags are shown at (A)

The left and right hand side front seat airbag deflector brackets are shown at (B)

- The airbags are secured to the left and right hand seat frames by (x1) lower fixing and (x1) locating tab

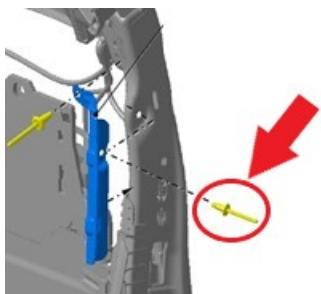
Only the side rivets shown in Figure 2 are affected on the left and right hand side front seats

Checks are required to be conducted on the left and right hand front seat side rivet mandrels (all vehicles)

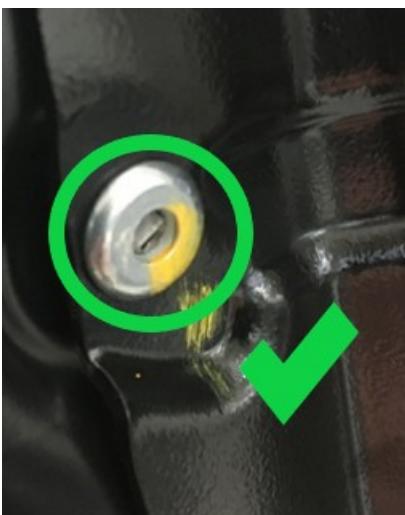
Figure 5

- The example shown in Figure 5, shows a mandrel which is not protruding

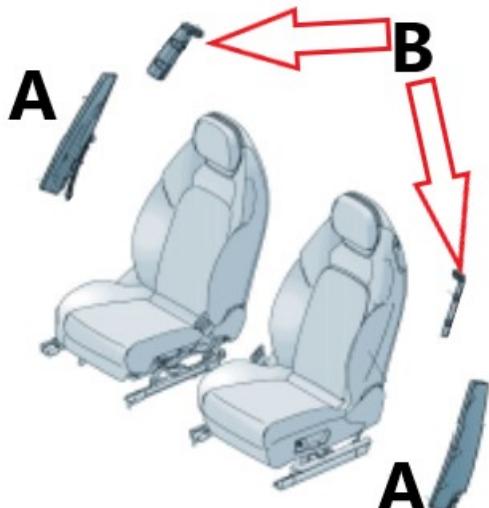
Figure 1

The left and right hand side front seat airbags are shown at (A)

The left and right hand side front seat airbag deflector brackets are shown at (B)

- The airbags are secured to the left and right hand seat frames by (x1) lower fixing and (x1) locating tab

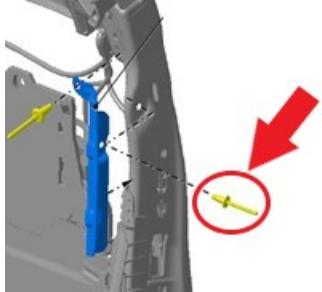
Only the side rivets shown in Figure 2 are affected on the left and right hand side front seats

Checks are required to be conducted on the left and right hand front seat side rivet mandrels (all vehicles)

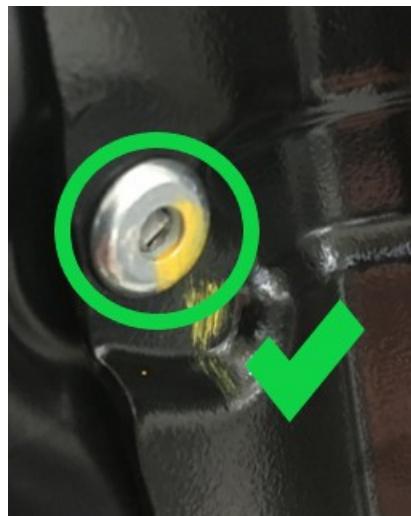
Figure 5

- The example shown in Figure 5, shows a mandrel which is not protruding

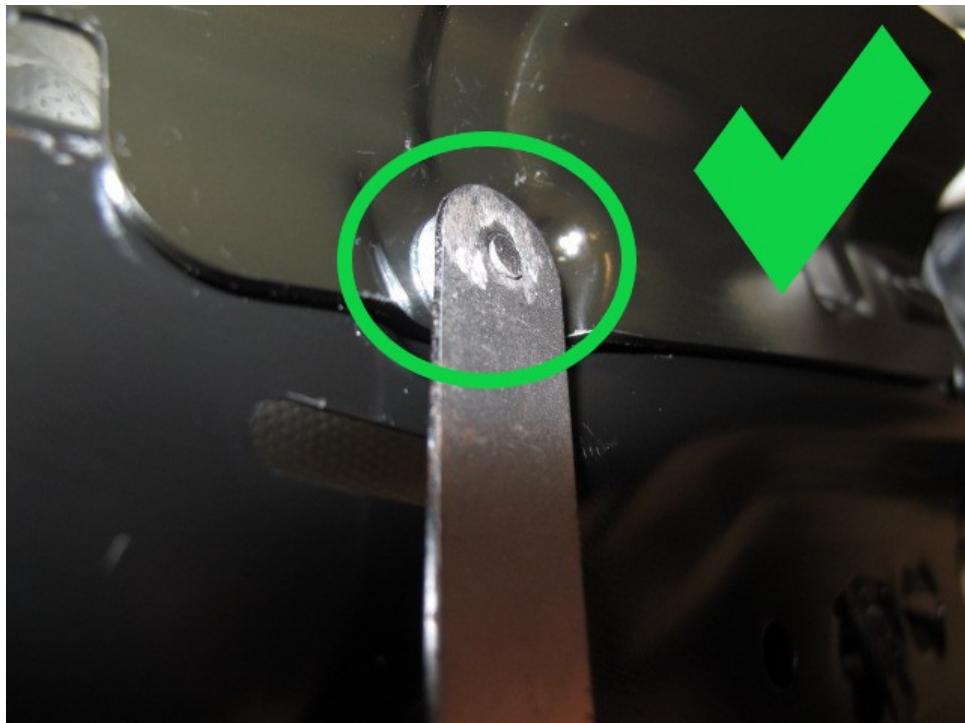
- In the event the mandrel is protruding <1mm (Less than or equal to 1mm) as shown in Figure 22 - Proceed to step 8

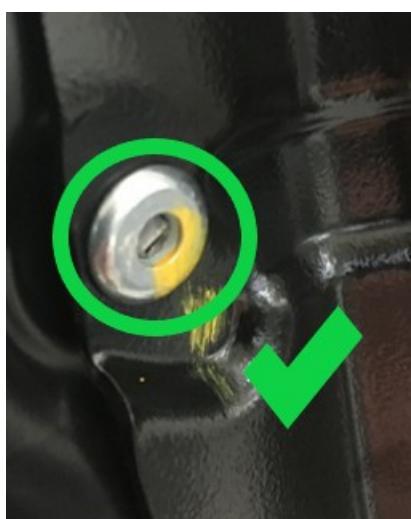
- The mandrel is not protruding Figure 23 - Proceed to step 8

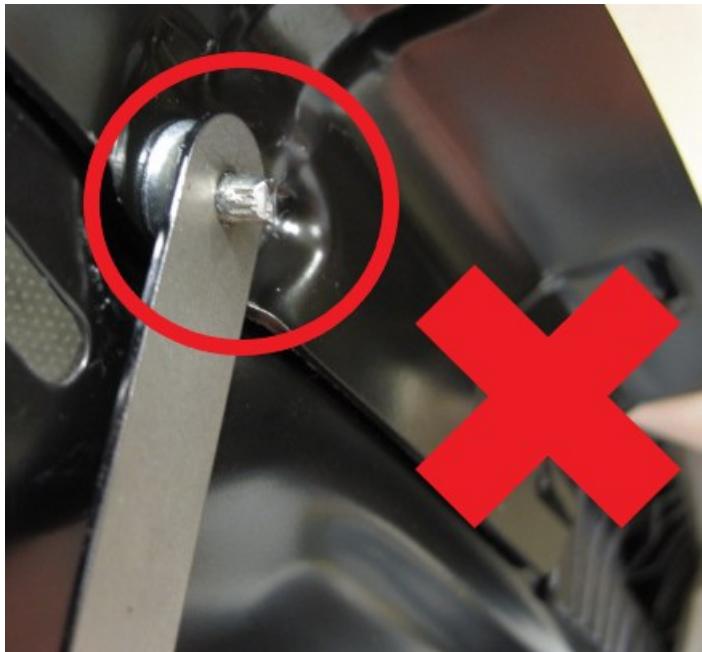
In the event the mandrel is protruding as shown in Figure 24 >1mm (greater than 1mm) the operative must conduct the mandrel rework procedure within Section 2 to completion
