**23507R4
July, 2024**

**SUBJECT: SAFETY RECALL
Grille surround on certain 2020 thru 2024
International® HX® Series trucks built 03/13/2019
thru 02/28/2023**

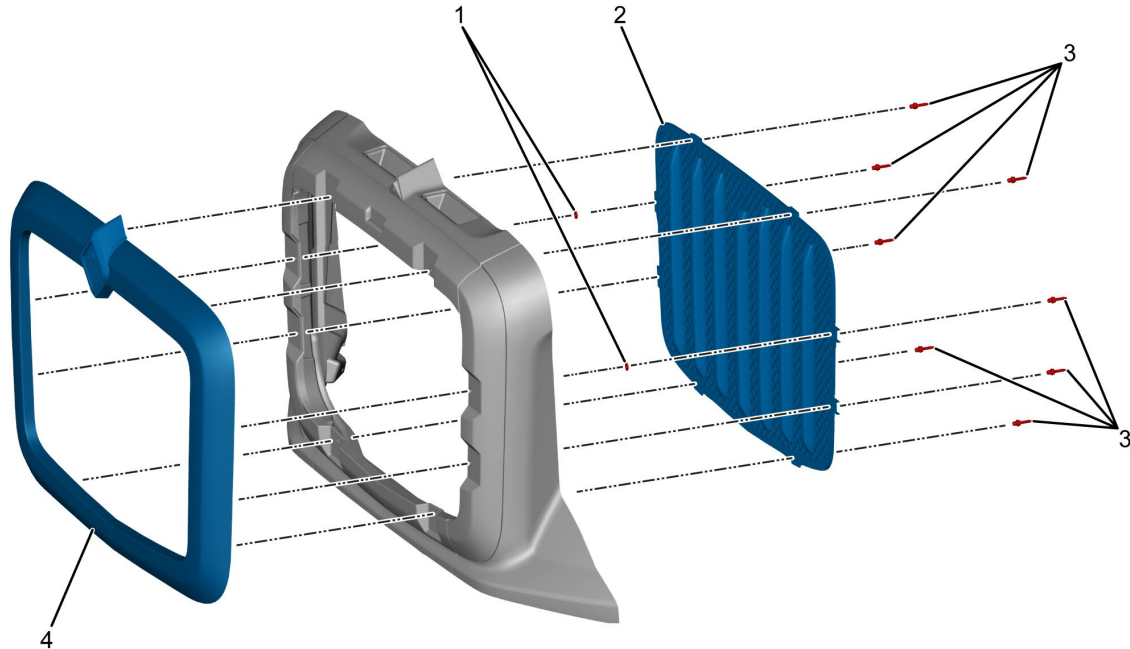
Figure 1. HX615 and HX620 Models Grille Surround Removal

Over time, the grille surround may come loose from the eight mounting brackets that secure it to the hood. This may cause the grille surround to separate from the truck. A grille surround that separates from the truck and falls to the roadway while the vehicle is in operation can increase the risk of a vehicle crash that may result in property damage, personal injury, or death.

1. M8 palnut (2)
 2. Grille assembly
 3. M8 Keps nut (8)
 4. Grille surround
2. Remove eight M8 Keps nuts (Figure 1, Item 3) from the back of grille surround (Figure 1, Item 4). Save M8 Keps nuts for reuse.
 3. Remove grille assembly (Figure 1, Item 2) from truck by pushing inward and rotating 90 degrees to remove it through hood opening.
 4. Remove two M8 palnuts (Figure 1, Item 1) from stud by rotating them counterclockwise. Save M8 palnuts for reuse.
 5. Remove and discard grille surround (Figure 1, Item 4).
 6. With hood in open position, position new grille surround (Figure 1, Item 4) into place on hood and install two M8 palnuts (Figure 1, Item 1).
 7. Install grille assembly (Figure 1, Item 2) inserting it through hood front opening, rotate grille 90 degrees, and position into place.

8. Install eight M8 Keps nuts (Figure 1, Item 3) and tighten nuts to 5.3–6.6 lb-ft (7.2–9.0 N·m).
9. Close and latch hood.
10. Remove wheel chocks.
