TO: Mercedes-Benz Dealer Principals, General Managers, Sales Managers, Service Managers, Parts Managers	FROM: Gregory Gunther, Department Manager, Vehicle Compliance and Analysis, Engineering Services
RE: Recall Campaign - Launch Notification Inspect Mounting of Rear Door Trim Bars MY22-23 GLE and GLS (167 and X167 platform)	DATE: April 21, 2023

Campaign No. 2023040011, April 2023

SUBJECT: **Models GLE and GLS (167, X167 platform)**
Model Year 2022-2023

Inspect Mounting of Rear Door Trim Bar

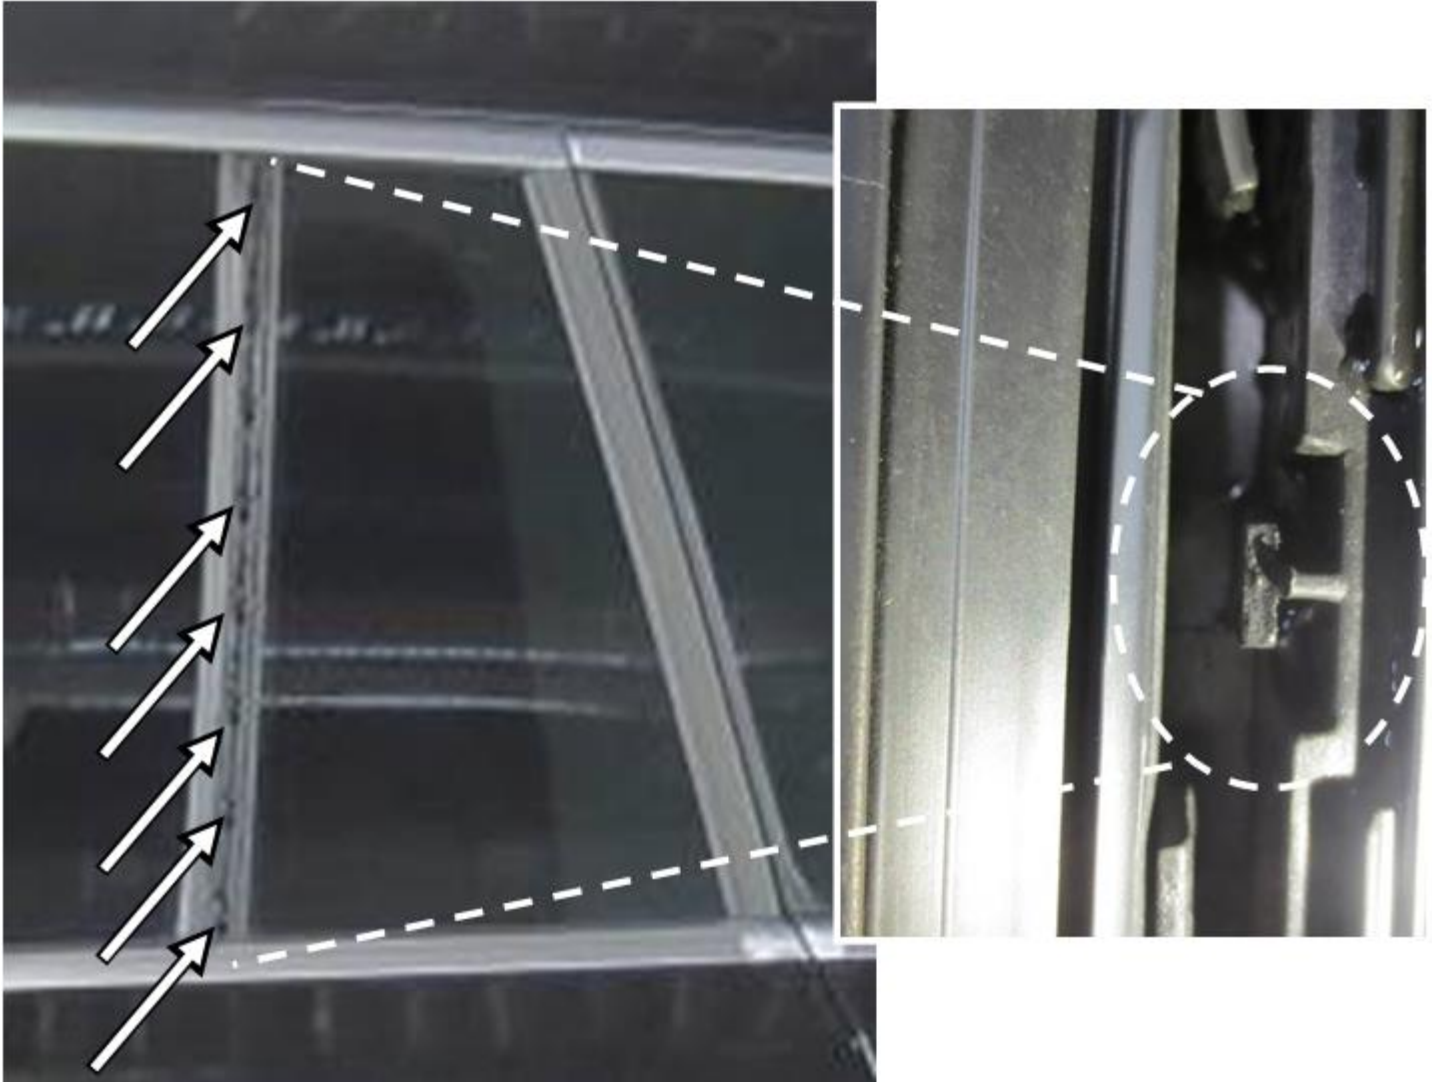
Figure 3

1. Remove window divider completely and check **holder for window divider** on frame of triangular window.

i If no damage is visible, reinstall window divider and check again whether it is tightly seated

a. Holder for window divider broken: Carry out **work procedure**.

b. Holder for window divider **not** broken: **End measure**.
