Recall Campaign Bulletin

Campaign No. 2023040009, April 2023

SUBJECT: **Model S-Class (223 platform)**
Model Year 2021

Rework the Primary Bulkhead Sealing

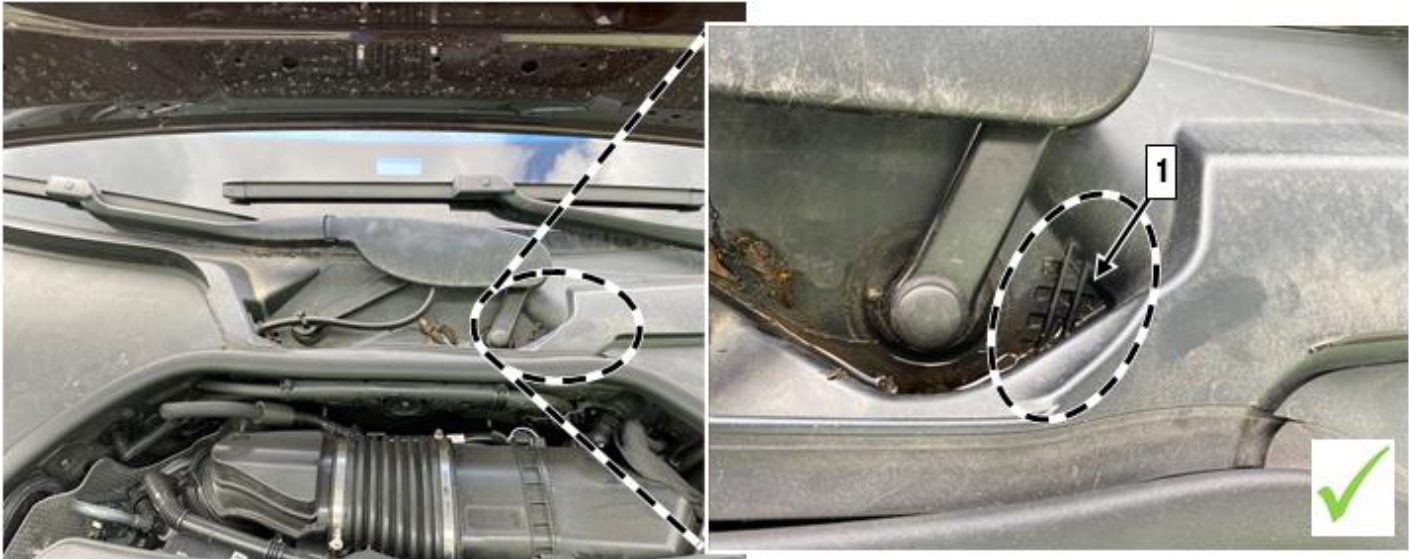
i Drain (1, Figure 2) of air/water duct at driver's side **must** be closed.

Figure 2 Drain of air/water duct OK

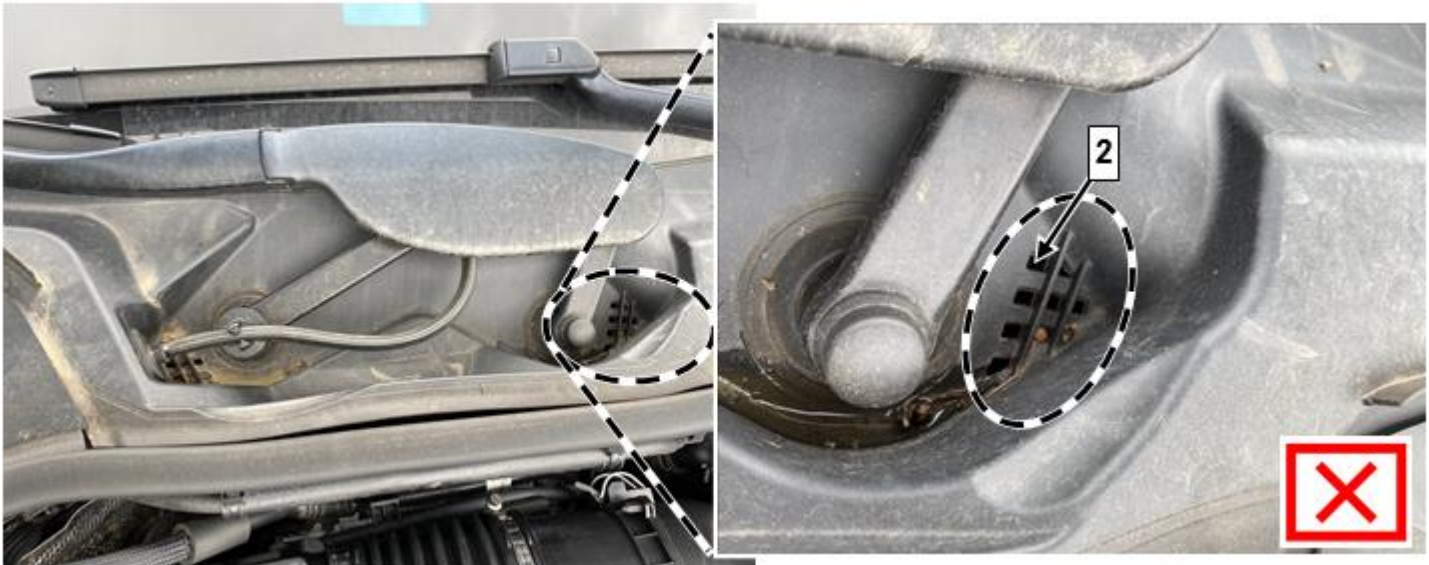
i If drain (2, Figure 2.1) is open, it **must** be replaced.

Figure 1.1 Drain of air/water duct not OK
