May 2023
FL969A-D
NHTSA #23V-237
Transport Canada #2023-202

Subject: Windshield Wiper Arms

Models Affected: Specific model years 2020-2022 Freightliner 108SD, 114SD, Business Class M2, and Cascadia vehicles; and Freightliner Custom Chassis Corporation Shuttle, Business Class M2, and S2RV chassis manufactured February 1, 2020, through September 1, 2021.

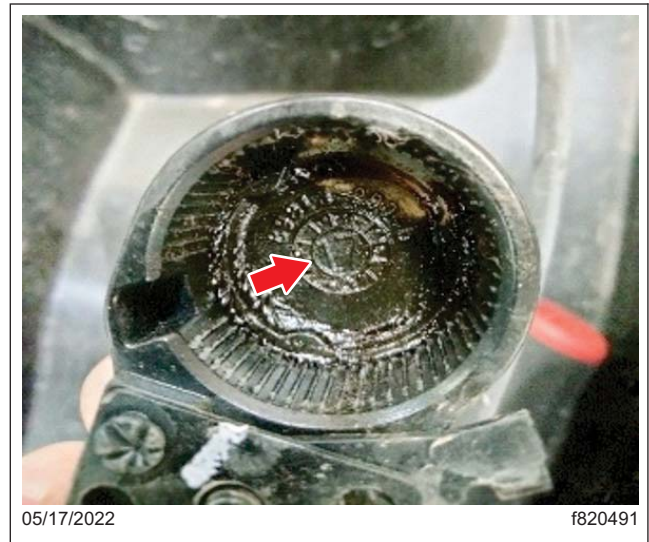
Fig. 2, Date Stamping on the Wiper Arm

In certain vehicles, the spline teeth in the windshield wiper arms may wear and break, resulting in a loss of wiper functionality, reducing the drivers visibility and increasing the risk of a crash.

Is the date stamping #21, or greater?

YES → Install the existing wiper arms in the parked position so they are aligned with the index marks on the windshield. Then go to step 19.

- Replace the wiper arm with the new wiper arm that has date stamping #21 or greater
