June 2023  
FL969A-D  
NHTSA #23V-237  
Transport Canada #2023-202  
REVISED NOTICE

## Subject: Windshield Wiper Arms

**Models Affected: Specific model years 2020-2022 Freightliner 108SD, 114SD, Business Class M2, and Cascadia vehicles; and Freightliner Custom Chassis Corporation Shuttle, Business Class M2, and S2RV chassis manufactured February 1, 2020, through September 1, 2021.**

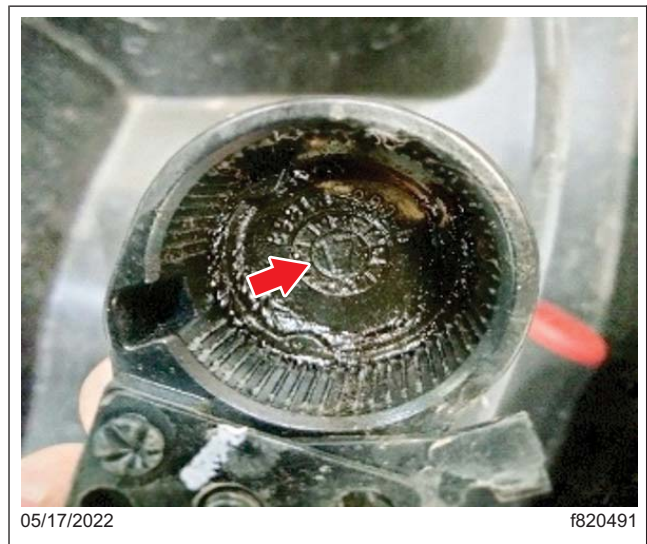
**Fig. 2, Date Stamping on the Wiper Arm**

In certain vehicles, the spline teeth in the windshield wiper arms may wear, resulting in a loss of wiper functionality, reducing the drivers visibility and increasing the risk of a crash.

Is the date stamping #21, or greater?

- Replace the wiper arm with the new wiper arm that has date stamping #21 or greater

NOTE: Both wiper arms—having old and new date stamping—bear the same part number.
