FL970 (D23R6) **REV1**

NHSTA #23V-238 (Non-School Bus)

Subject: Steer Axle Castle Nut and Cotter Pin

Models Affected: 2, 3 & 5 DETROIT™ Front Steer Axles

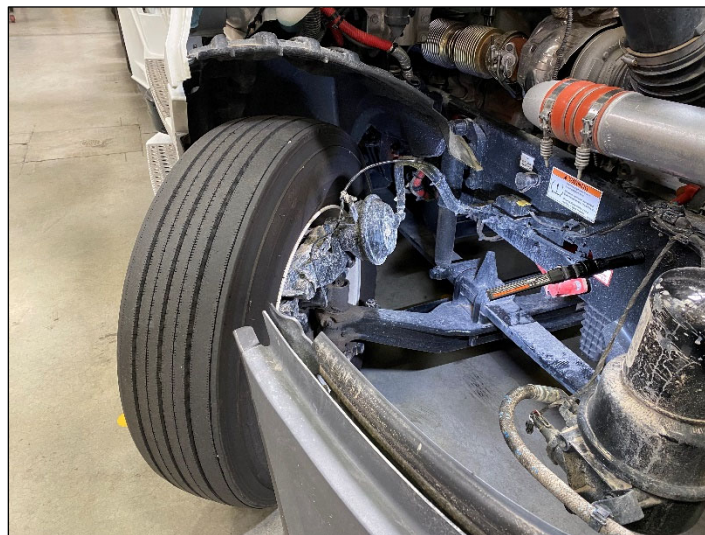
Fig. 1, Hood Opened and Wheel Turned Full Right

4. Start engine (key ON, engine ON), and turn the steering wheel to full right, as shown in [Fig. 1](#).
5. Turn ignition OFF with park brake set.

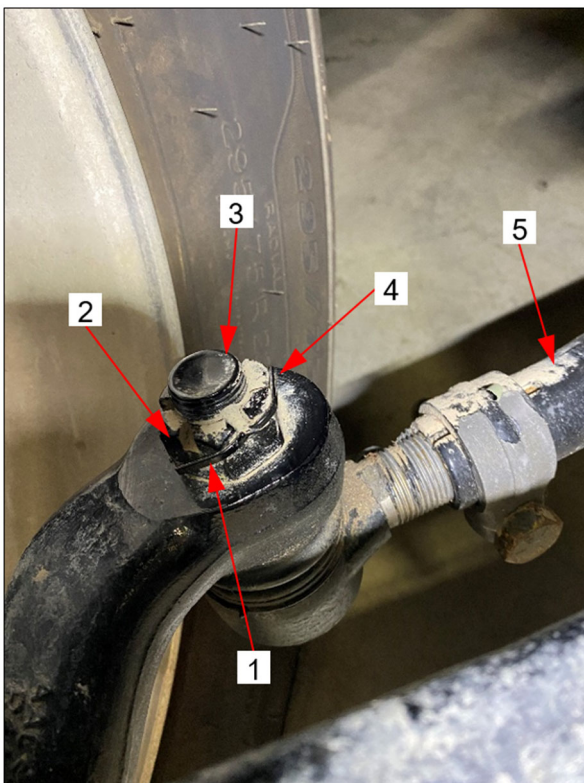
Fig. 2, Cotter Pin Location

On the affected vehicles, the steer axle tie rod castle nut cotter pin may be missing, allowing the steering arm to detach. This could lead to a loss of steering response and a lack of direction control, increasing the risk of a crash. The driver may experience some additional free-play in the steering and/or feel an improper steering alignment.

5. Remove the cotter pin from the tie rod end. See [Fig. 2](#) and [Fig. 3](#).

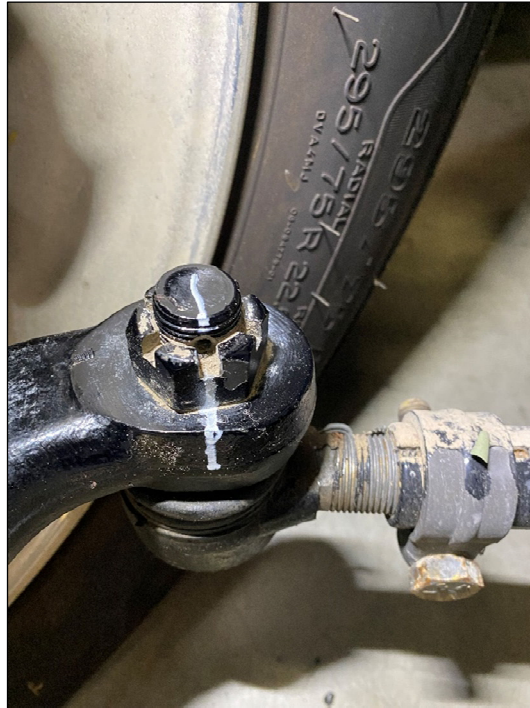
Fig. 4, Tie Rod Bolt, Castle Nut, and Tie Rod Arm Marked

6. Use a paint pen to mark the tie rod bolt, tie rod castle nut, and tie rod arm, as shown in [Fig. 4](#).

7. Tighten the castle nut to 130 lbf-ft (176 N·m), and inspect if either the tie rod bolt, tie rod castle nut, or tie rod arm have moved from the initial marked position. Do any of these components move after tightening the castle nut?
- YES** → Go to the **Tie Rod Assembly Replacement** procedure.
- NO** → Install a new cotter pin in the tie rod end.

1. Replace the tie rod assembly. For instructions, see **Group 33** of the applicable workshop manual.
2. Perform a full vehicle alignment. For instructions, see **Group 33** and **Group 35** of the applicable workshop manual.
IMPORTANT: If the vehicle is equipped with an APS3 steering gear, it must be calibrated when an axle alignment is performed. For calibration instructions, see **Group 46** of the applicable workshop manual.
3. Test drive the vehicle in order to calibrate the electronic stability control system (ESC).
4. Clean a spot on the base label (Form WAR259), and attach a campaign completion sticker for FL970 (Form WAR260), indicating this work has been completed.
