August 2023
FL970 (D23R6)
NHSTA #23V-238 (Non-School Bus)
NHTSA #23V-259 (School Bus)
Transport Canada #2023-206 (Non-School Bus)
Transport Canada #2023-219 (School Bus)

Subject: Steer Axle Castle Nut and Cotter Pin

Models Affected: 2, 3 & 5 DETROIT™ Front Steer Axles

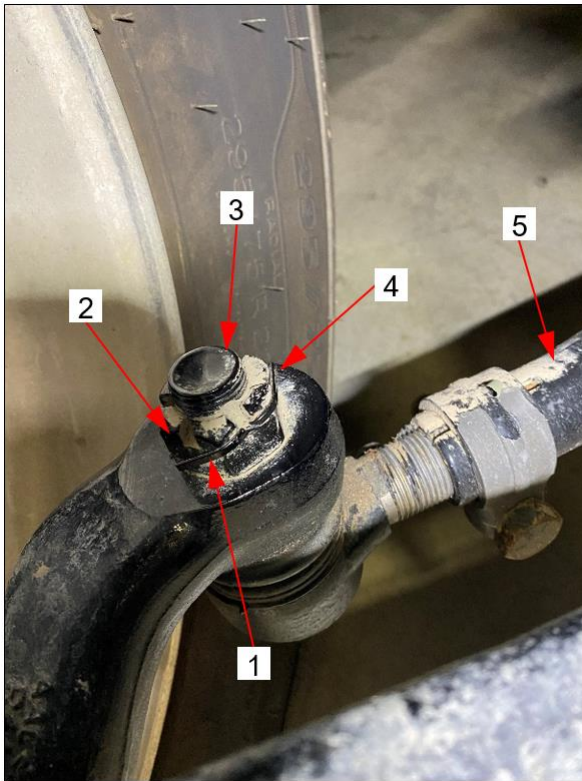
Fig. 2, Cotter Pin Location

5. Remove the cotter pin from the tie rod end. See [Fig. 2](#) and [Fig. 3](#).

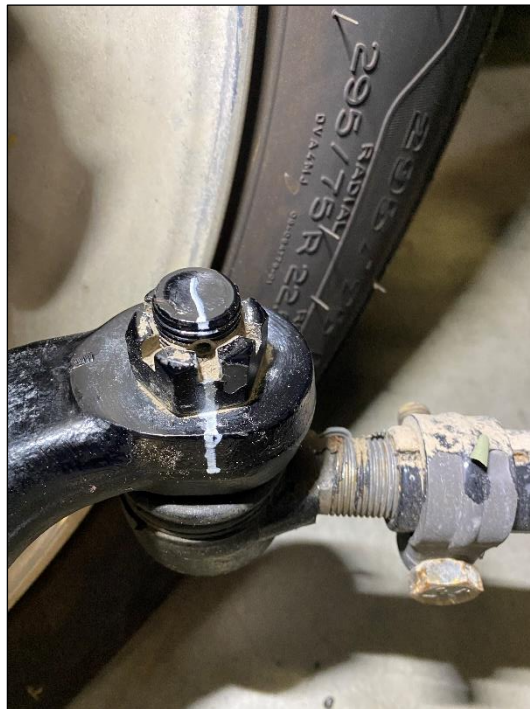
Fig. 4, Tie Rod Bolt, Castle Nut, and Tie Rod Arm Marked

6. Use a paint pen to mark the tie rod bolt, tie rod castle nut, and tie rod arm, as shown in [Fig. 4](#).

7. Tighten the castle nut to 130 lbf-ft (176 N-m), and inspect if either the tie rod bolt, tie rod castle nut, or tie rod arm have moved from the initial marked position. Do any of these components move after tightening the castle nut?
- YES** → Go to the **Tie Rod Assembly Replacement** procedure.
- NO** → Install a new cotter pin in the tie rod end.
