**RECALL CAMPAIGN
INSTRUCTIONS**

REF. NO. C24000085

**REPLACEMENT OF
FUEL TANK CONNECTING PIPE**

MODEL YEARS 2022 - 2023

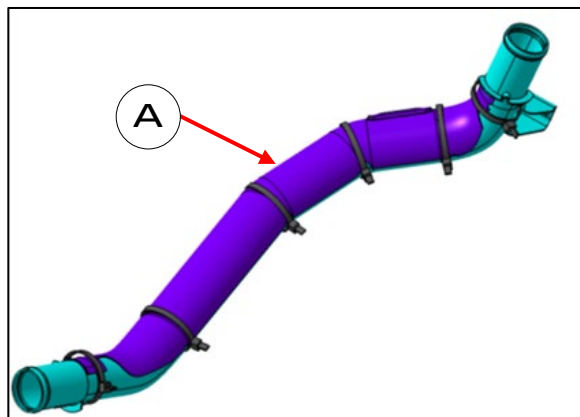
Two 35 - 45mm diameter screw collars will also be needed, as shown below. These collars should be purchased on the local market and not from the Parts Department.

Description	Part No.	Quantity
FUEL TANK CONNECTING PIPE (A)	988896	1

Description	Part No.	Quantity
SCREW COLLAR, Ø35-45 mm	296781	2
