February 2024  
FL973 A-F  
NHTSA #23V-333  
Transport Canada #2023-276  
REVISED BULLETIN

## Subject:TBB C2 Interior Side Sheet Joint

**Models Affected:Specific model years 2021-2024 Thomas Built  
Buses Saf-T-Liner C2 school buses manufactured  
January 24, 2020,through April 18, 2023.**

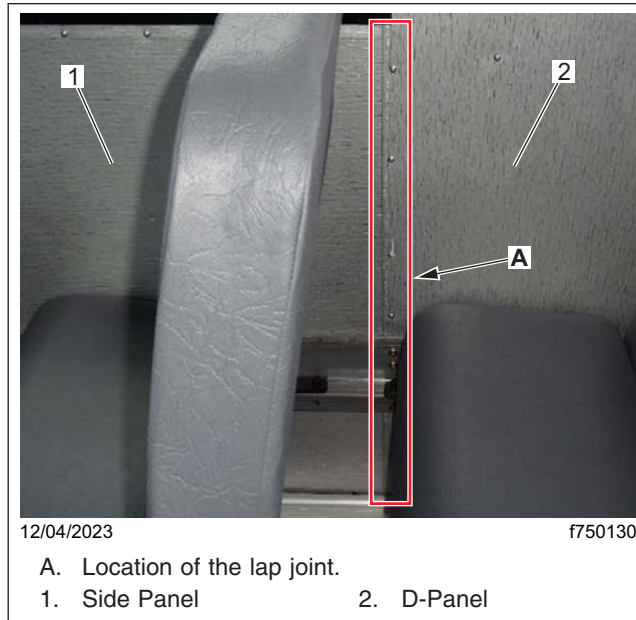
**Fig. 2, Location of the Lap Joint**

On the affected vehicles, the rear interior joint formed by the D-panel overlapping the side-sheet at the last rafter may have been manufactured incorrectly, resulting in insufficient joint strength, increasing the risk of injury in a crash.

- To identify the correct installation location for the new fasteners, locate the rear interior joint formed when the D-panel overlaps with the side-sheet at the last rafter as shown in **Fig. 2**, and mark the fastener locations as follows.
